# Motor vehicle inspection

**MTA Pre Purchase Inspection ABN: 72158123418**

| Vehicle Make and Model | Mazda 2 |

| Inspection Date: | 27 Sep 2017 |

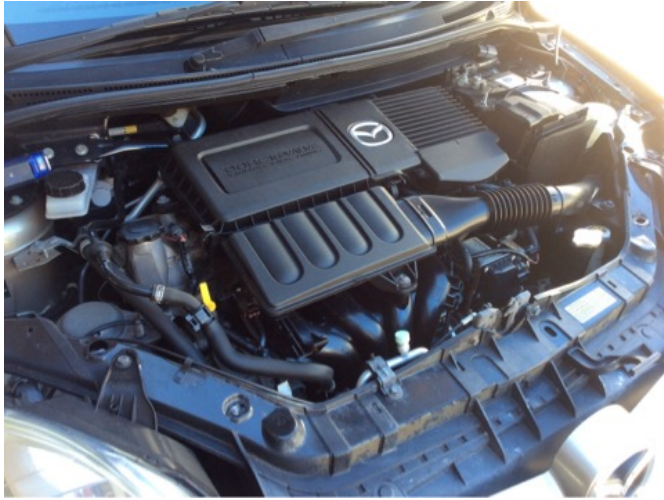
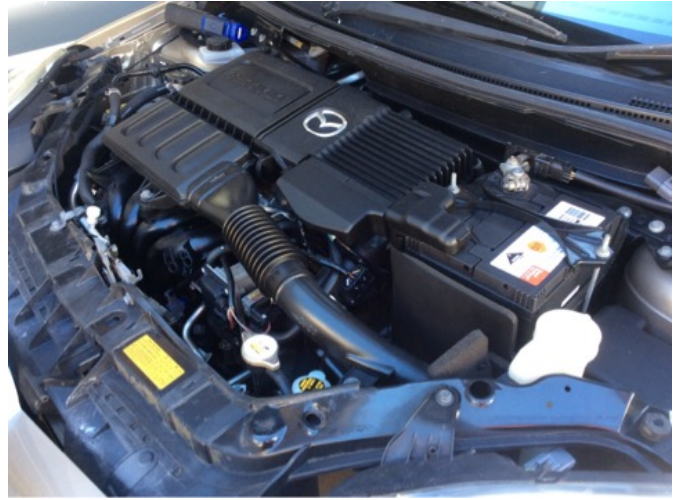
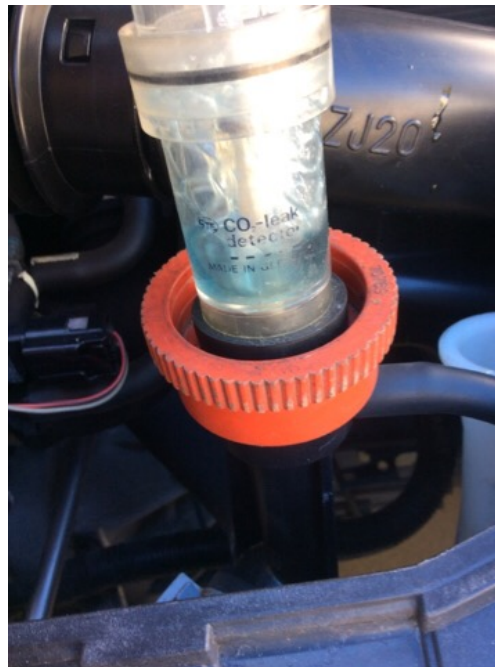
The engine and it components appear in good order of service at the time of inspection.

Engine runs and sounds good with no internal running faults.

Engine mounts have been load tested appear to be ok however unable to access condition of concealed mounts.

Exhaust system is in good general condition for age and kilometers. No major leaks or damage evident at this time.

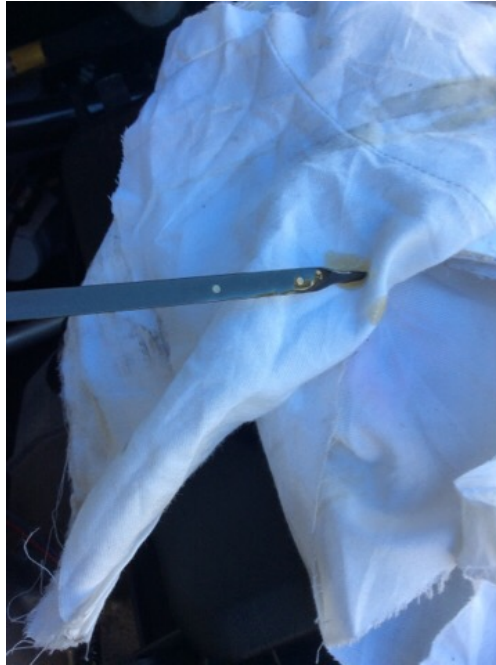
## Oil and lubrication

Oil level is correct and appears to have been recently serviced.

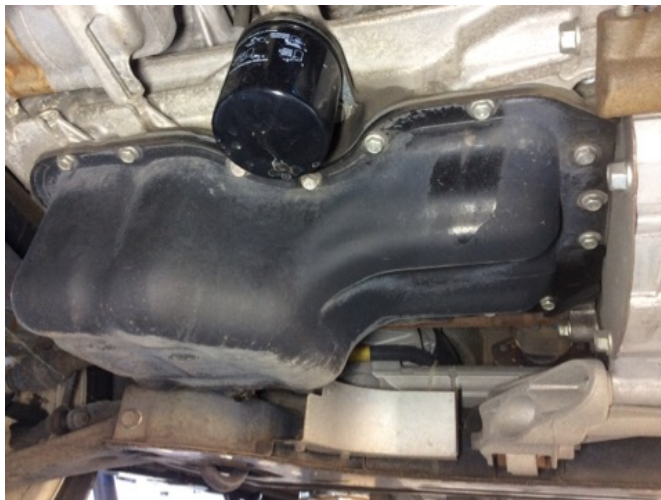
### **Engine oil leaks**

No engine oil leaks found at time of inspection.

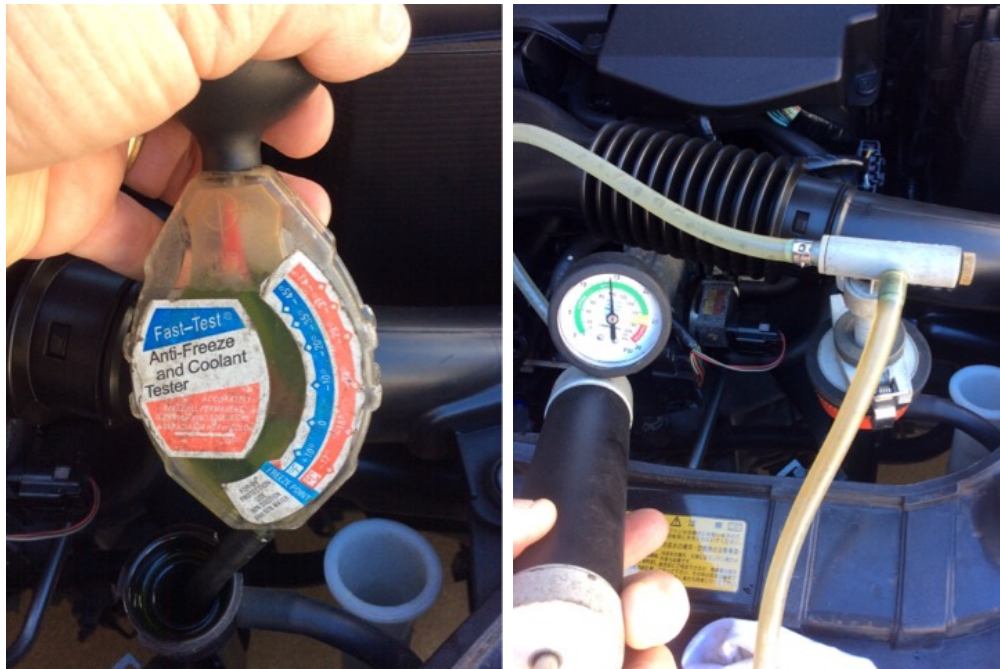
The cooling system and its components appear in good order of service at the time of inspection. Cooling system has passed pressure test. Engine is running at normal temperature. Radiator corrosion inhibitor concentrate level measured and is at serviceable level.

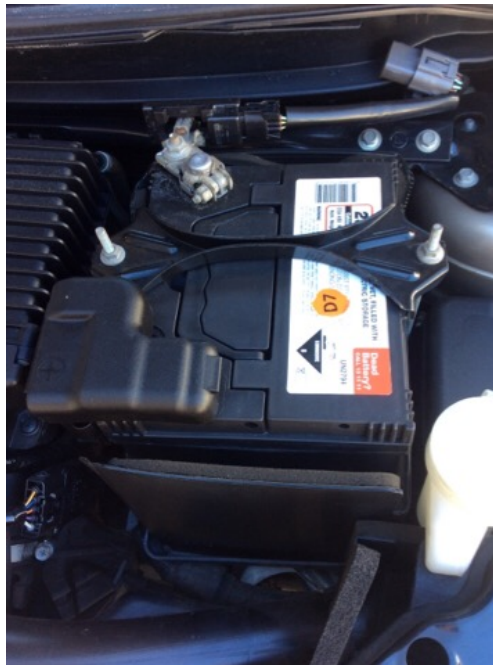
### Battery

Battery appears to have been recently replaced.

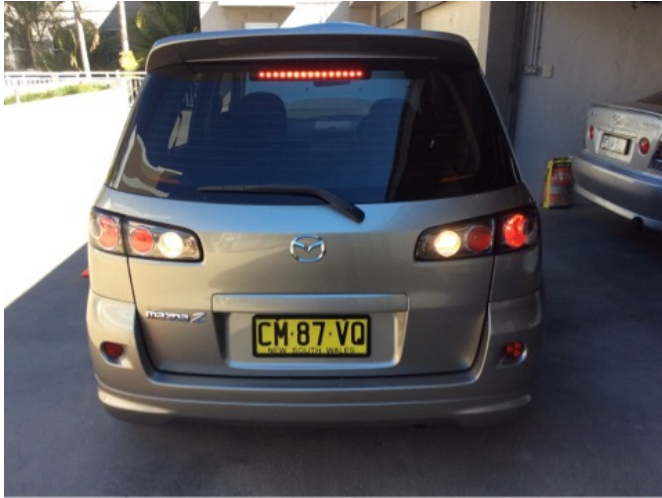
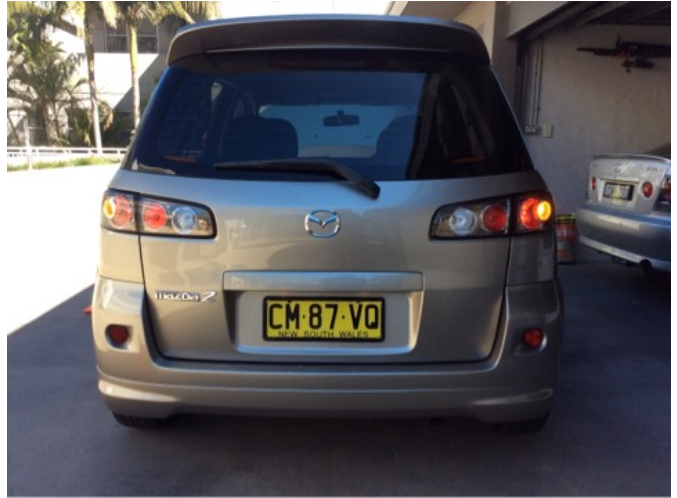
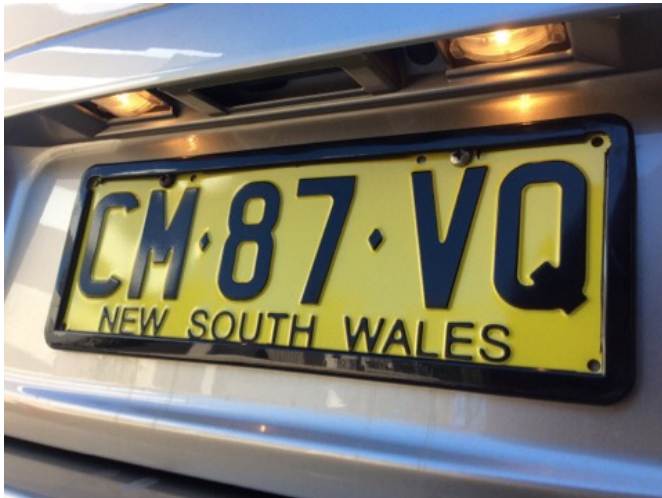
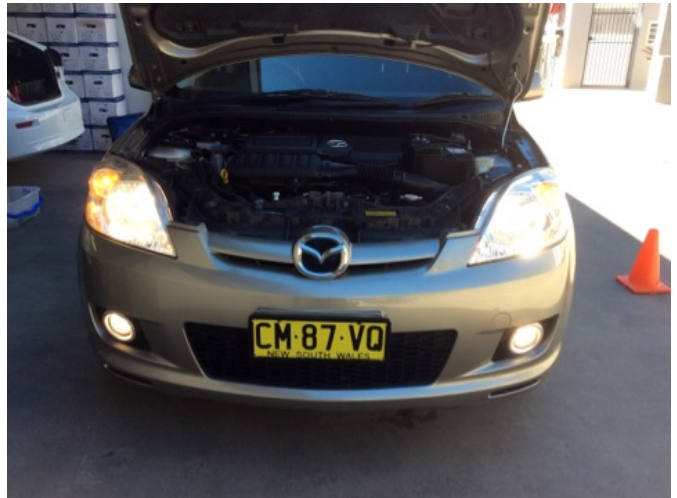
### Lights and lenses

Front and rear lights have been tested-all working at time of inspection.

Upgraded headlight globes fitted.

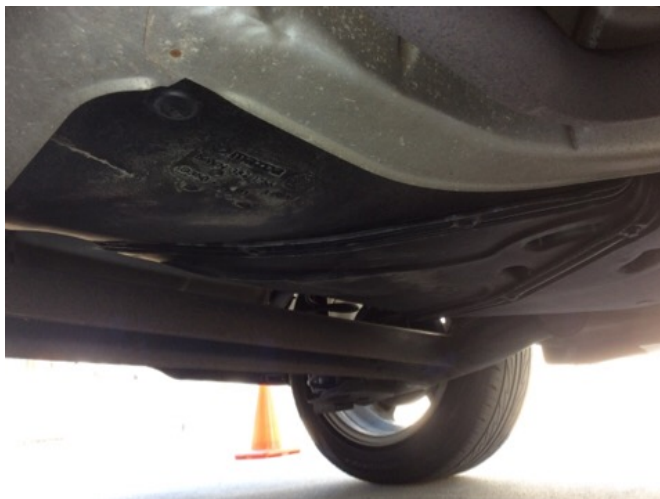
The fuel system appears to have no faults and is in good condition at time of inspection. No fuel leaks evident.

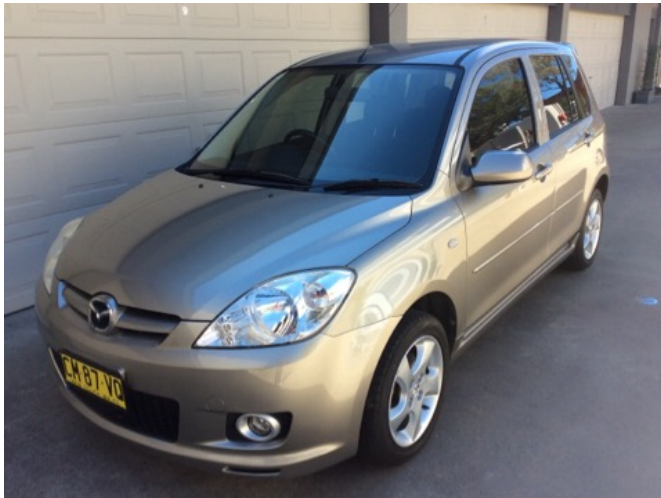
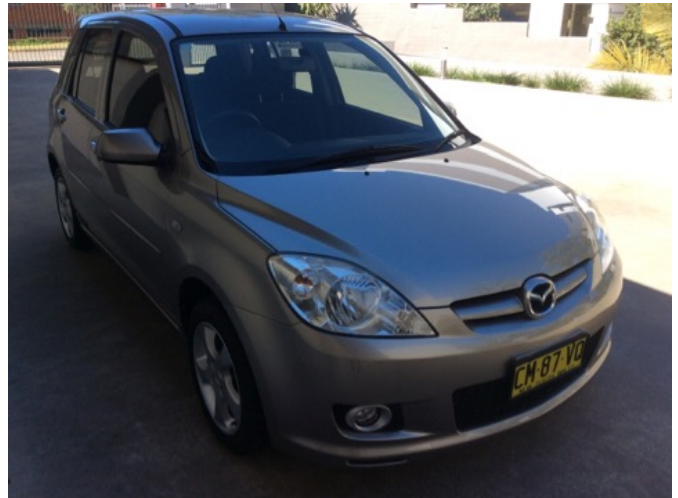
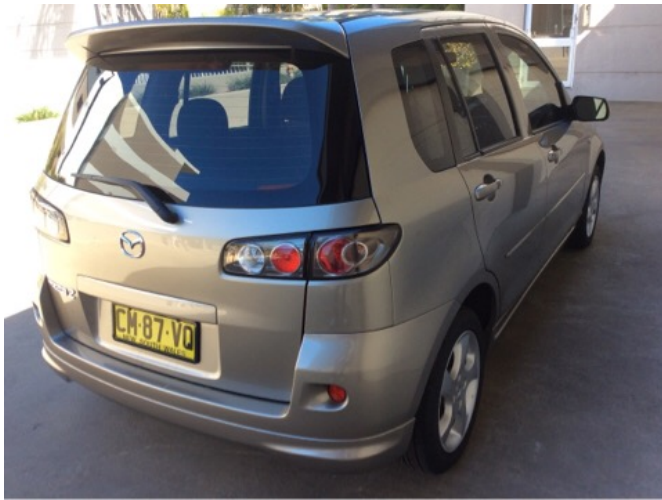
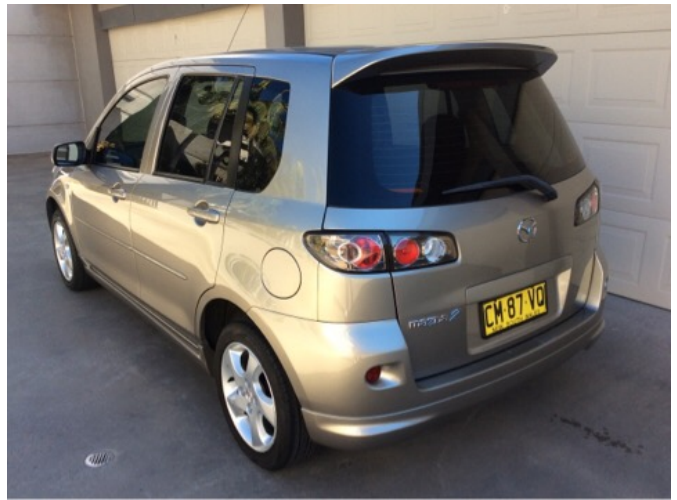
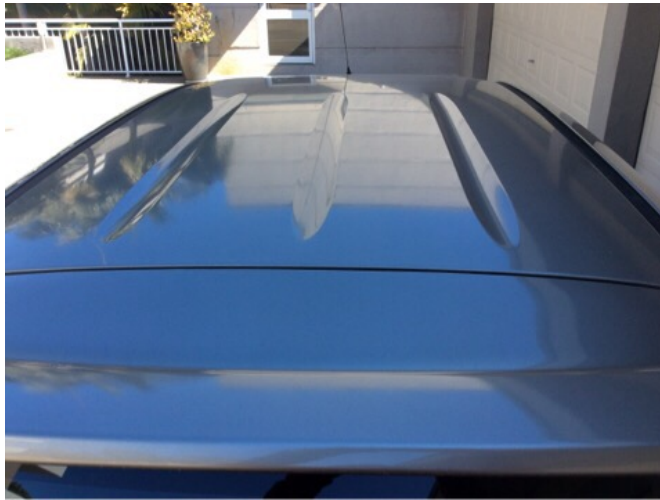
The body appears to be in good order. No major accident damage or repairs evident at time of inspection.

Vehicle shows no signs of previous body repairs. Overall paint thickness is consistent with factory original thickness.

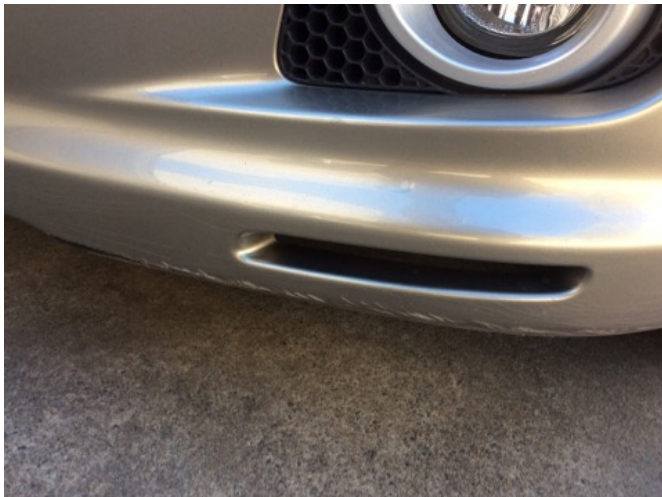
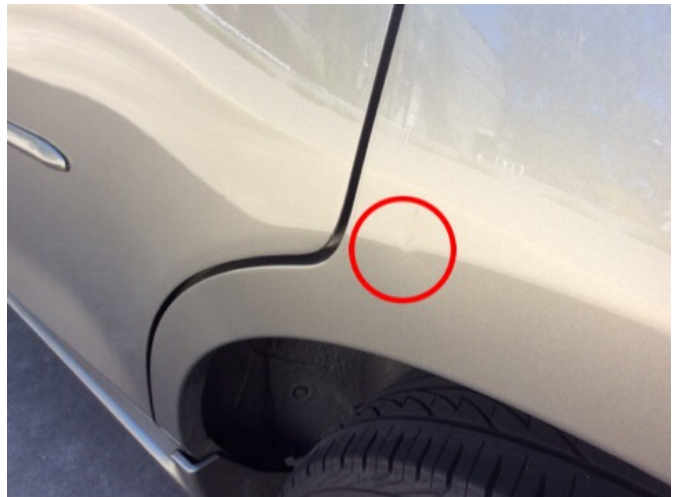
## External appearance

Carpark type dents, chips, scratches and marks to various panels and bumpers however external presentation is good.

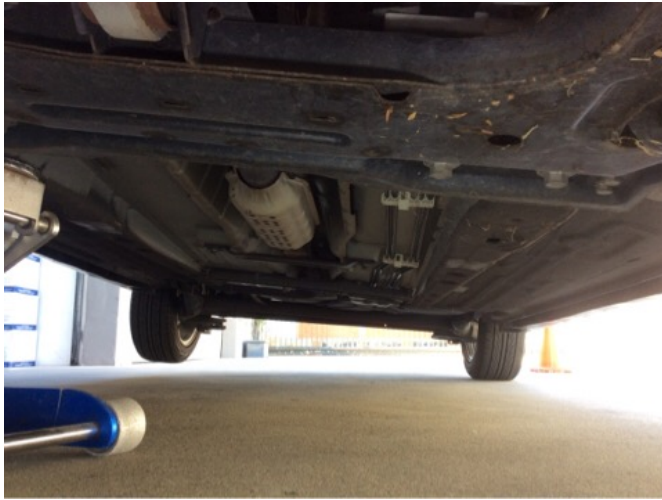
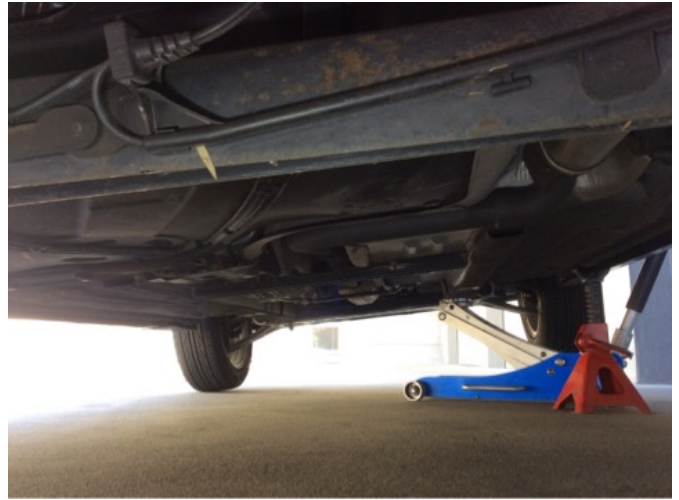
## **Underbody.**

The underbody of the vehicle is in good order at the time of inspection

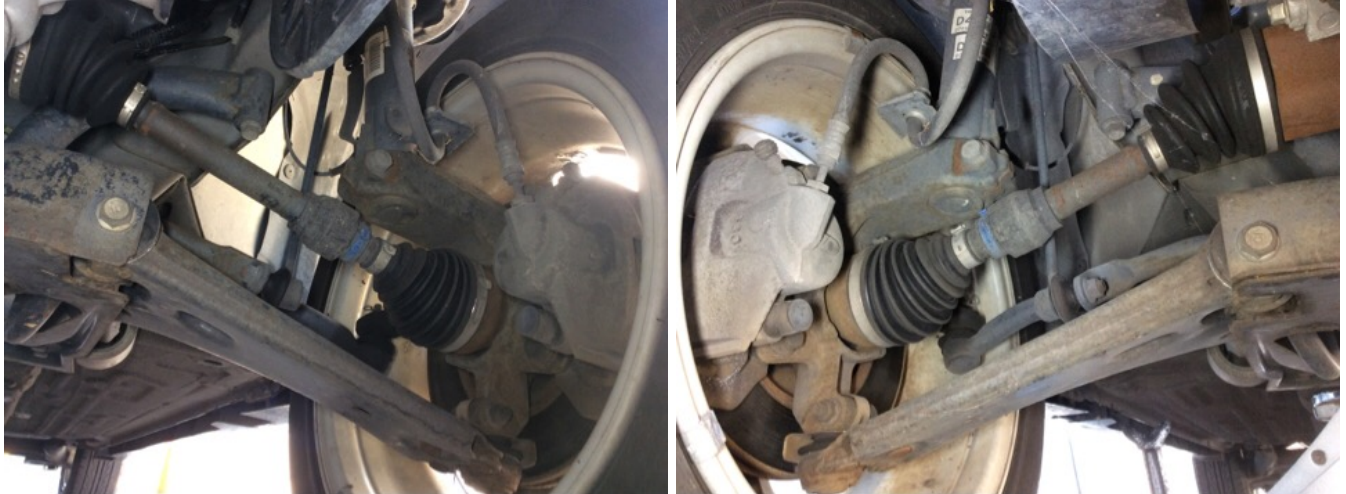
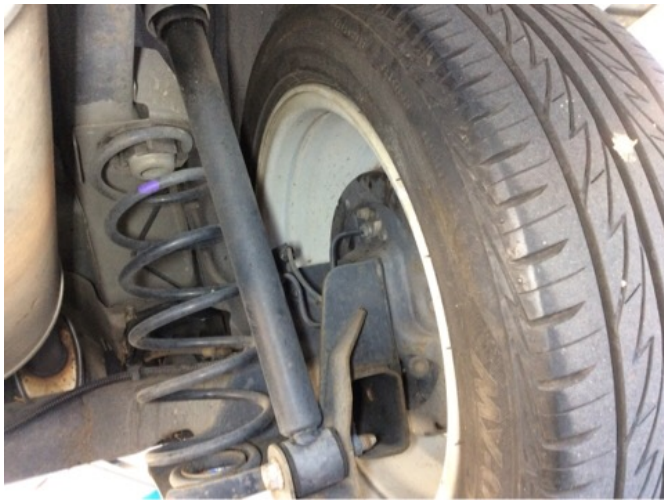
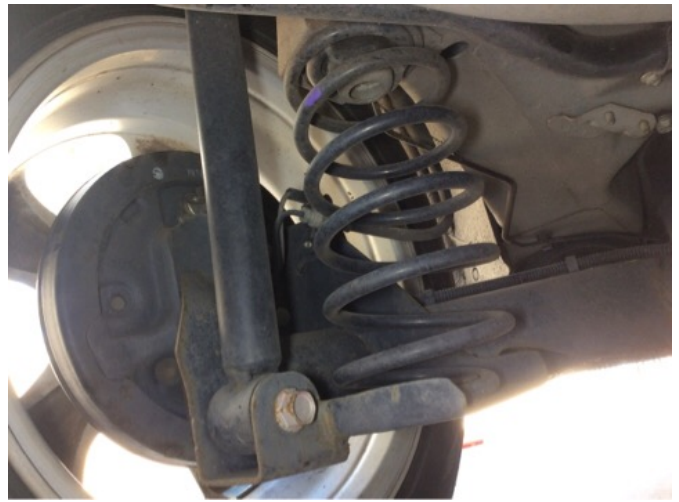
No major issues noted during inspection.

Steering suspension and rubber bushes showing typical wear for kilometres, some components will require replacing as needed during vehicles service life-all ok at this stage.

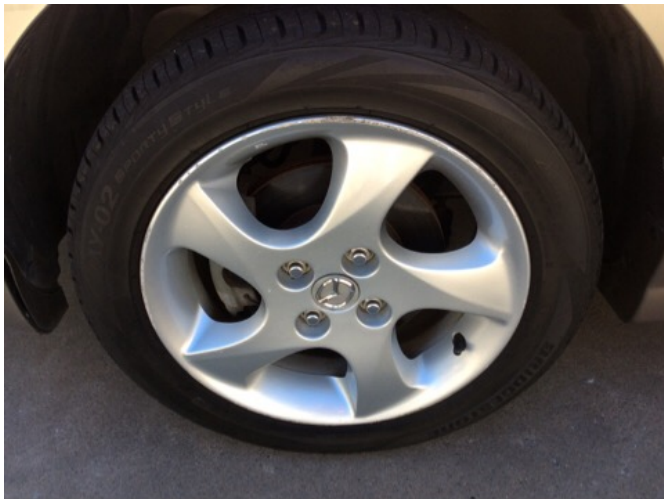
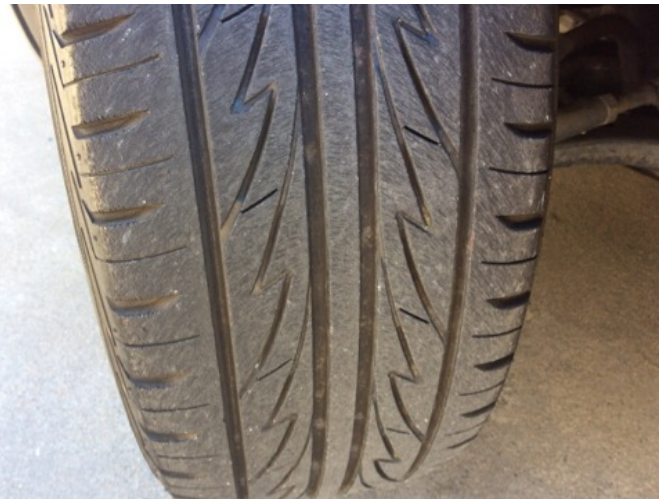
#### **Front Left**

Kerb marks to wheel rims.

95%

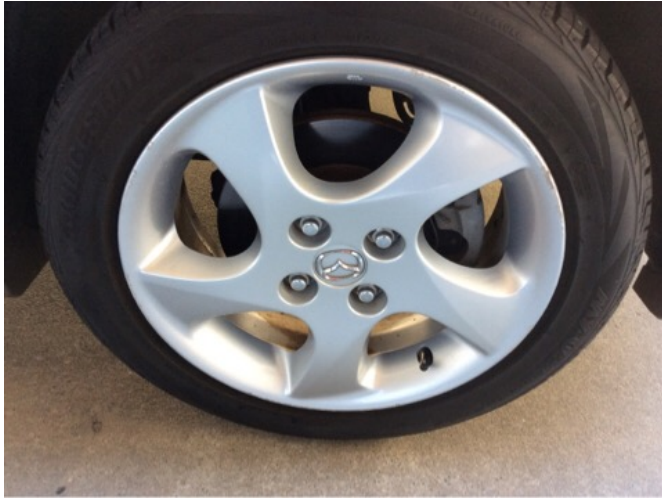
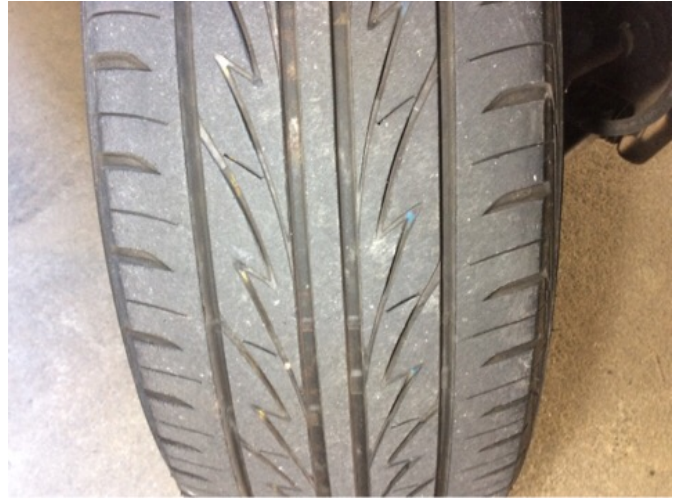
#### **Front Right**

Approximately 95%

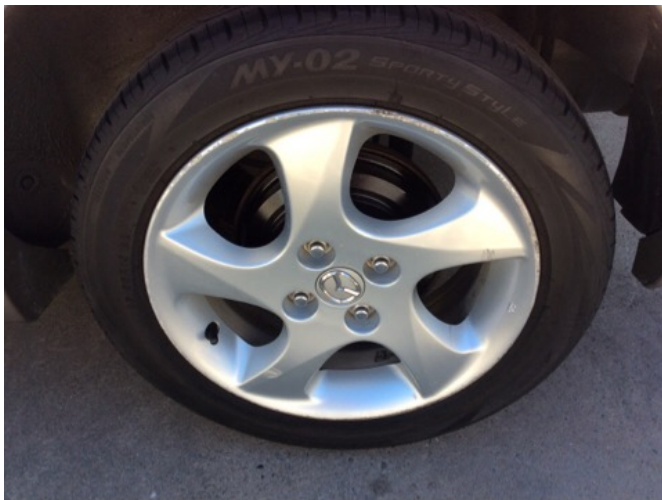
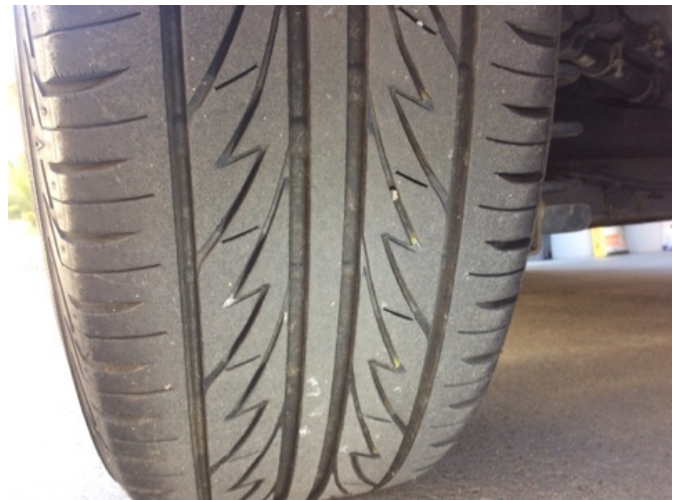
### Rear Left

Approximately 95%

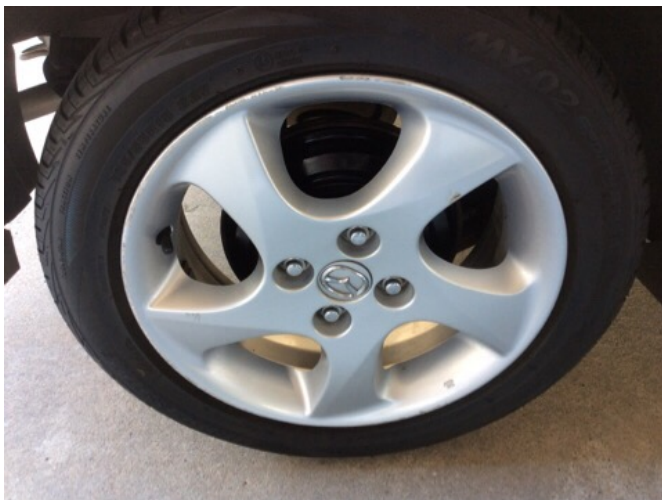
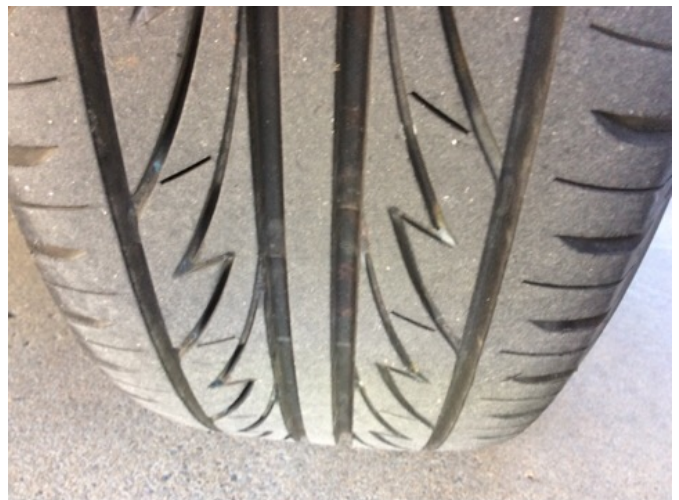
### Rear Right

Approximately 95%

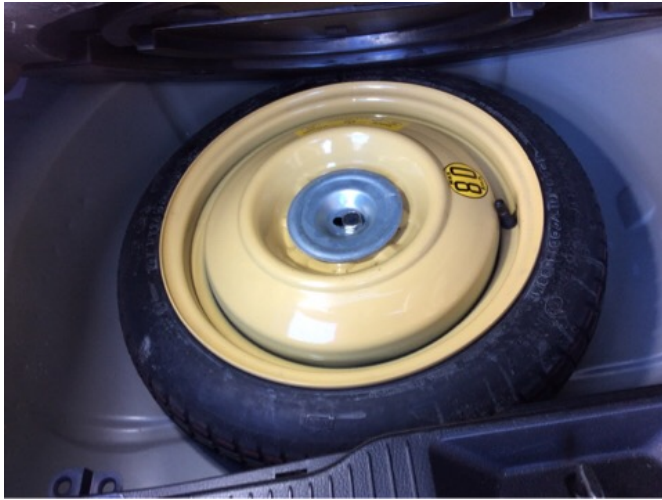
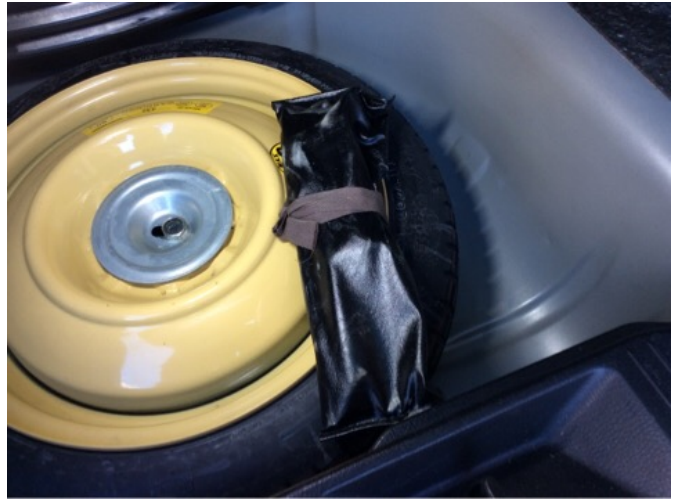
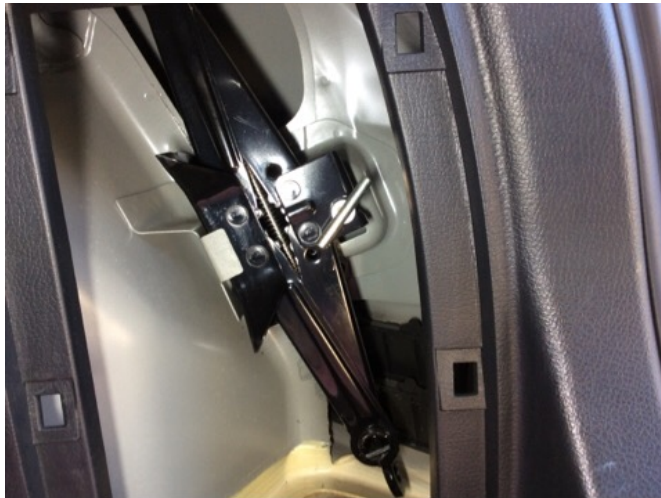
## Spare

Approximately 100%

Temporary spare as standard

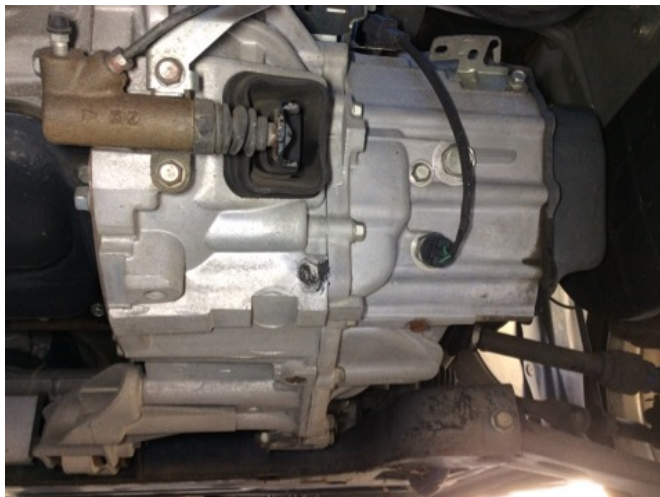
No faults or issues found with external driveline and transmission components, visually appears to be in good order at the time of inspection. This is subject to test drive outcomes. Refer to road test for transmission and driveline operation.

No oil leaks visible at underbody driveline.

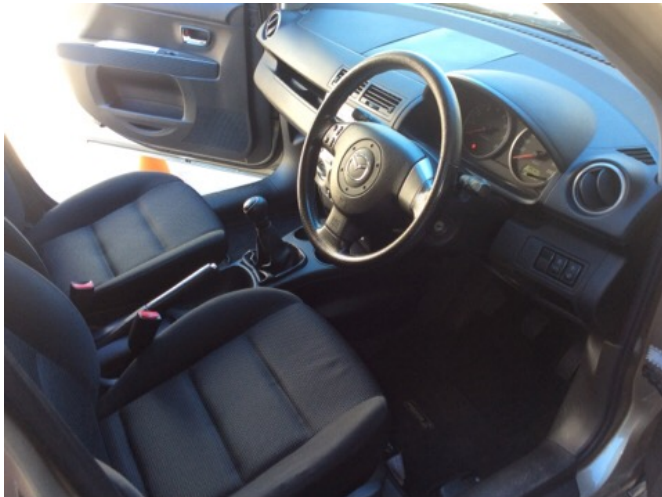
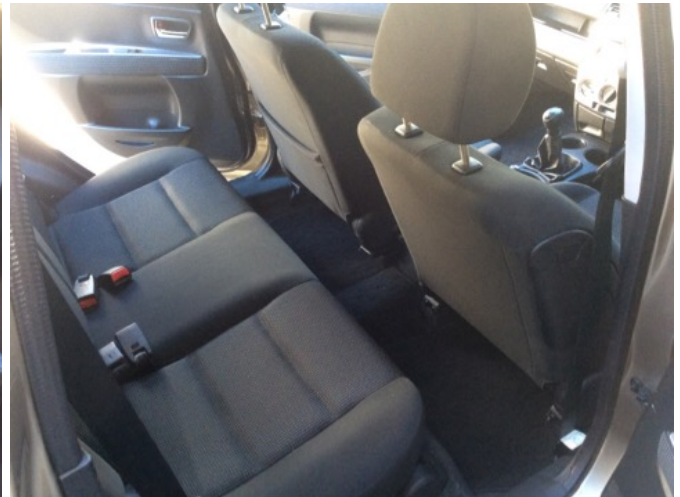
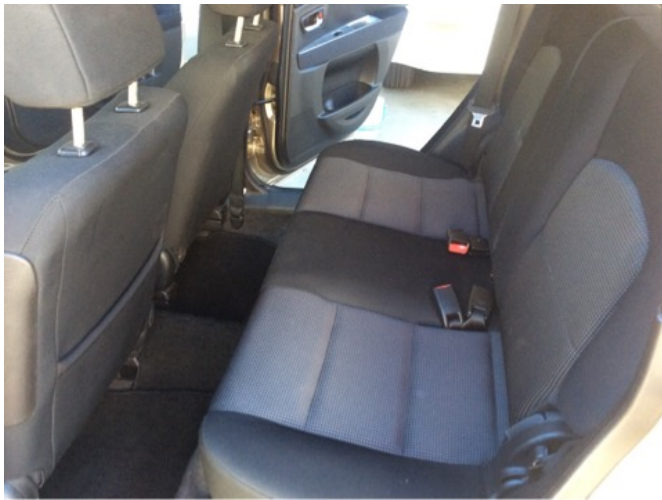
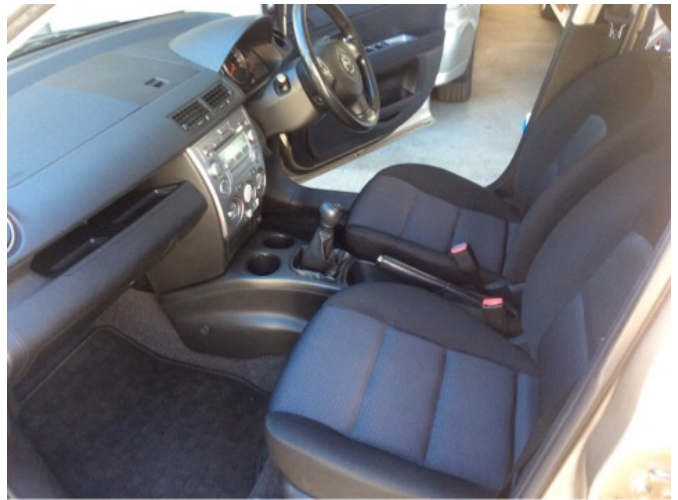
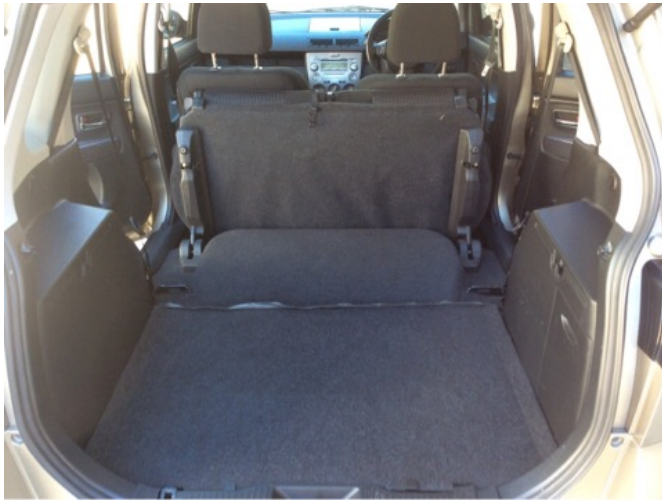
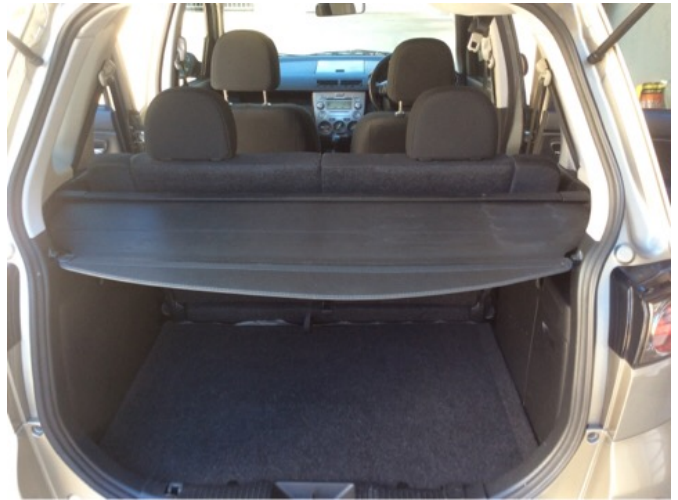
The interior trim and components appear to be in good order at the time of inspection.  
General wear and tear to upholstery and trims mainly to contact areas.

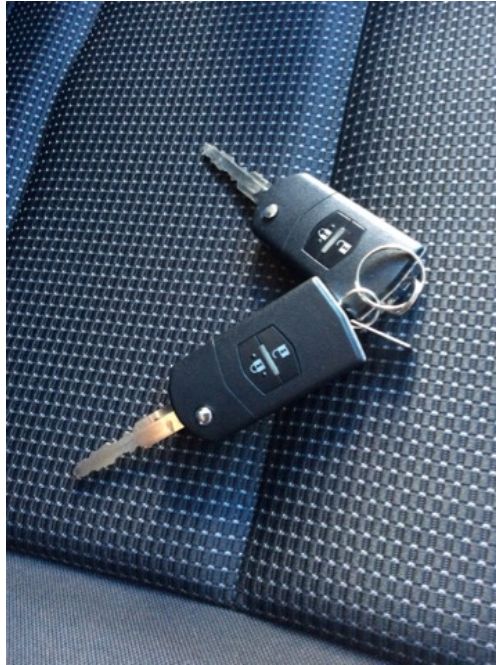
### **Keys and remotes**

Two keys sighted.

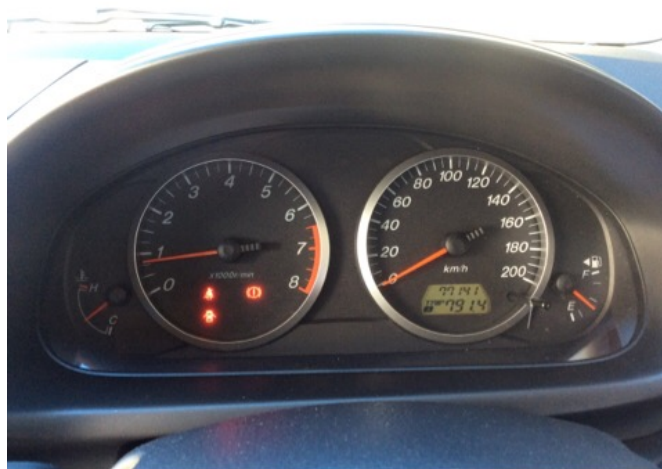
### **Warning lights / Cluster**

No warning lights illuminated at time of inspection.

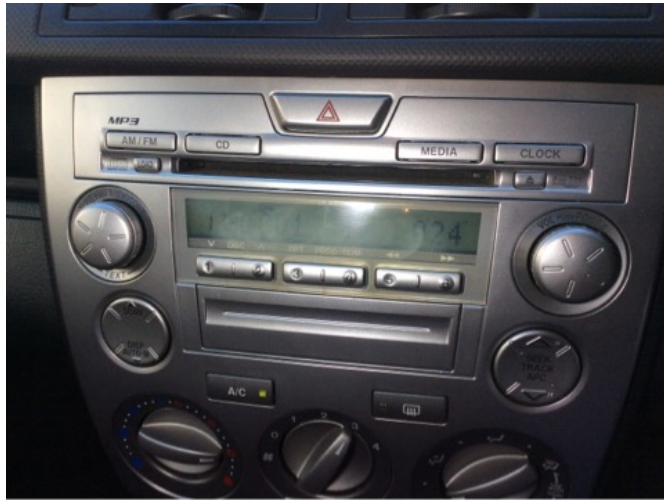
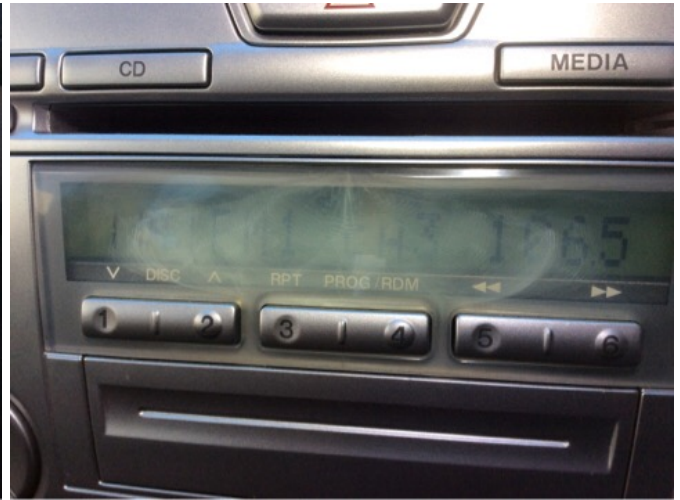
### **Entertainment.**

Entertainment system operational (radio and Cd player)

Radio led display difficult to read.

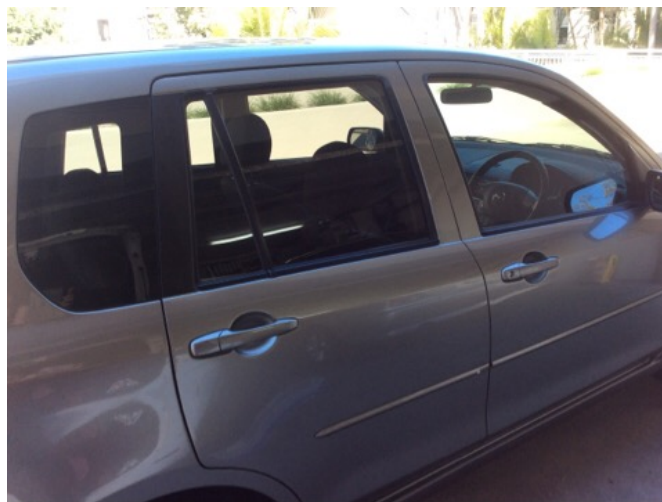
### Aftermarket Window tint and accessories.

Windows have been tinted.

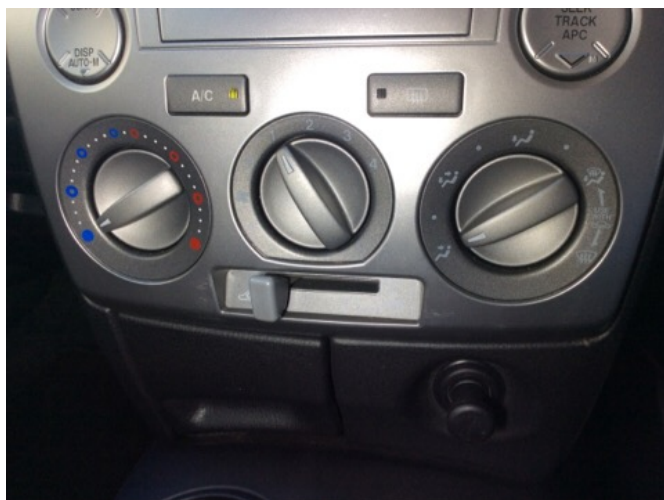
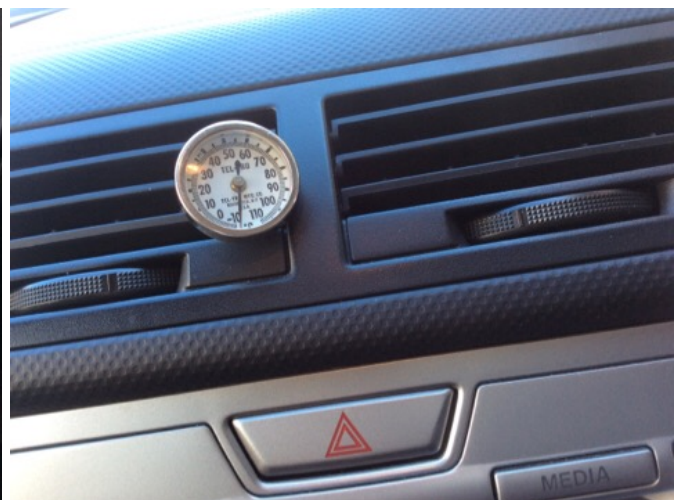
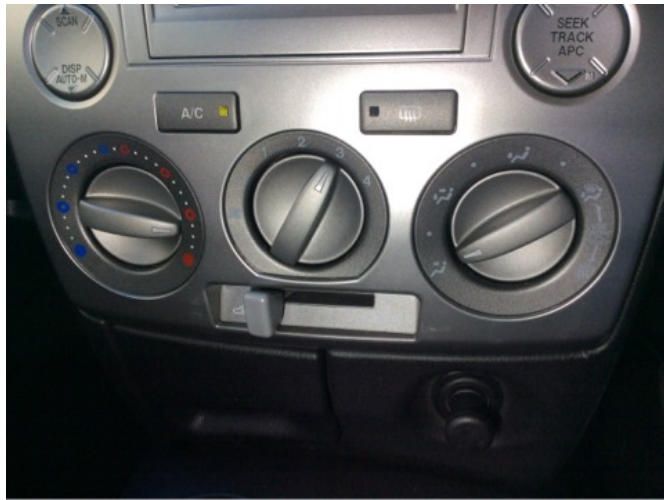
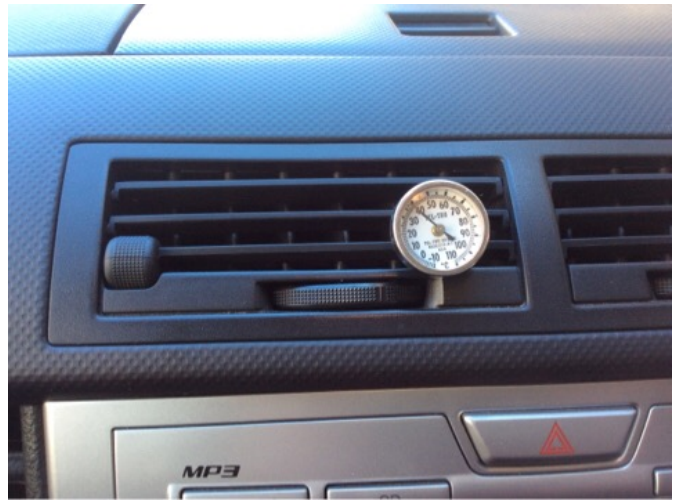
### Air conditioning

Air conditioning and heater has been tested-all operational.

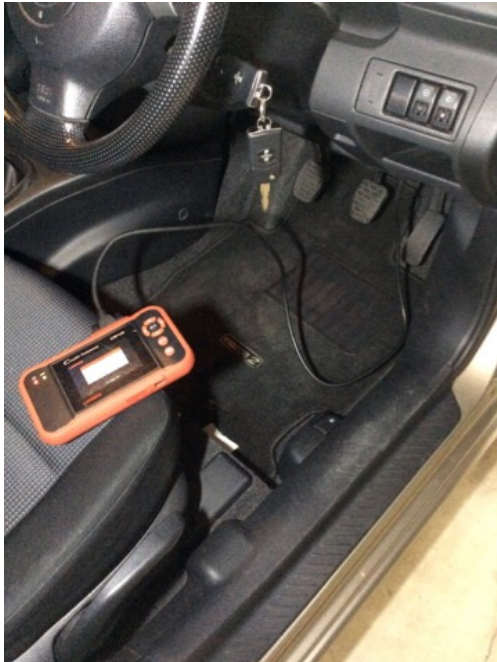
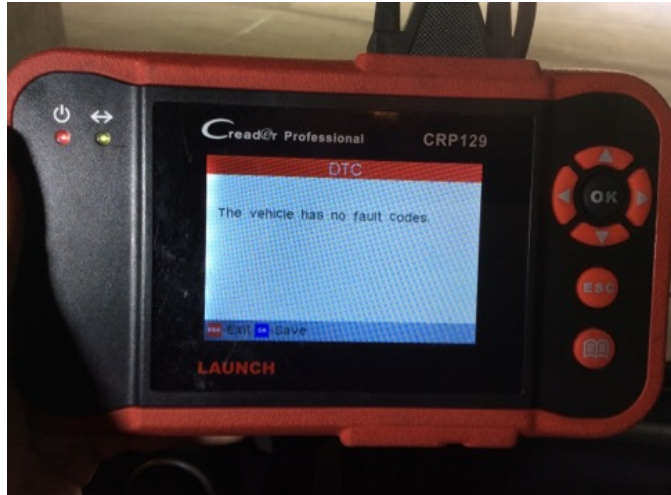
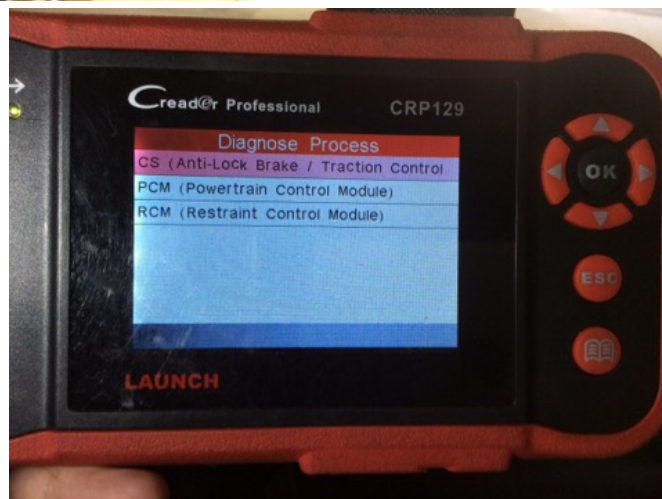
## VEHICLE MANAGEMENT SCAN

VEHICLE MANAGEMENT SYSTEM HAS BEEN SCANNED-NO FAULT CODES  
RECORDED-ALL OK.
