Inspection Report

MTA Pre Purchase Inspections ABN 72158123418

Client Name	Jake Rxxxxxx
Client Email	rxxxx@gmail.com
Vehicle Make and Model	Subaru Forester
Year of Manufacture	2014
Registration Number	CVE98L
Booking Reference	CAMxxxxP

Inspection Date:	29 Jan 2020
Inspection Time:	07:30 am

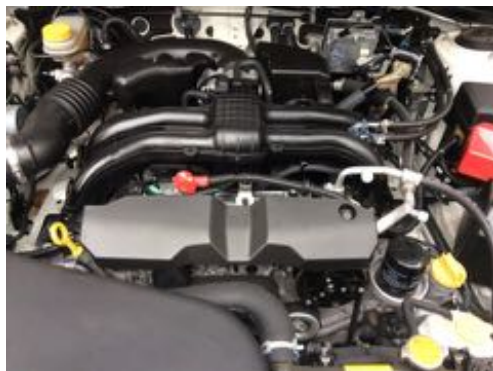
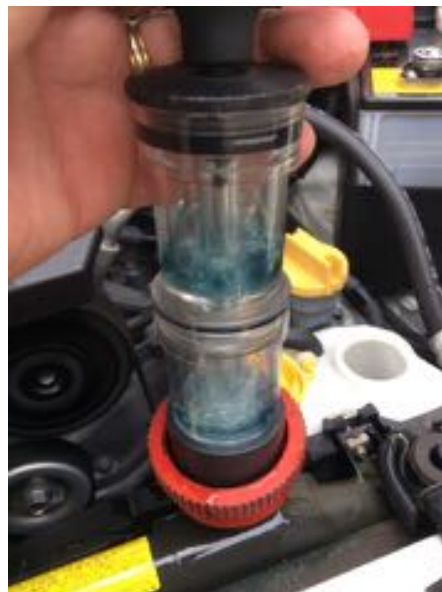
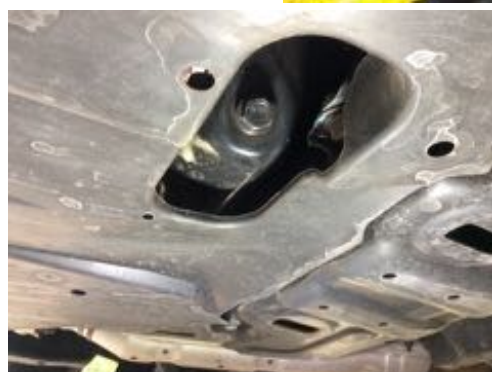
The engine and its components appear to be in good order of service at the time of inspection.

The engine runs and sounds good with no internal running faults.

No engine oil leaks were visible at the time of inspection. The engine may have been degreased as part of preparation of sale.

The exhaust system is in good general condition for its age and kilometres. No leaks or damage evident.

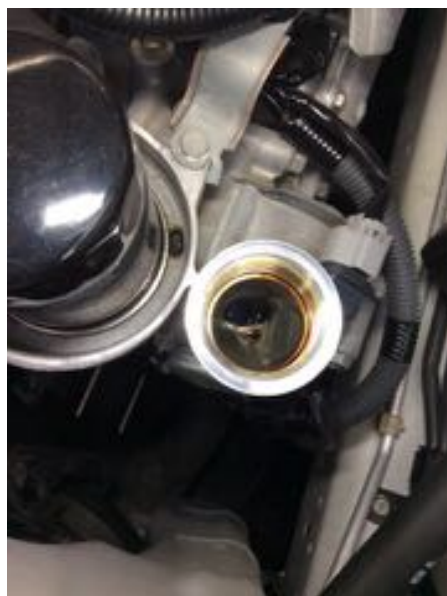
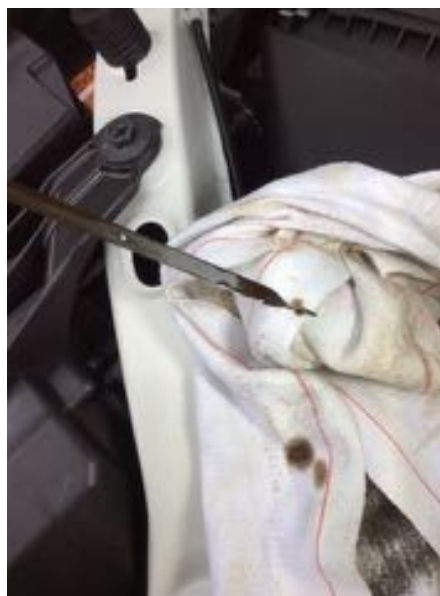
Oil and lubrication

Oil level low-suggest top up to acceptable level/ service.

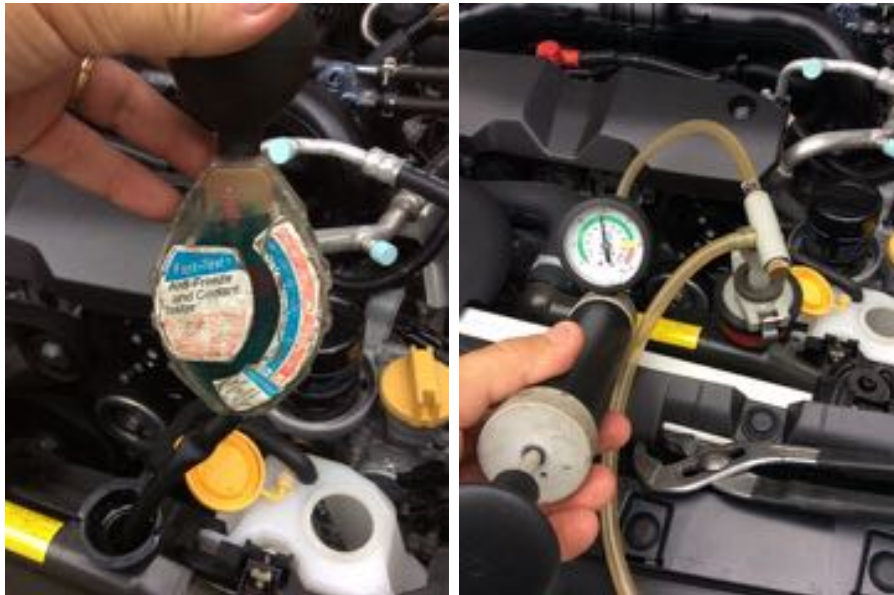
The cooling system and its components visually appear in good order of service at the time of inspection. The cooling system has passed a pressure test. The engine is running at normal operating temperature. The radiator corrosion inhibitor concentrate level has been measured and is at serviceable level.

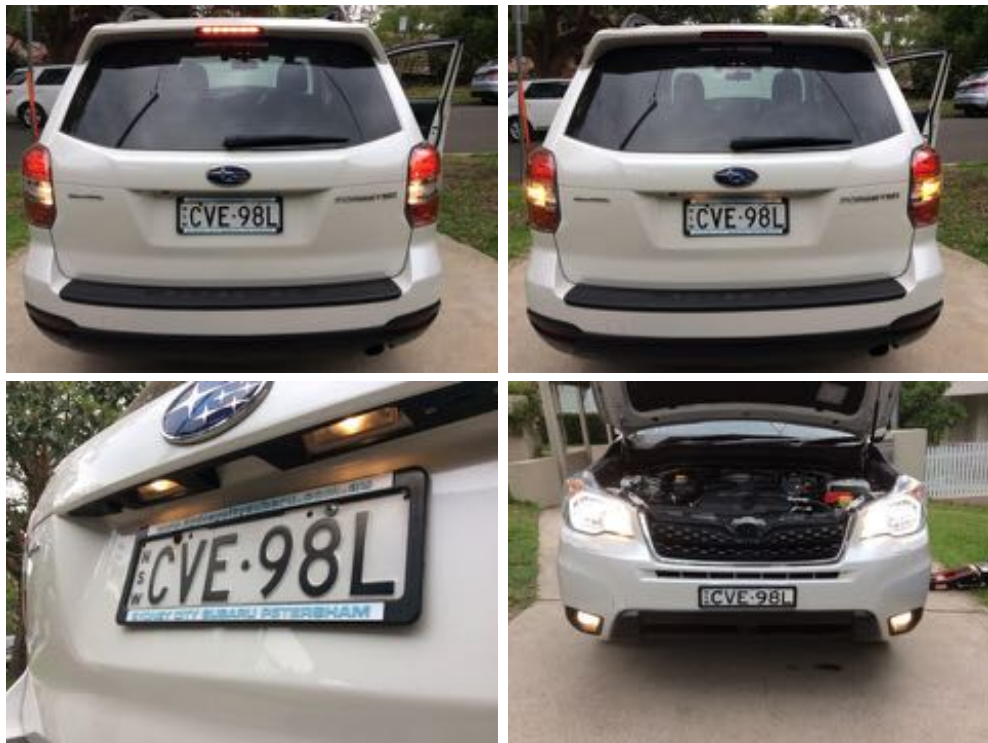
Lights and lenses

Front and rear lights have been tested-all working at time of inspection.

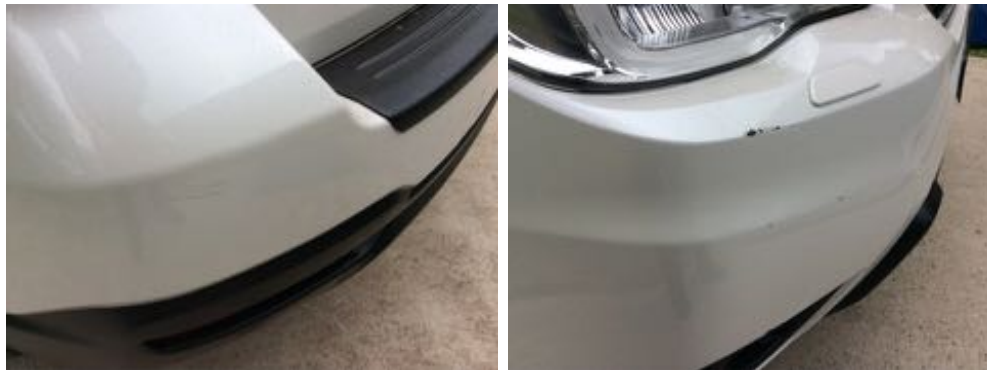
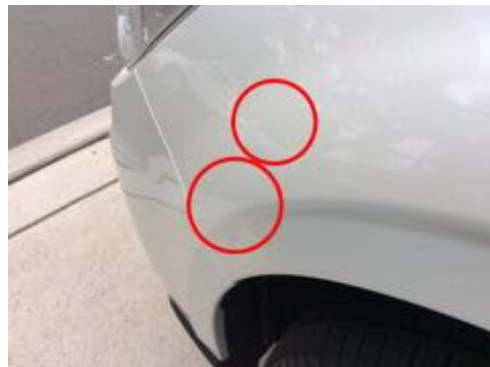
External appearance

Dents, chips, scratches and marks to various panels and bumpers.

Some carpark dents to side panels.

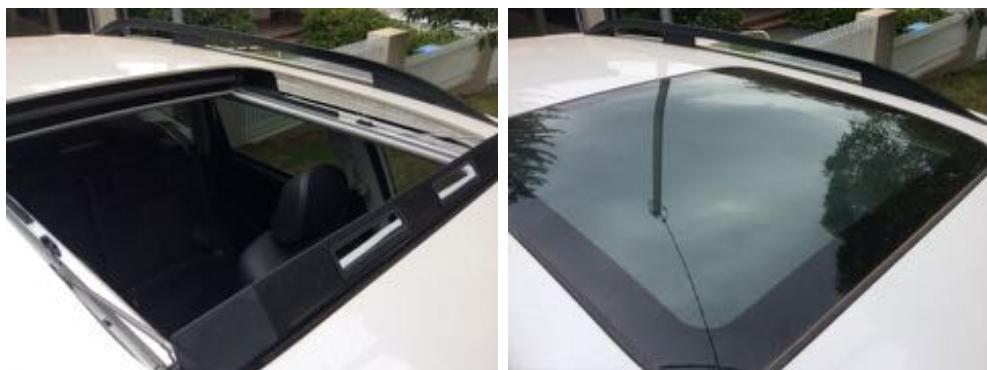
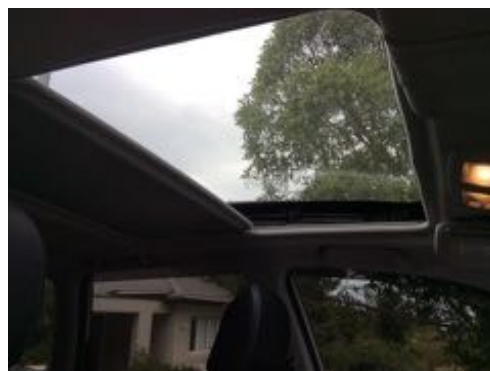
Sunroof and convertible roof

Sunroof operates correctly.

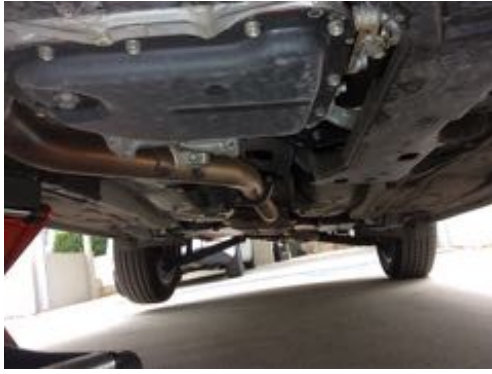
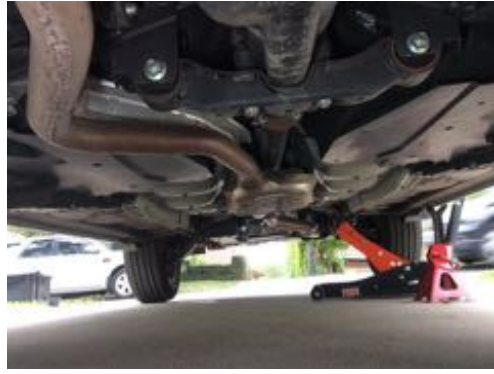
Underbody.

The underbody of the vehicle is in good order at the time of inspection

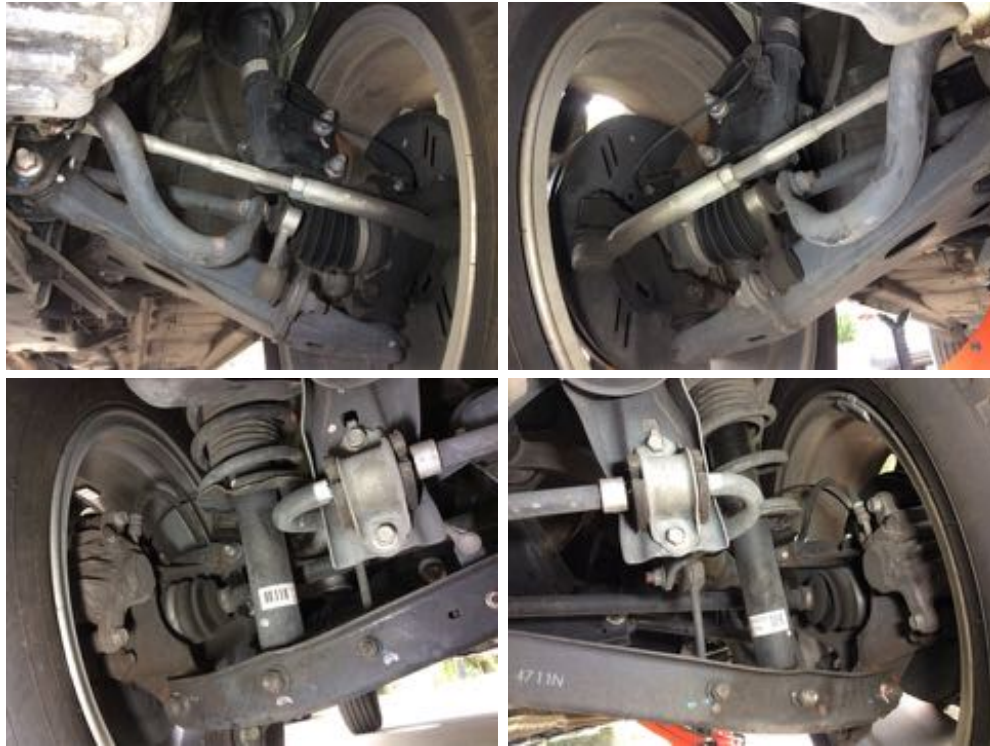
Steering suspension and rubber bushes showing typical wear for kilometres, some components will require replacing as needed during vehicles service life.

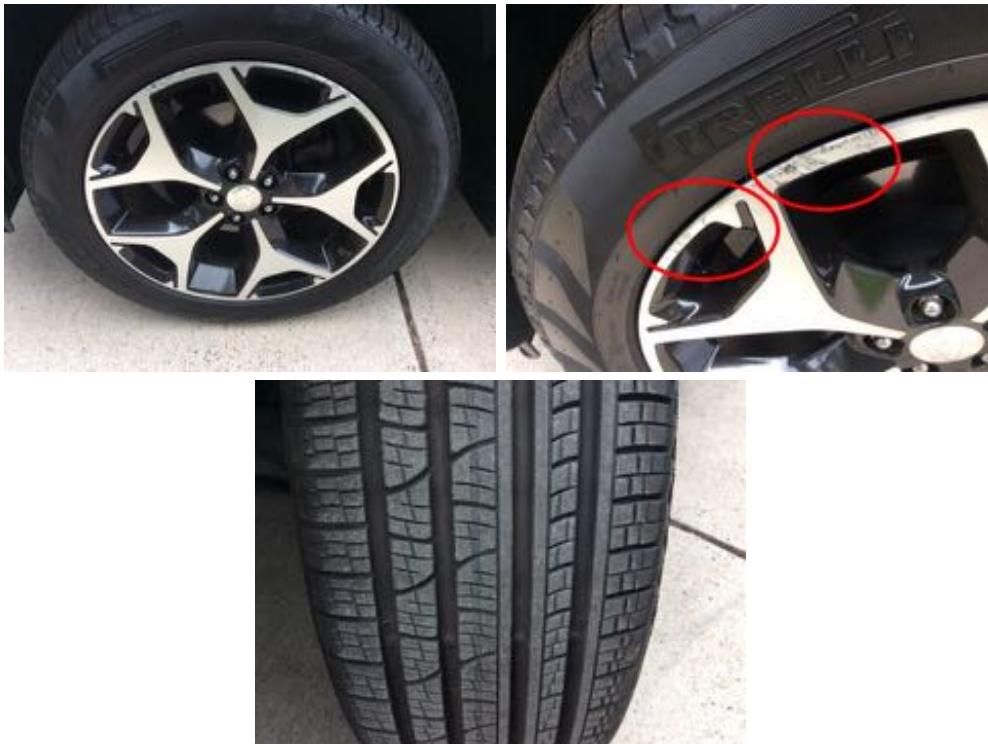
Kerb marks to wheel rims.

Rear tyres are not fitted as matching pairs.

Approximately 90%

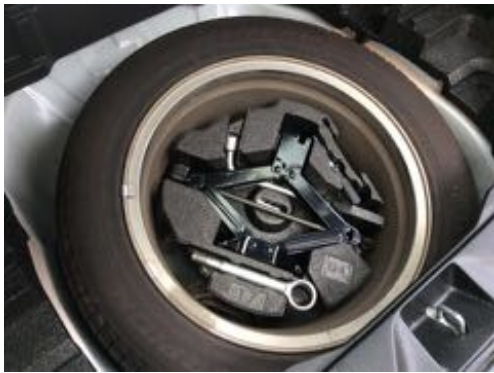
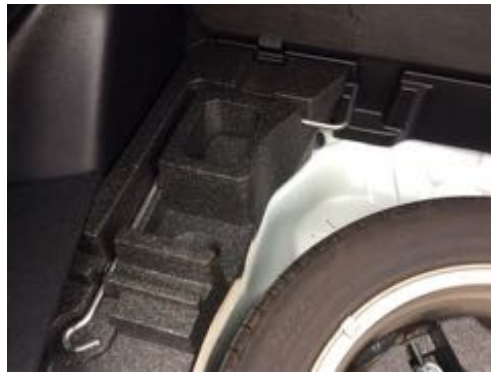
Spare

Approximately 90%

Tyre pressure low suggest check for puncture.

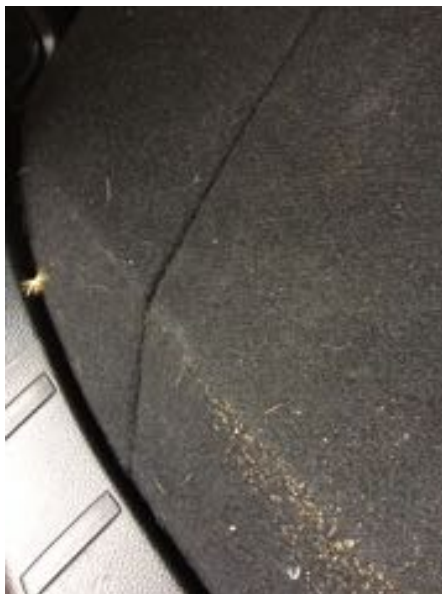
Some pet hair noticed on interior carpet no unpleasant odours to report.

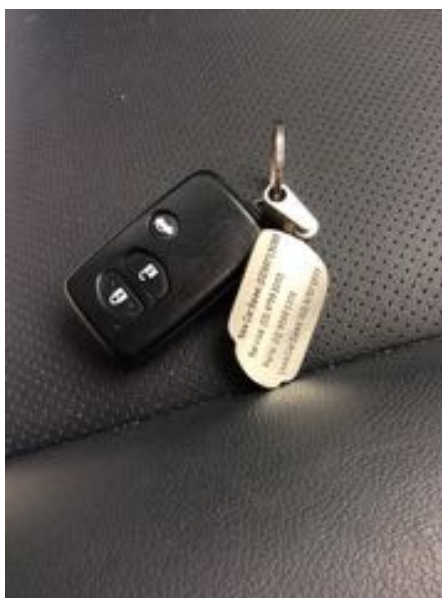
Keys and remotes

One key sighted-suggest checking with seller for additional keys.

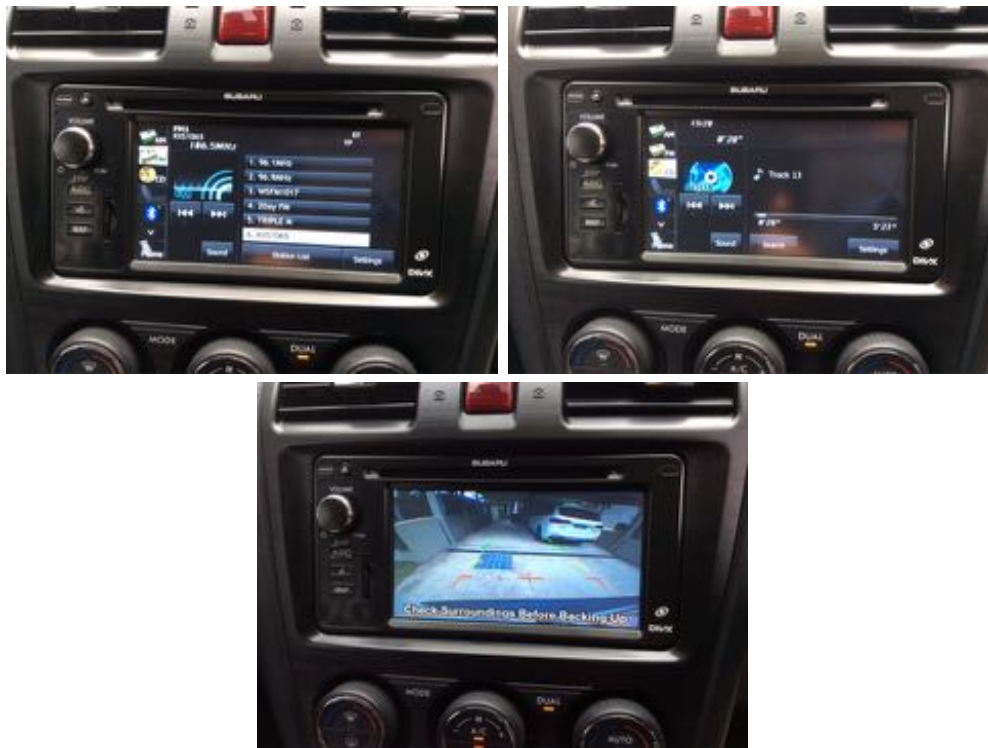
Entertainment system operational (radio and Cd player)

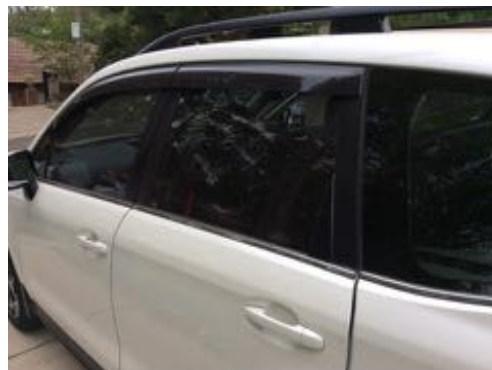
Aftermarket Window tint and accessories.

Windows have been tinted.
