Inspection Report

MTA Pre Purchase Inspections ABN 72158123418

Client Name	Fabiana Bxxxx
Client Email	fx@hotmai.com
Vehicle Make and Model	Toyota Rav 4
Year of Manufacture	2006
Registration Number	AXJ59N
Booking Reference	CAMxxxxP

Inspection Date:	06 Nov 2021
Inspection Time:	12:05 pm

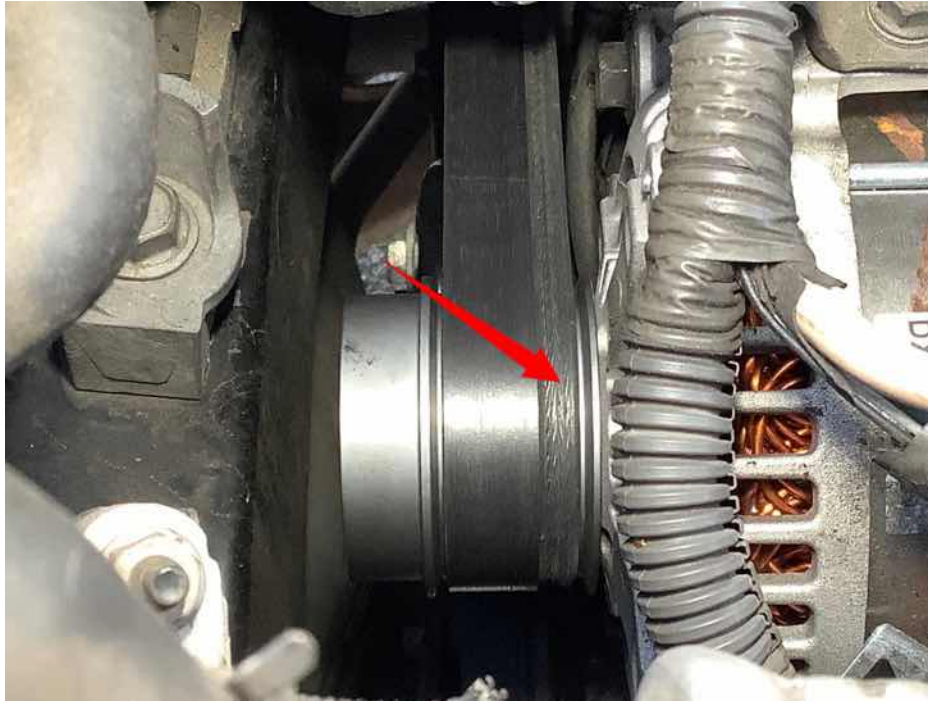
Engine bay-General

External drive belt has fatigue cracks-suggest replacement.

Bonnet hold retaining clip broken.

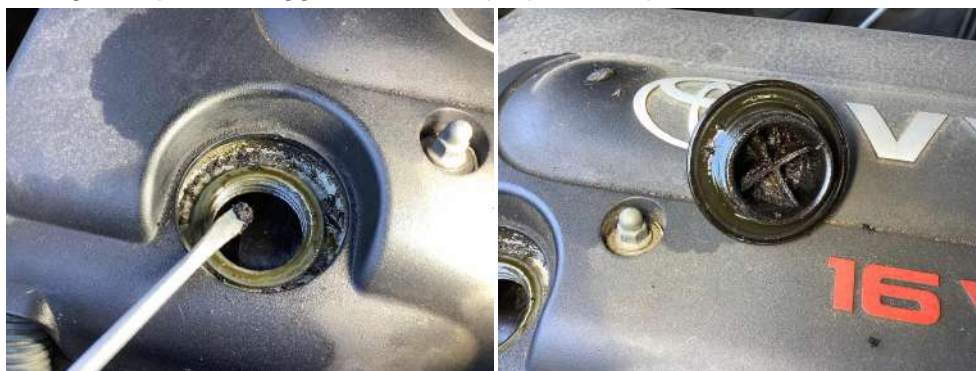
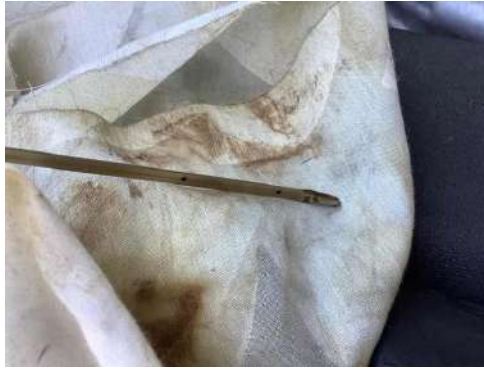
Oil and lubrication

Carbon/sludge built up in oil system. Recommend oil system clean, flush and service -oil strainer/pick up may also require service and reassess.

Oil level not registering on dip stick-suggest service/top up to acceptable level.

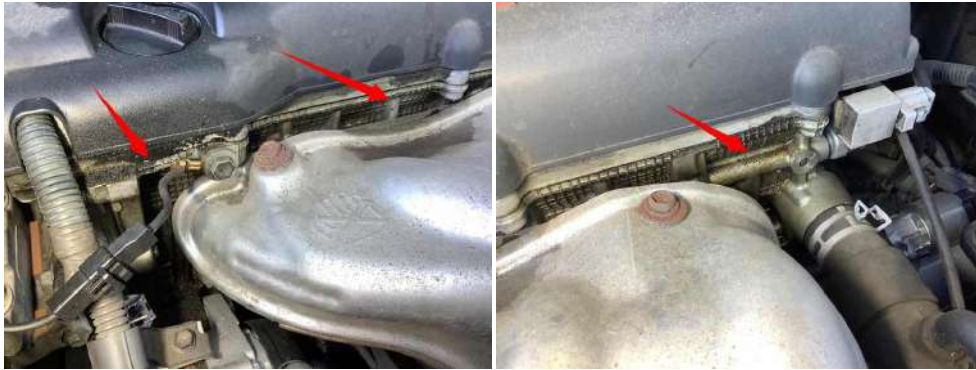
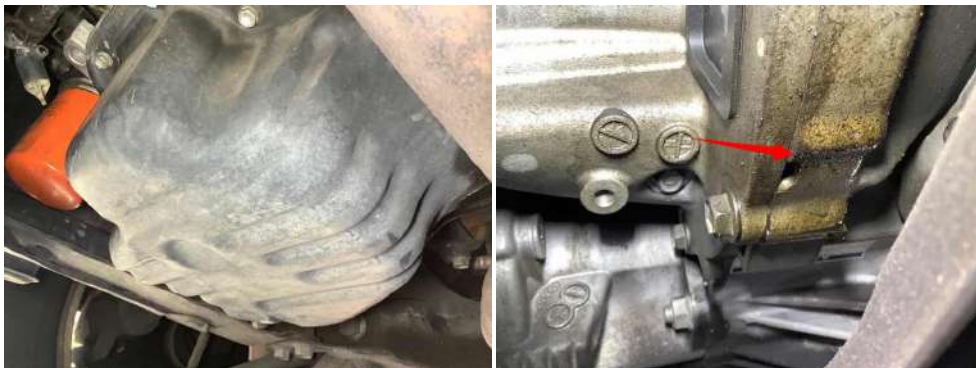
Engine oil leaks

Oil leak at top of engine consistent with rocker cover gasket leak, needs degrease wash to confirm if only leak and repair as required.

Oil visible at rear of engine, bell housing area-consistent with rear main oil seal leak, recommend clean and re-assess, and repair accordingly.

Oil evident at timing cover and front of sump, clean and reassess/repair as required

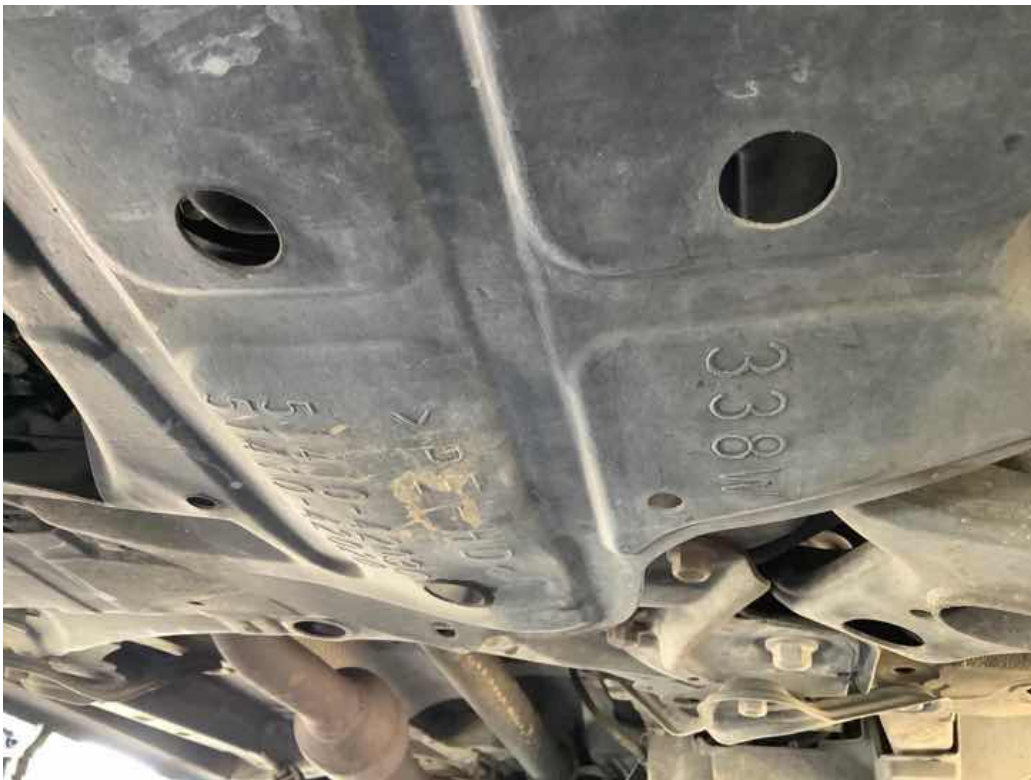
Engine covers

Engine has plastic covers/shields fitted which limit view of components.

Not secure at all points.

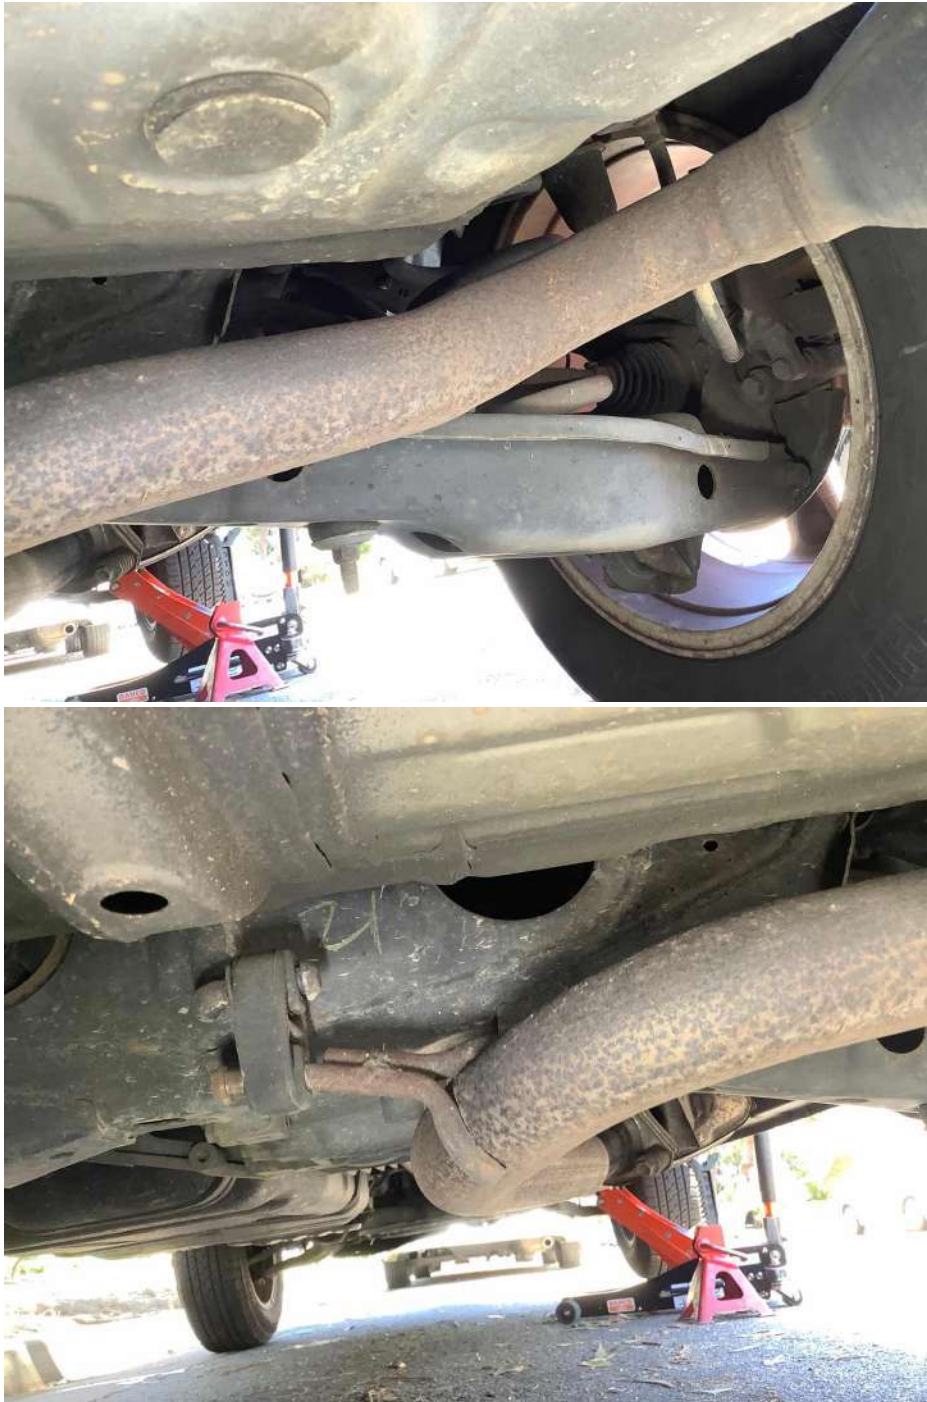
Exhaust Comments

Exhaust has surface rust on pipes and mufflers.

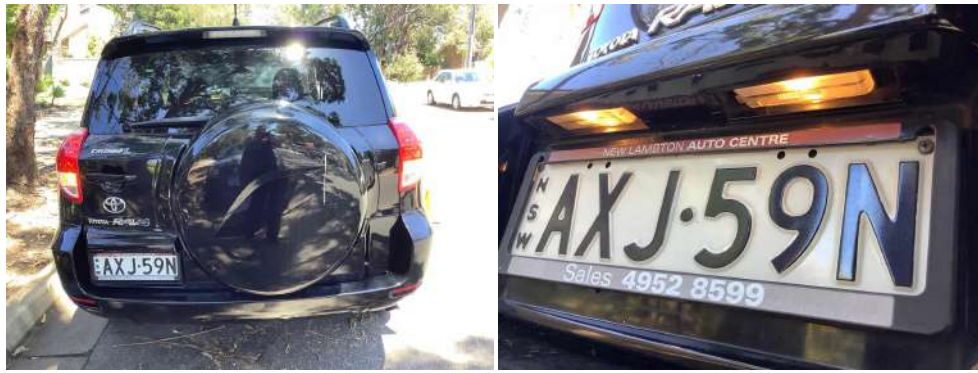
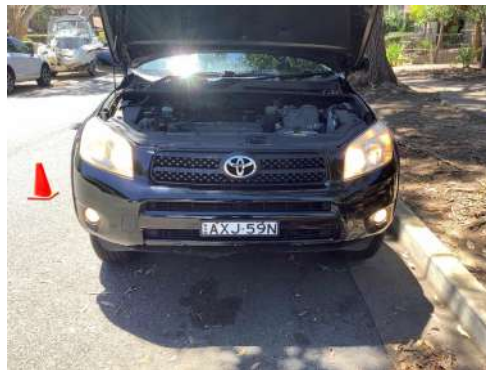
Lights and lenses

Front and rear lights have been tested-all working at time of inspection.
Headlight lenses are tarnished, polish and re-assess.

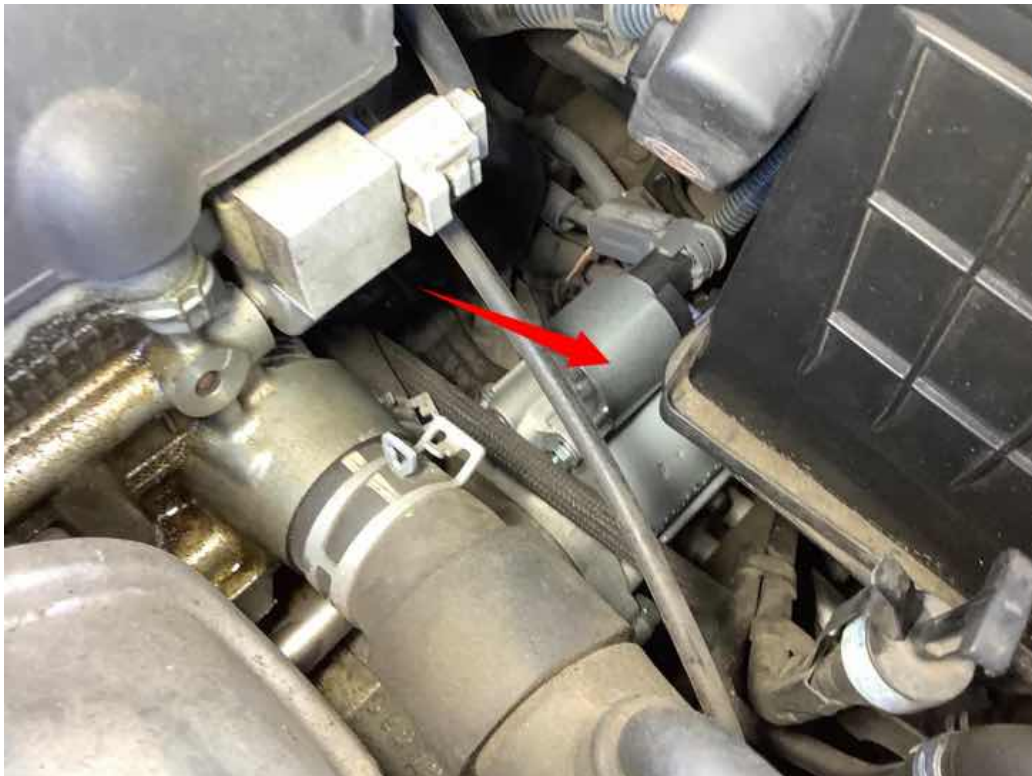
Starter motor appears to have been replaced.

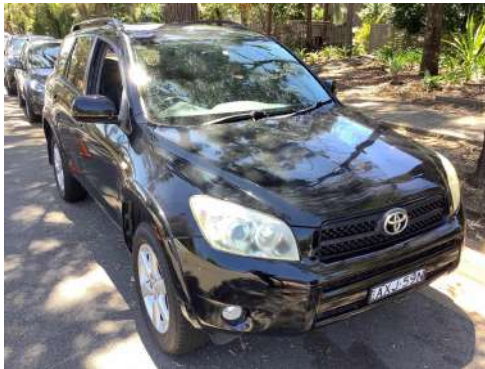
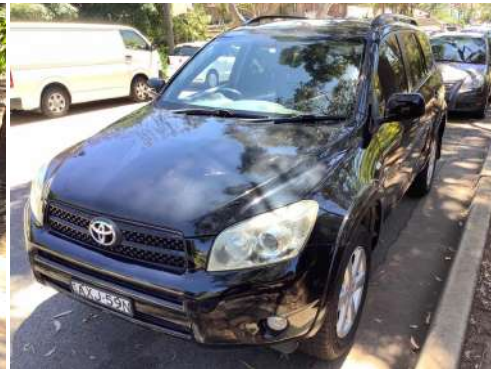
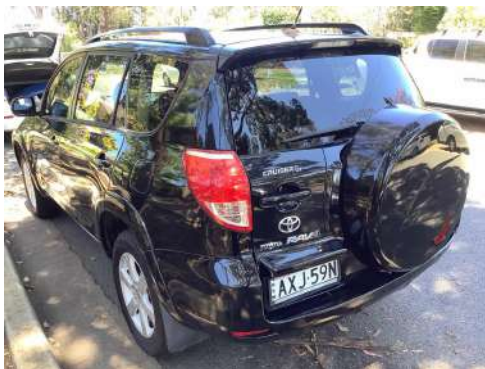
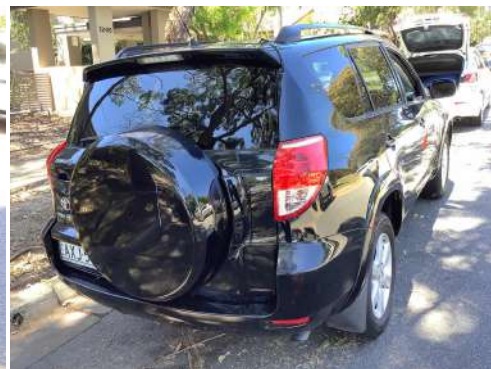
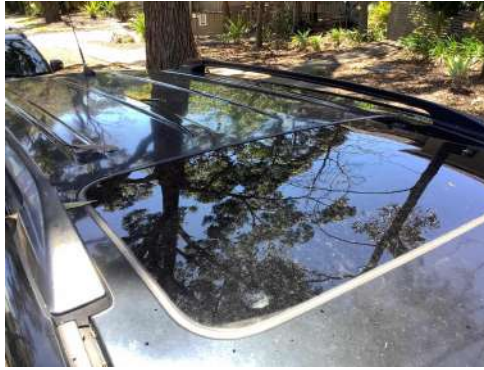
Panel and paint repairs

Vehicle has had panel and paint repairs to passenger side panels- No evidence of any chassis or structural repairs found.

Overall repairs and paint finish have deteriorated over time.

Dents, chips, scratches and marks to various panels and bumpers

Light hail type dents on upper body panels. Buyer should carry out final visual inspection prior to purchase.

Paint is faded on bonnet and roof / upper panels.

Vehicle will require cosmetic paint repairs to improve overall exterior appearance.

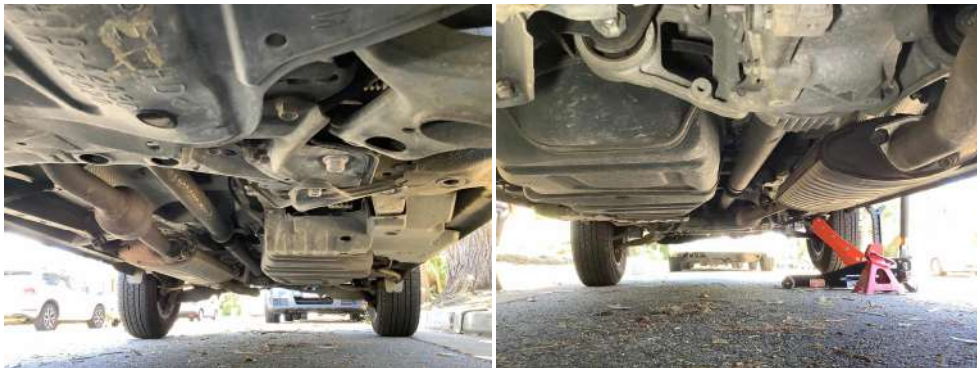
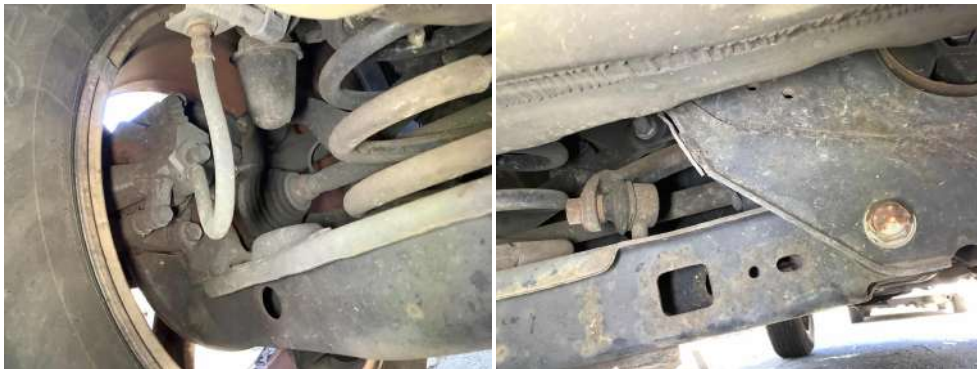
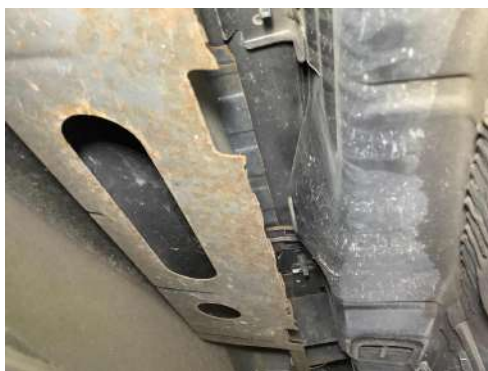
**Underbody.**

Some minor surface rust visible at underbody and is consistent with age and type of vehicle.

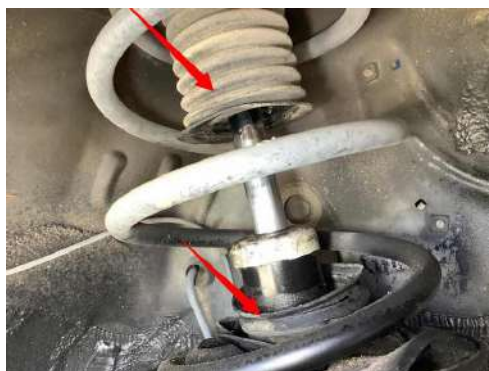
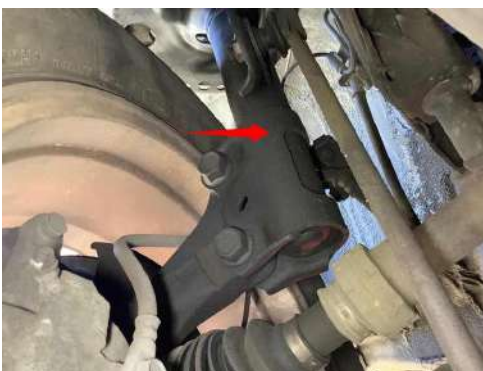
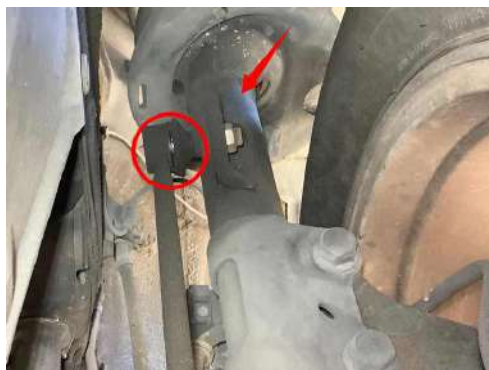
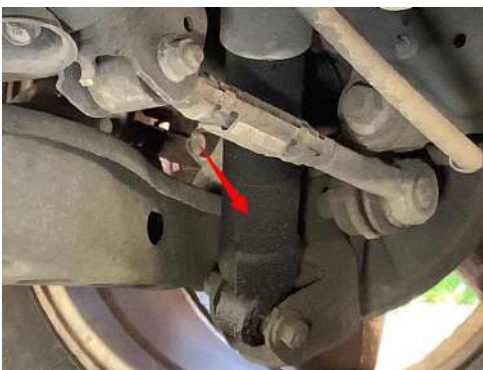
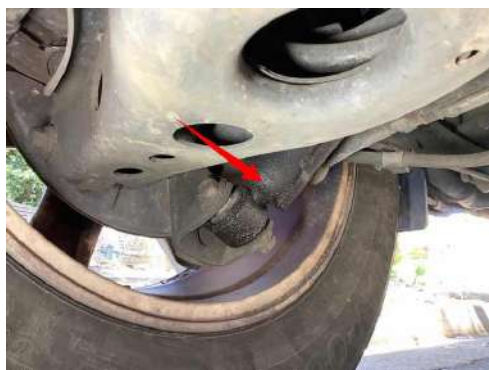
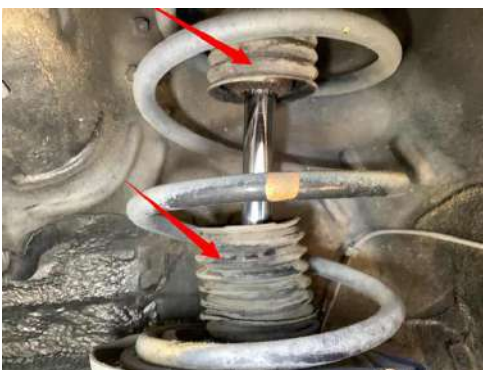
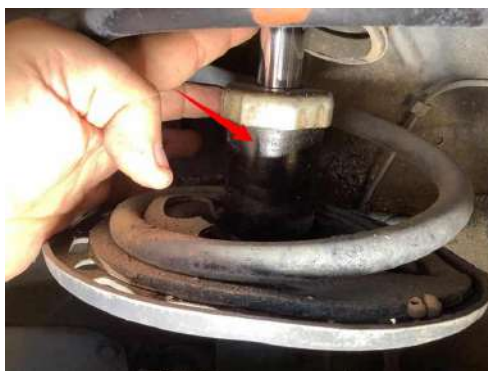
Steering and suspension recommendations

Shock absorber is leaking, replace as required-front and rear.

Shock absorber dust boot split-replace as required.

Front link pins worn-replace.

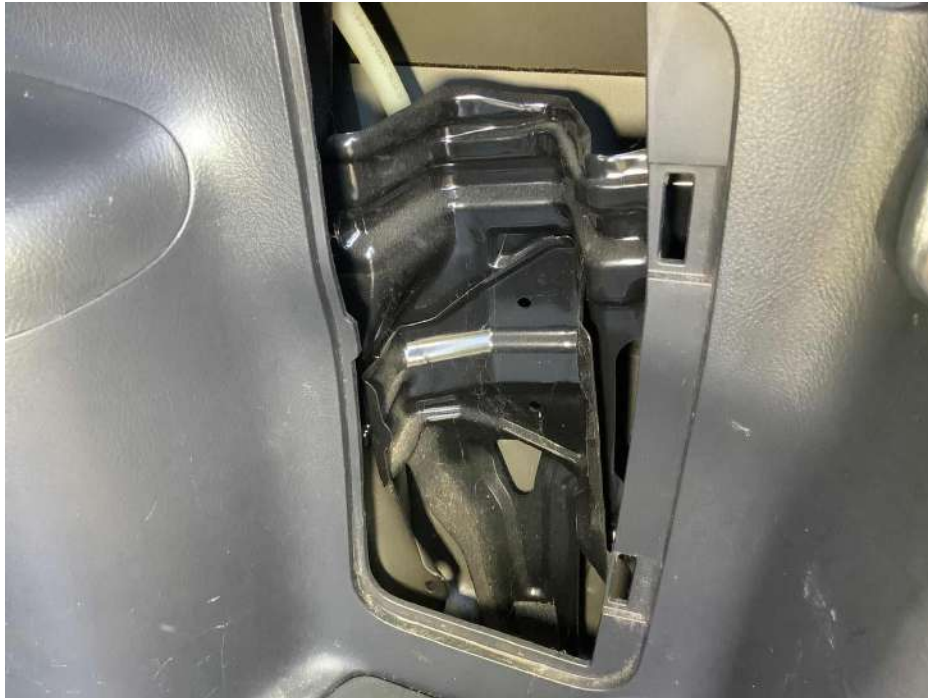
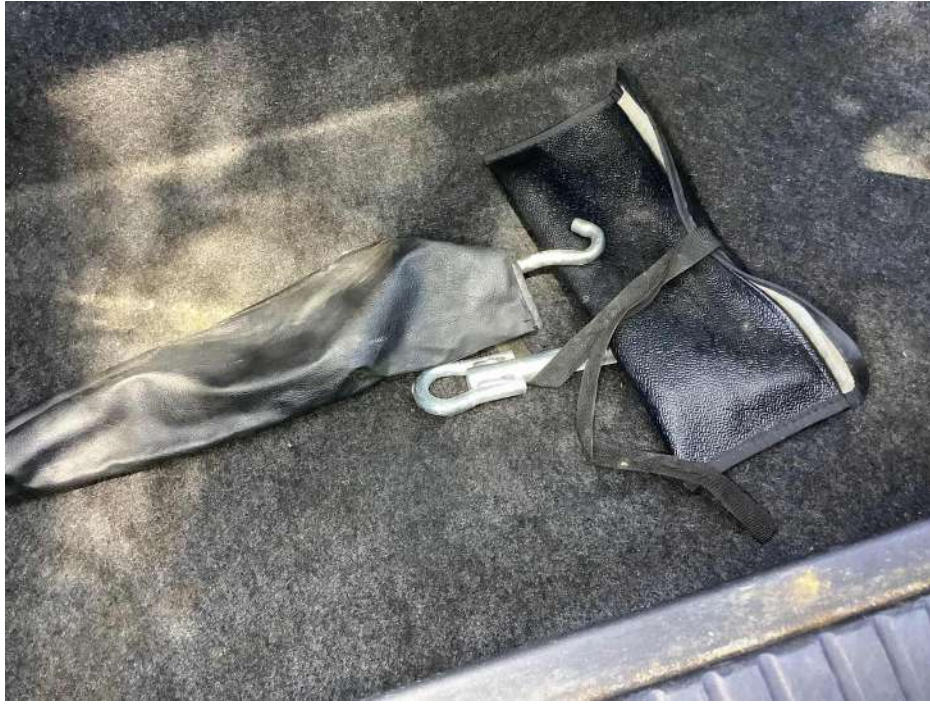
Wheels and Tyres.

Gutter rash/kerb marks to wheel rims.

Jack not in designated location-missing.

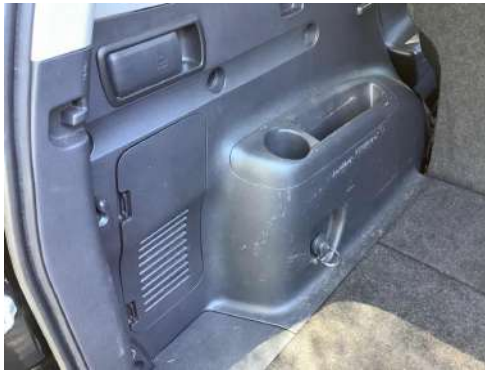
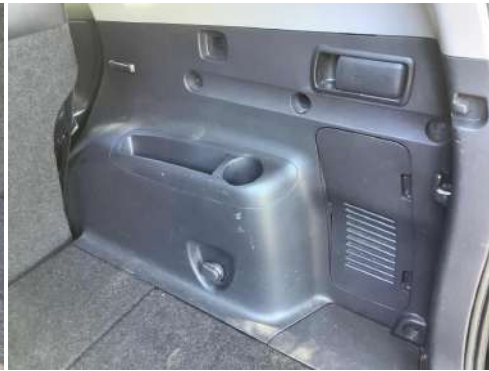
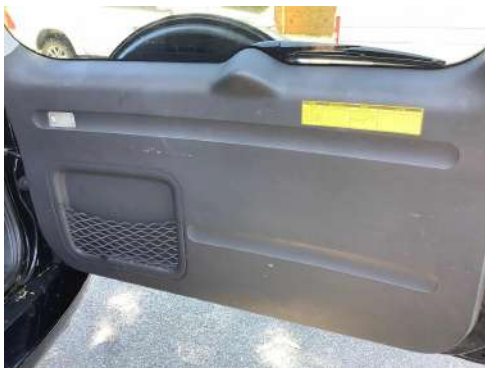
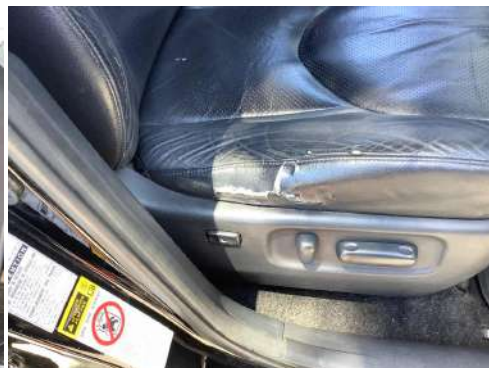
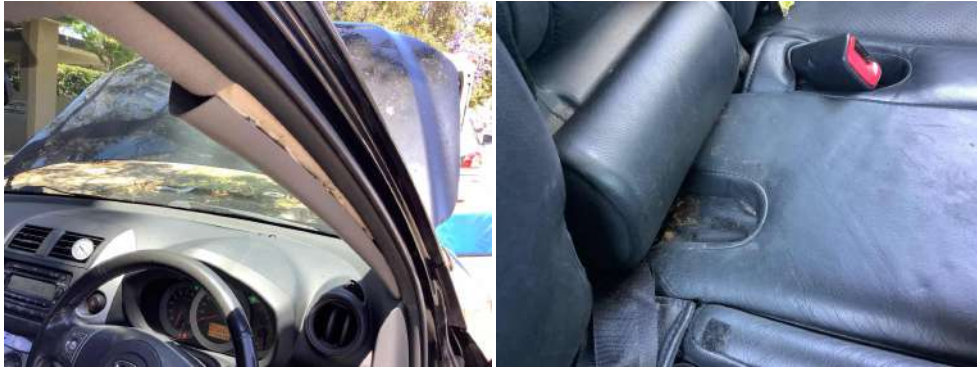
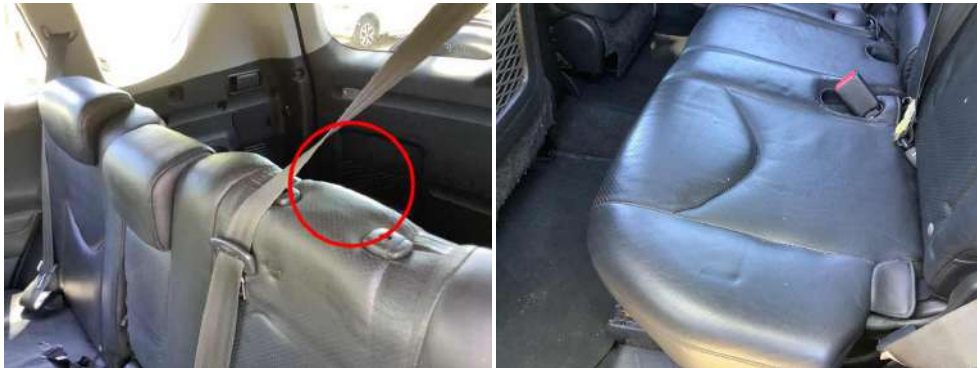
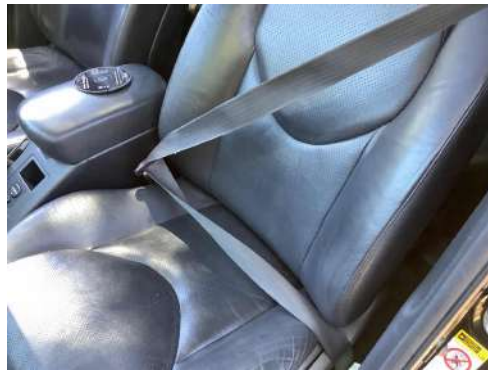
Interior comments (General)

Interior trims & seats have light marks.
 Interior trim & carpet is dirty recommend full interior detailing.
 Rear cargo cover not fitted at this time.
 Baby seat previous fitted-impressions to seat trim evident.
 Head restraint missing.
 Seat belt twisted.
 Air vent slats damaged.
