# Inspection Report

**MTA Pre Purchase Inspections ABN 72158123418**

Client Name	Fabiana XXXXXXXX
Client Email	fxX@gmail.com
Vehicle Make and Model	Toyota Rav 4
Variant	Cruiser
Year of Manufacture	2006
Registration Number	AXJ59N
Booking Reference	CAMXXXXP
Total Fee	\$295.00

Inspection Date:	06 Nov 2021
Inspection Time:	12:05 pm

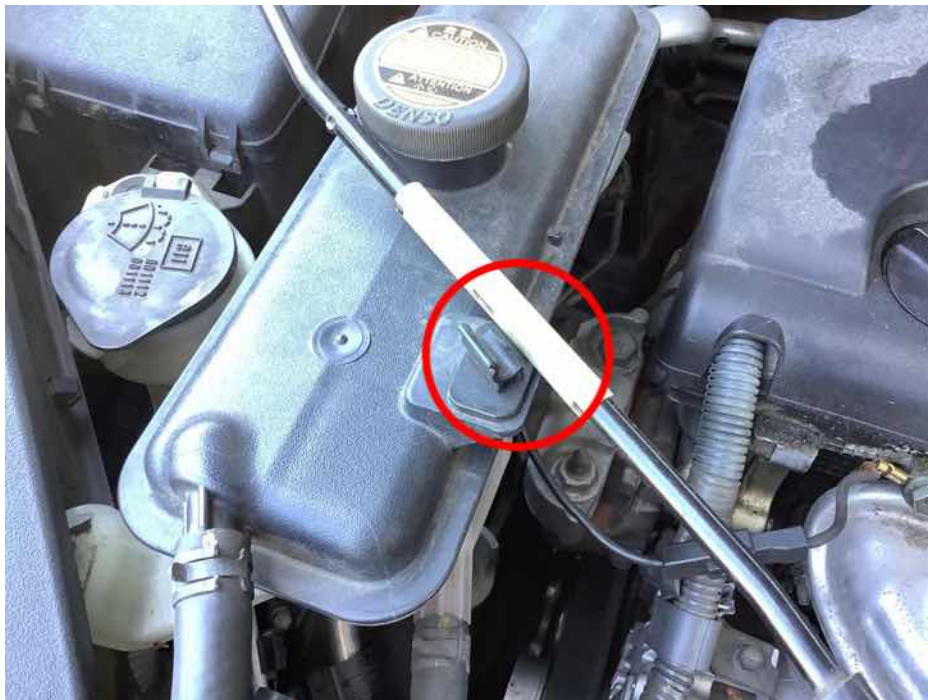
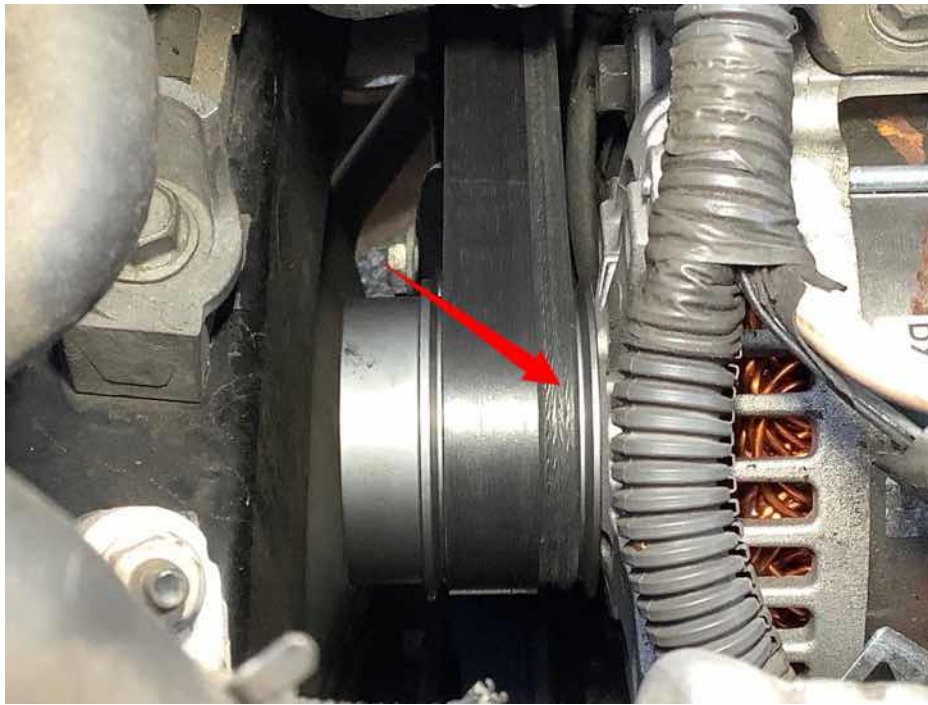
External drive belt has fatigue cracks-suggest replacement.

Bonnet hold retaining clip broken.

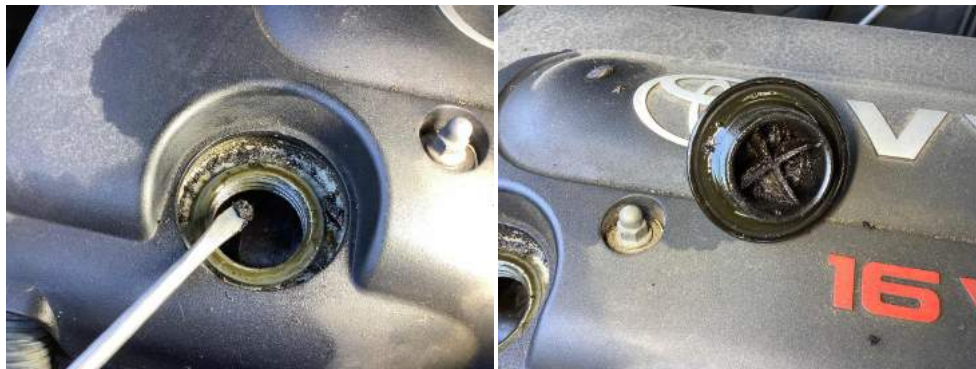
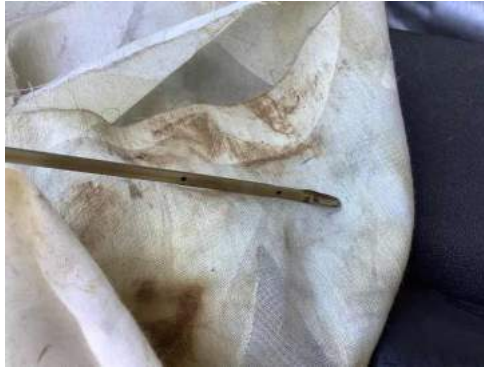
Carbon/sludge built up in oil system. Recommend oil system clean, flush and service -oil strainer/pick up may also require service.

Oil level not registering on dip stick-suggest service/top up to acceptable level.

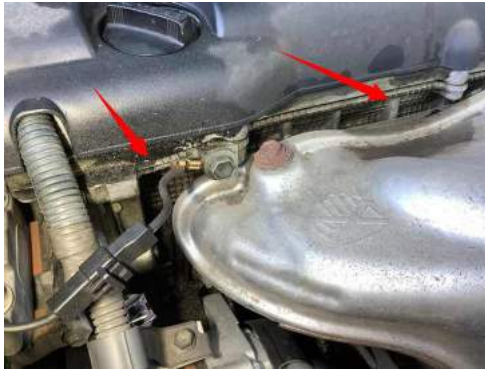
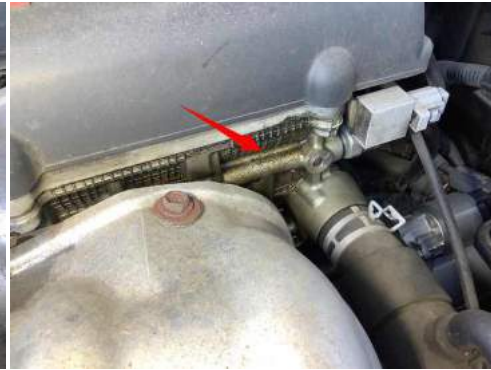
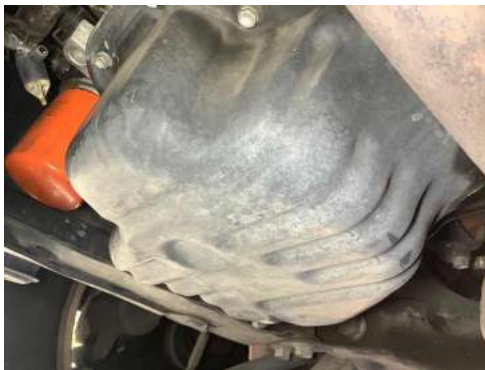
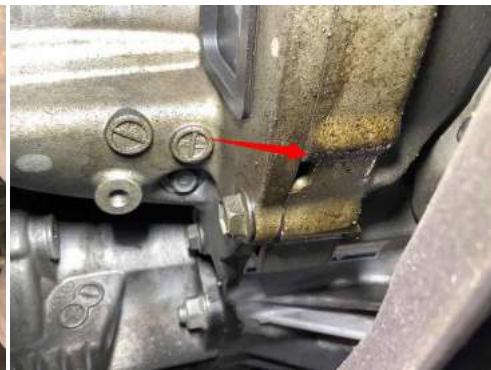
Oil leak at top of engine consistent with rocker cover gasket leak, needs degrease wash to confirm if only leak and repair as required.

Oil visible at rear of engine, bell housing area-consistent with rear main oil seal leak, recommend clean and re-assess, and repair accordingly.

Oil evident at timing cover and front of sump, clean and reassess/repair as required

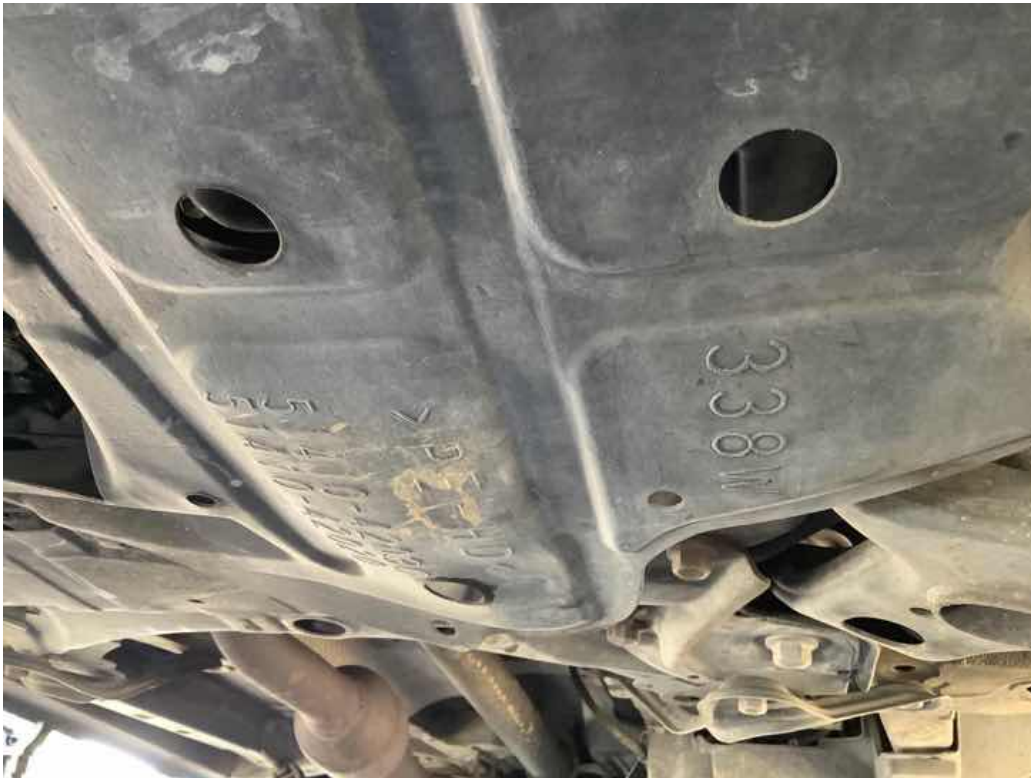
Engine has plastic covers/shields fitted which limit view of components.

Not secure at all points.

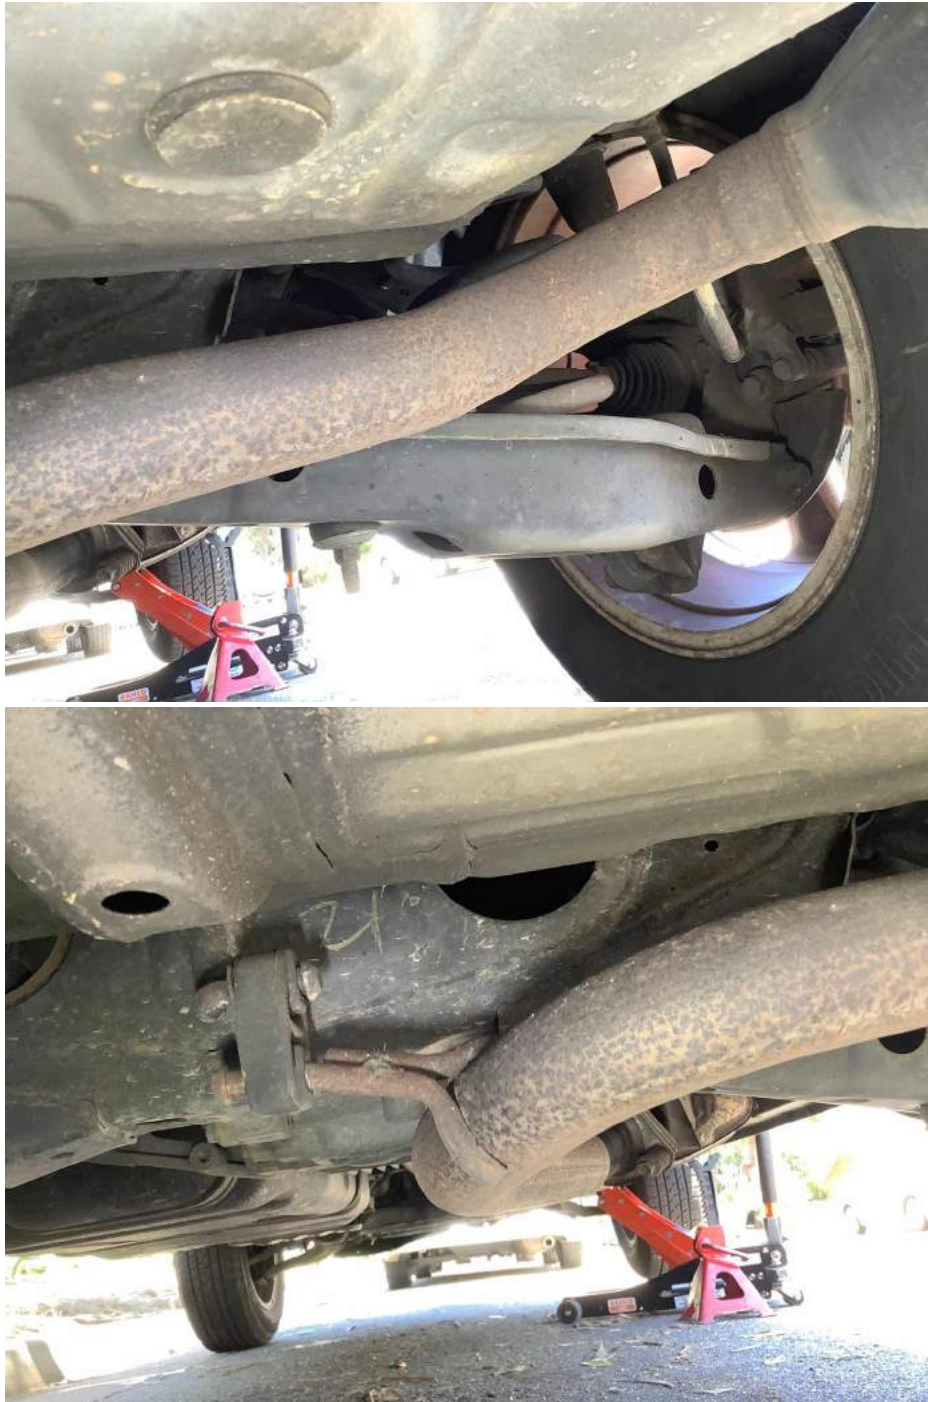
Exhaust has surface rust on pipes and mufflers.

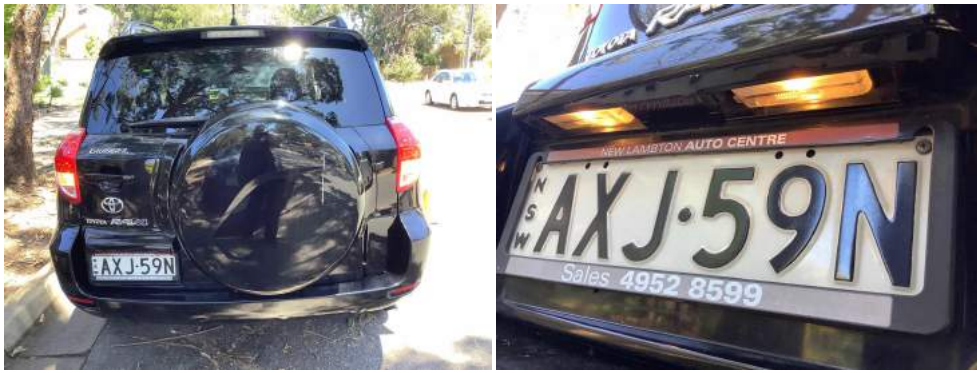
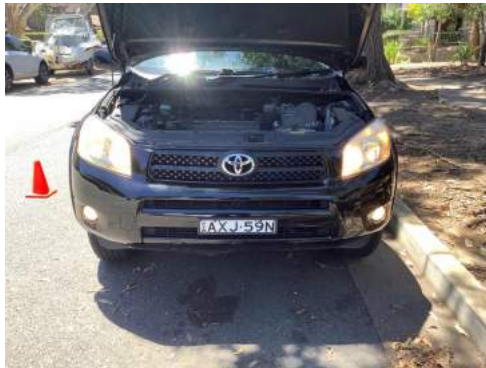
Front and rear lights have been tested-all working at time of inspection.  
Headlight lenses are tarnished, polish and re-assess.

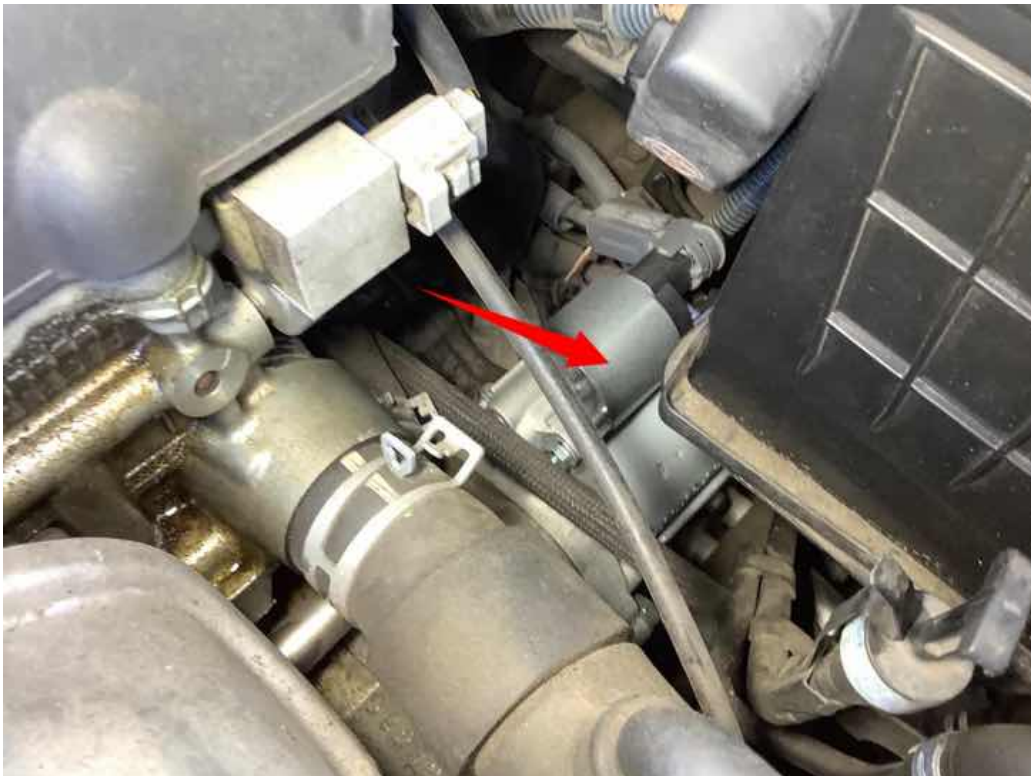
Starter motor appears to have been replaced.

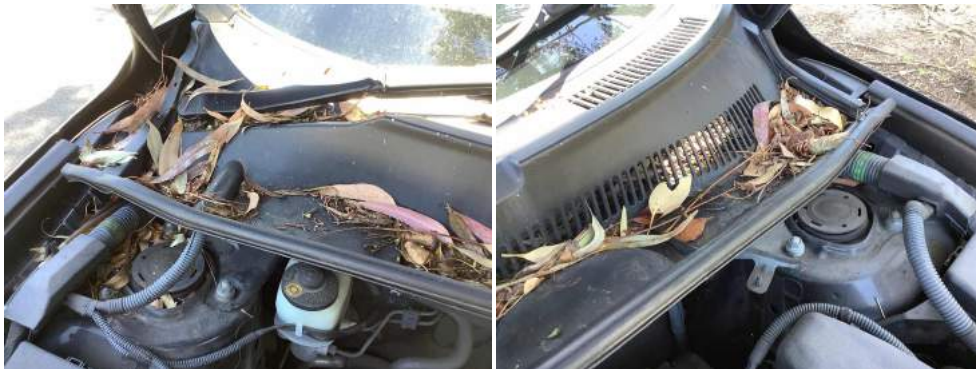
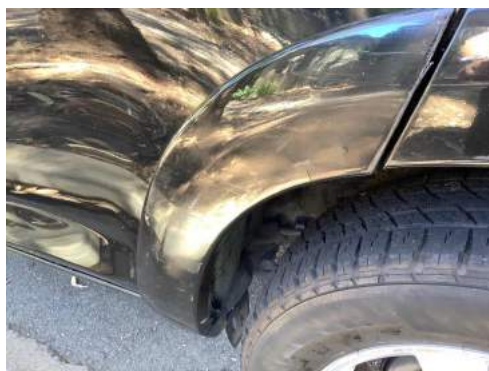
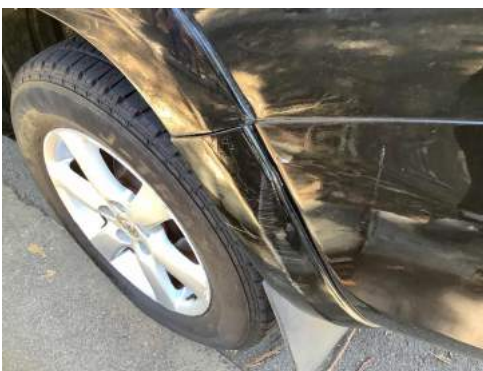
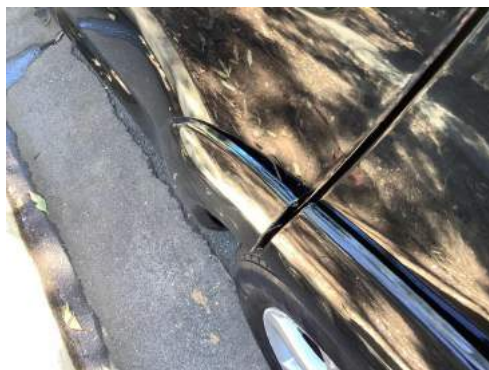
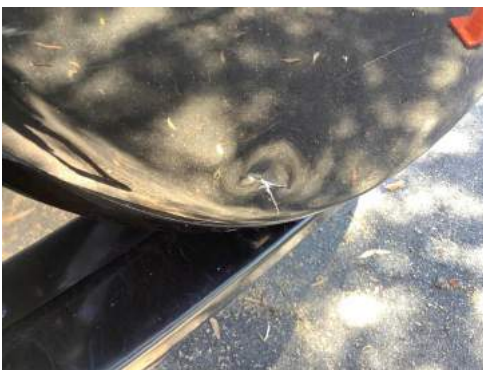
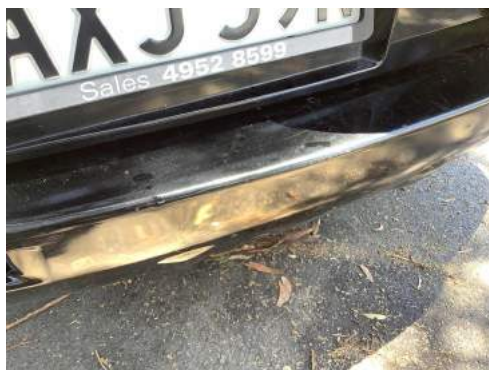
Vehicle has had panel and paint repairs to passenger side panels- No evidence of any chassis or structural repairs found.

Overall repairs and paint finish have deteriorated over time.

Dents, chips, scratches and marks to various panels and bumpers

Light hail type dents on upper body panels. Buyer should carry out final visual inspection prior to purchase.

Paint is faded on bonnet and roof / upper panels.

Vehicle will require cosmetic paint repairs to improve overall exterior appearance.

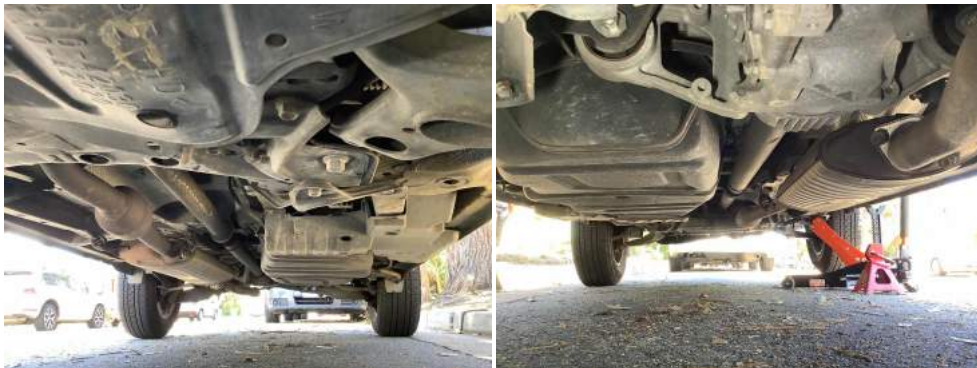
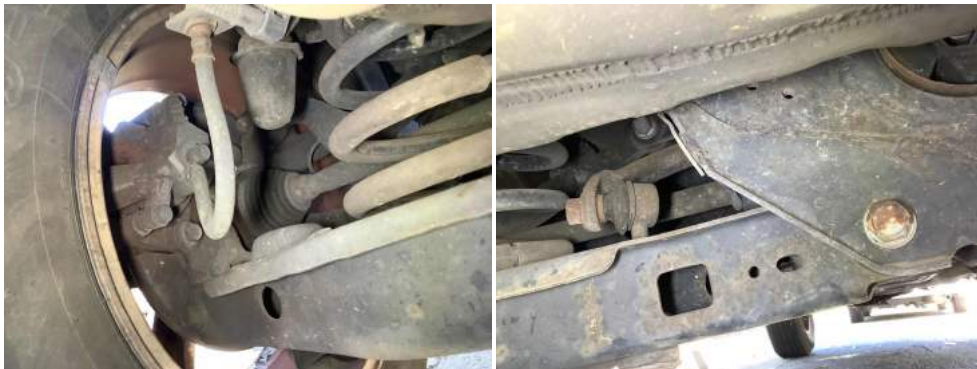
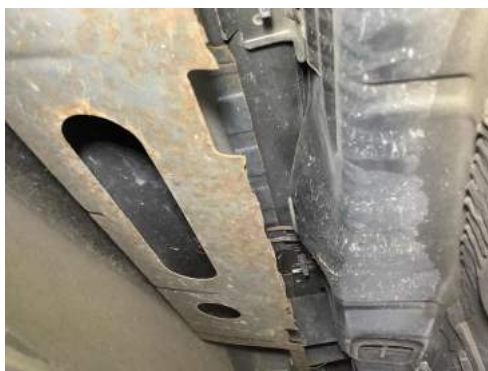
Some minor surface rust visible at underbody and is consistent with age and type of vehicle.

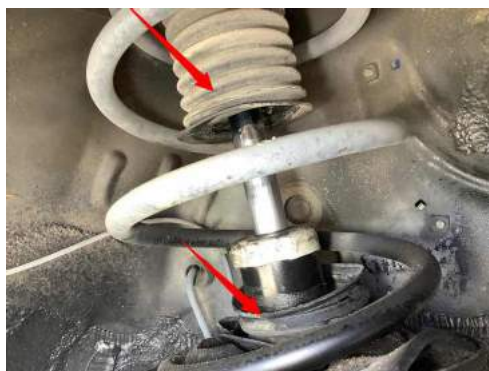
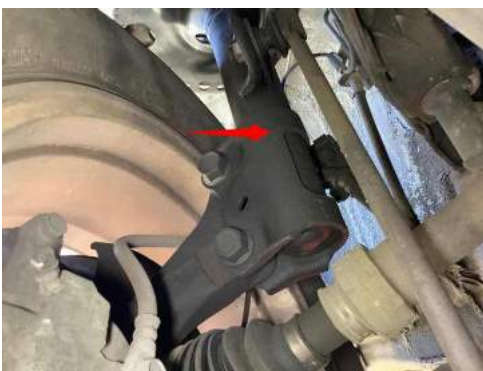
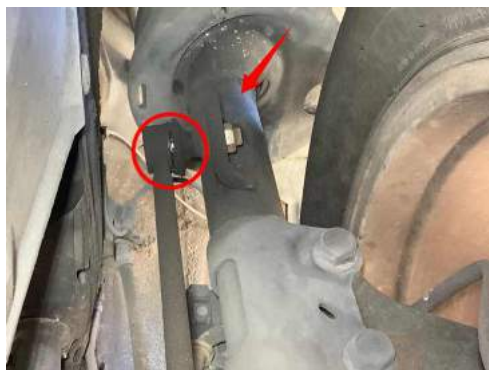
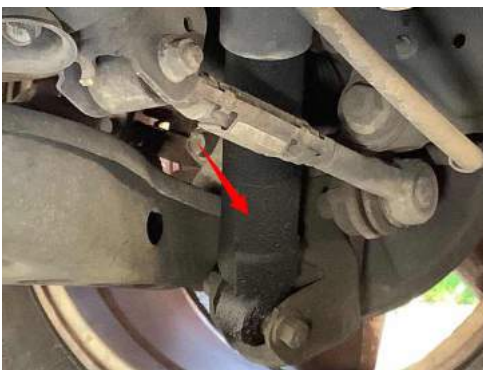
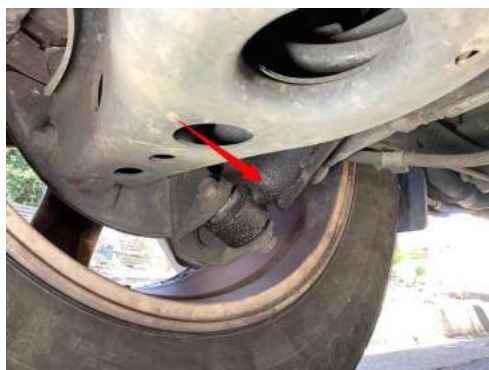
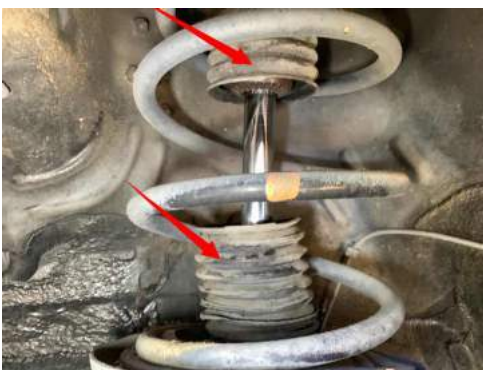
Shock absorber is leaking, replace as required-front and rear.

Shock absorber dust boot split-replace as required.

Front link pins worn-replace.

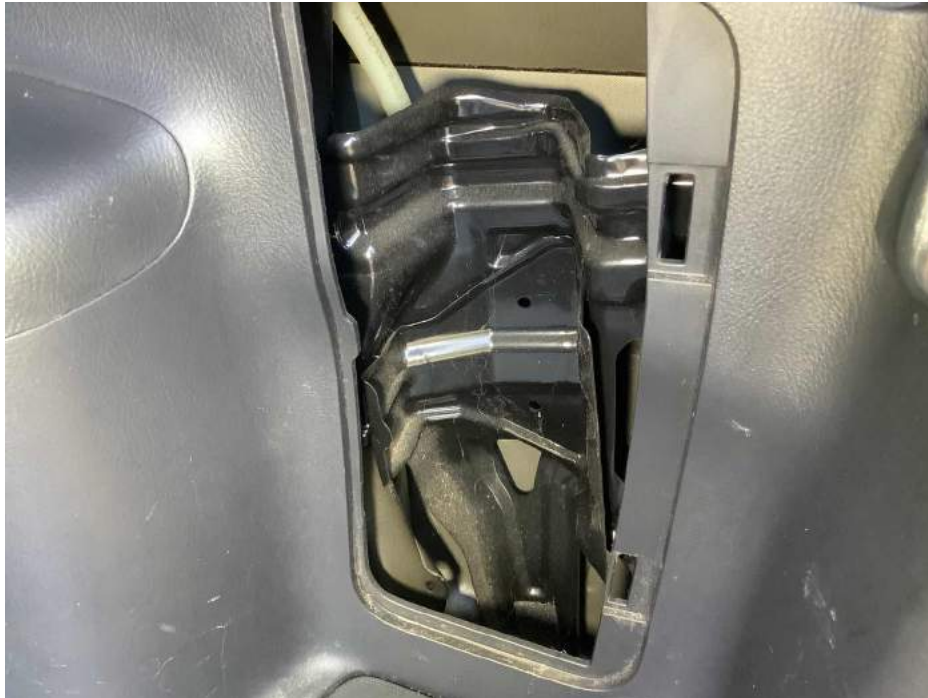
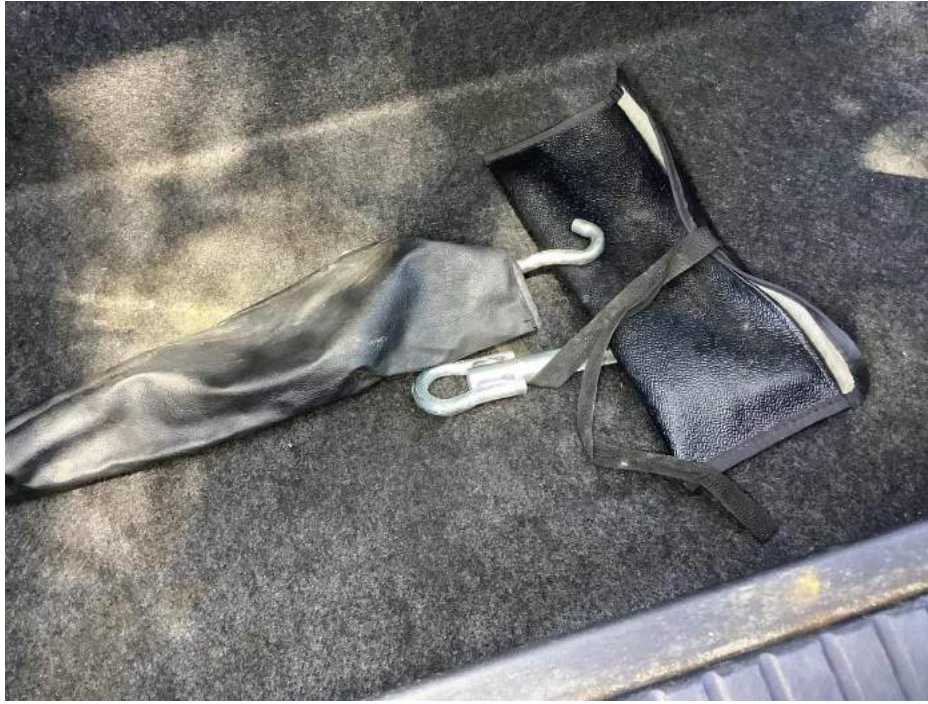
Gutter rash/kerb marks to wheel rims.

Jack not in designated location-missing.

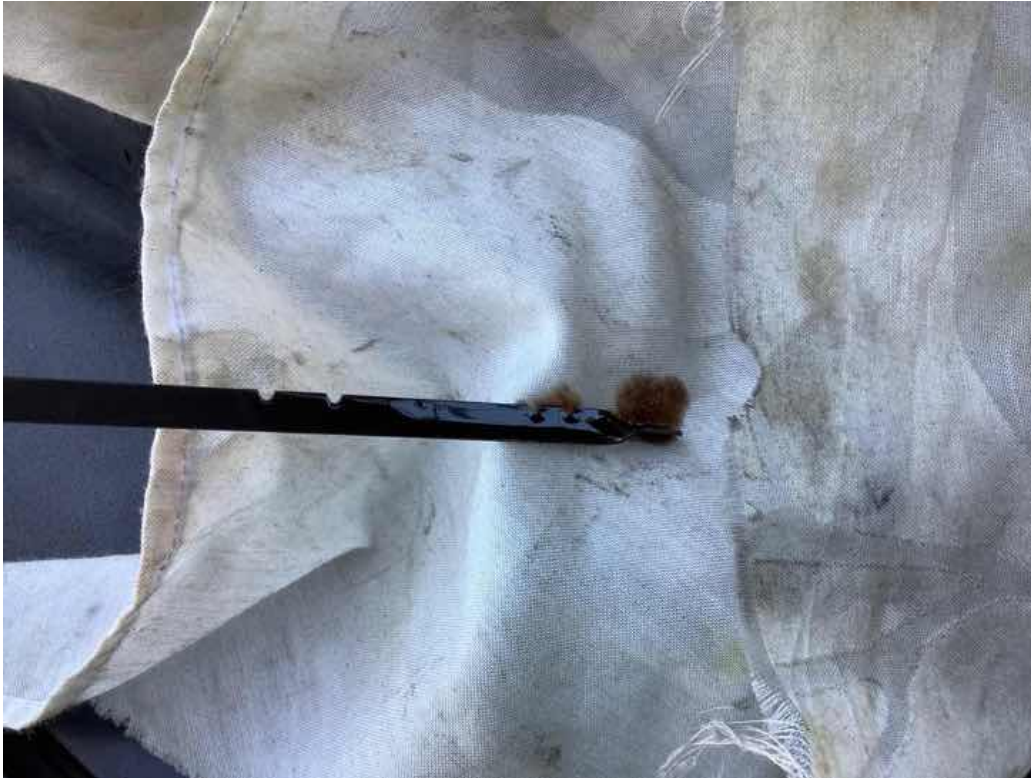
No oil leaks visible at underbody driveline.  
Recommend Auto transmission service-oil dirty.

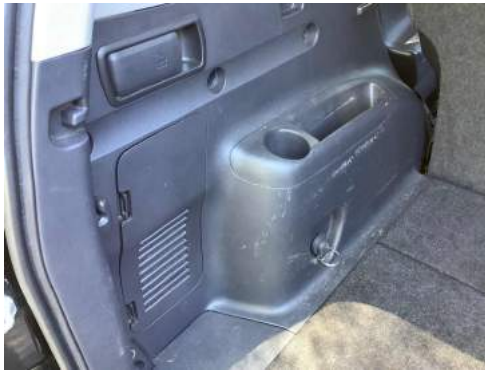
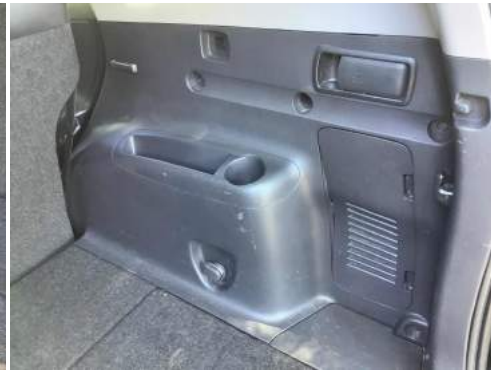
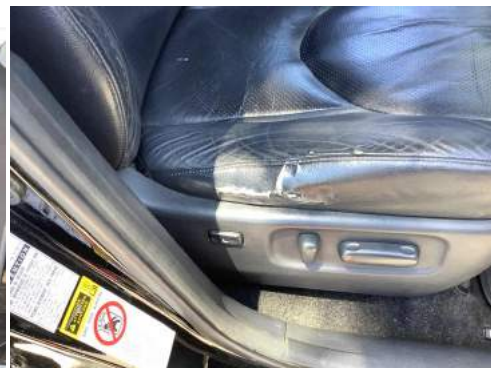
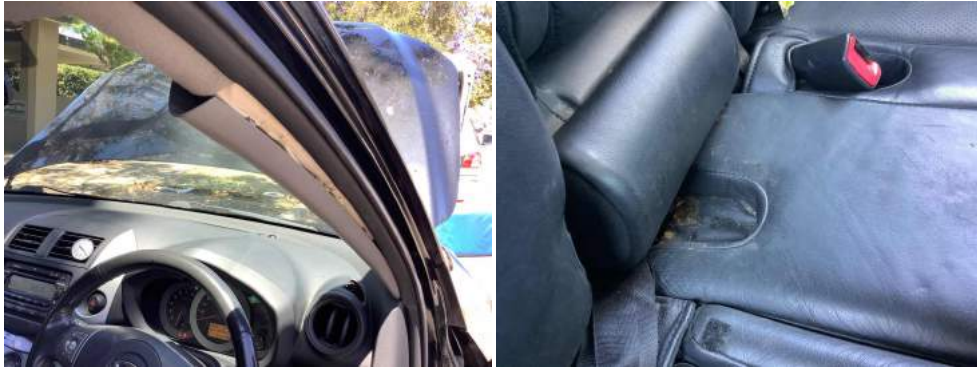
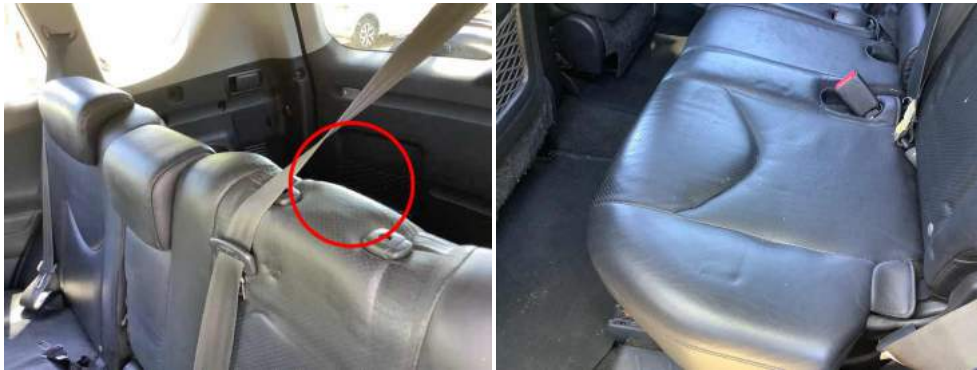
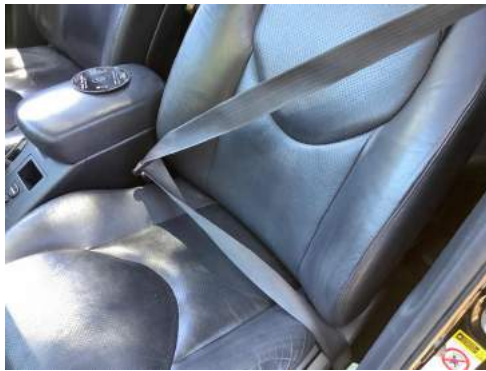
Interior trims & seats have light marks.  
 Interior trim & carpet is dirty recommend full interior detailing.  
 Rear cargo cover not fitted at this time.  
 Baby seat previous fitted-impressions to seat trim evident.  
 Head restraint missing.  
 Seat belt twisted.  
 Air vent slats damaged.
