# Inspection Report

**MTA Pre Purchase Inspections ABN 72158123418**

Client Name	Fabiana XXXXXXXX
Client Email	fxX@gmail.com
Vehicle Make and Model	Toyota Rav 4
Variant	Cruiser
Year of Manufacture	2006
Registration Number	AXJ59N
Booking Reference	CAMXXXXP

Inspection Date:	06 Nov 2021
Inspection Time:	12:05 pm

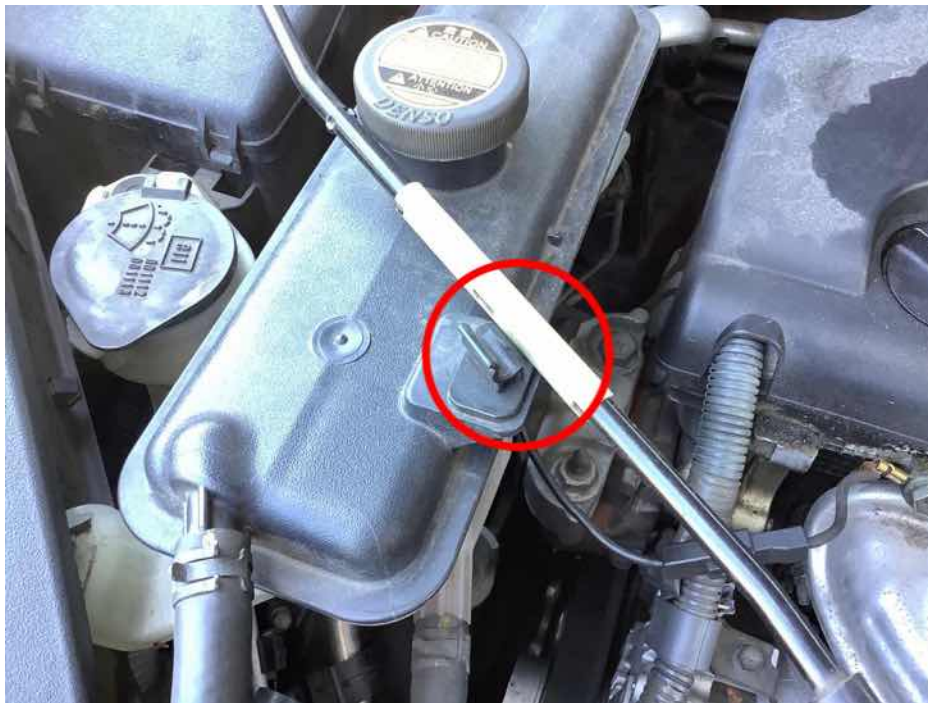
### Engine bay-General

External drive belt has fatigue cracks-suggest replacement.

Bonnet hold retaining clip broken.

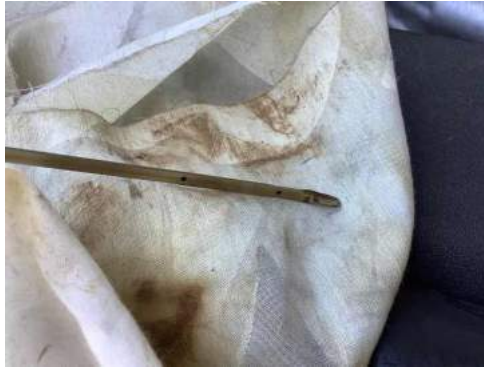
### **Oil and lubrication**

Carbon/sludge built up in oil system. Recommend oil system clean, flush and service -oil strainer/pick up may also require service.

Oil level not registering on dip stick-suggest service/top up to acceptable level.

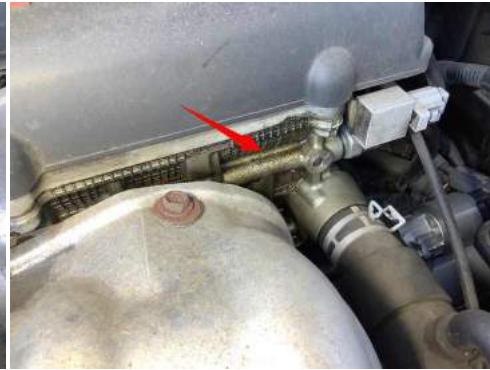
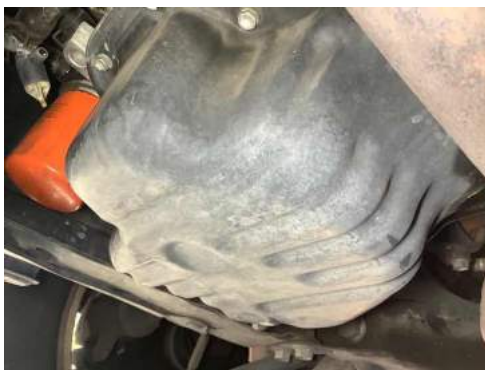
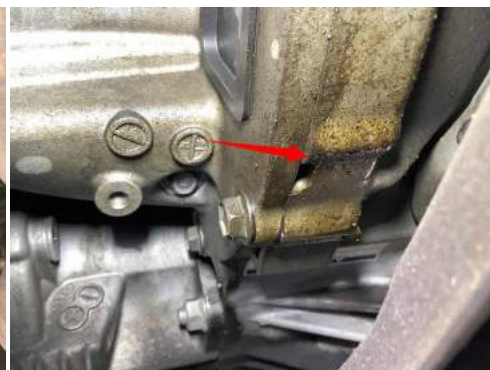
### Engine oil leaks

Oil leak at top of engine consistent with rocker cover gasket leak, needs degrease wash to confirm if only leak and repair as required.

Oil visible at rear of engine, bell housing area-consistent with rear main oil seal leak, recommend clean and re-assess, and repair accordingly.

Oil evident at timing cover and front of sump, clean and reassess/repair as required

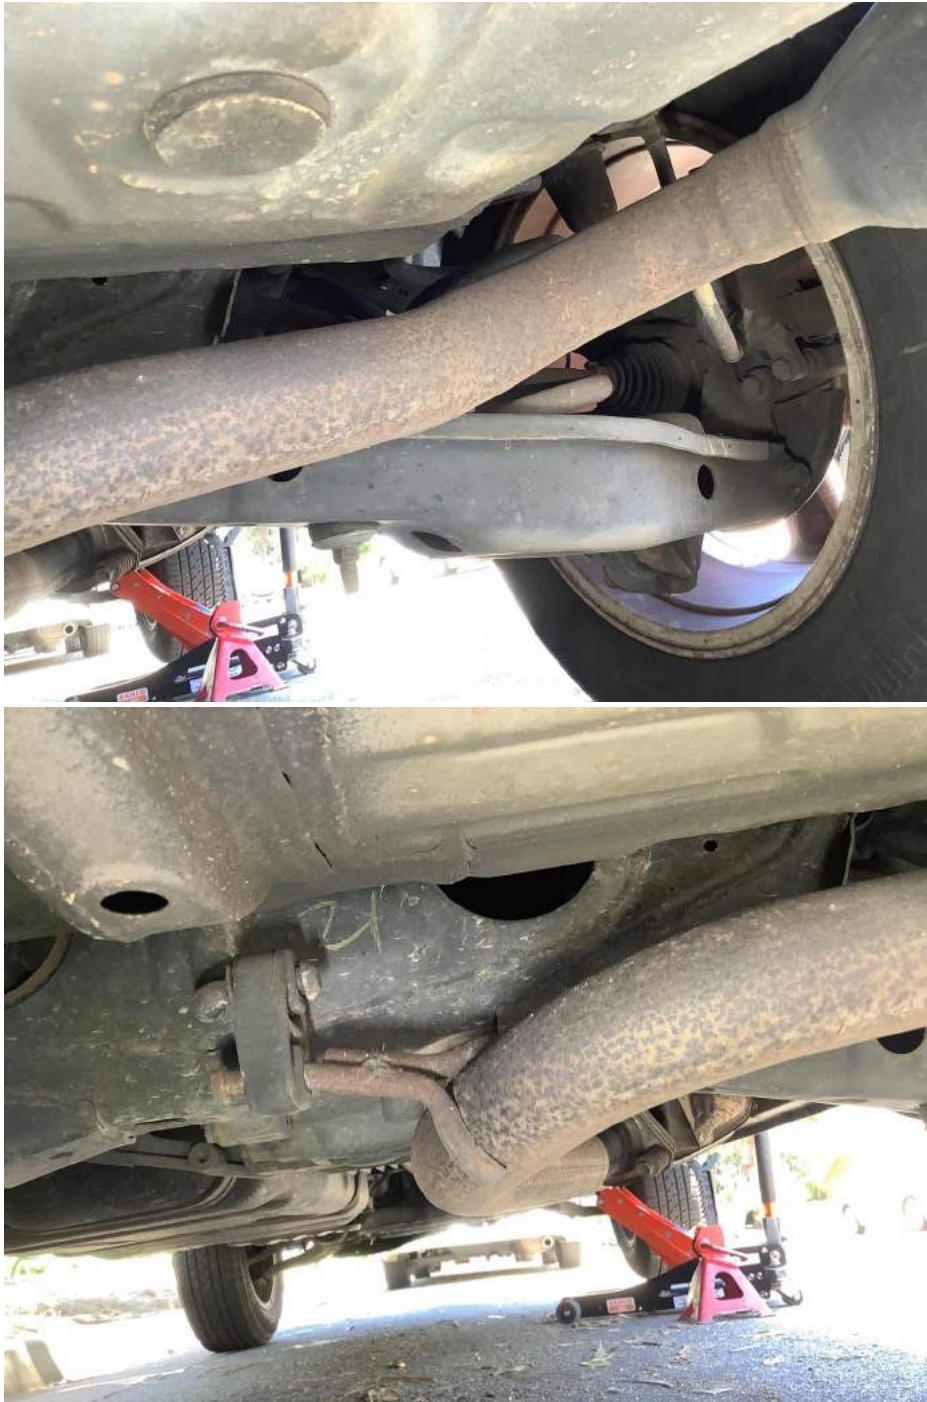
**Exhaust Comments**

Exhaust has surface rust on pipes and mufflers.

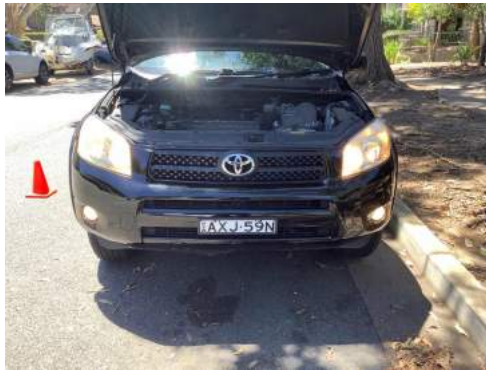
### Lights and lenses

Front and rear lights have been tested-all working at time of inspection.  
Headlight lenses are tarnished, polish and re-assess.

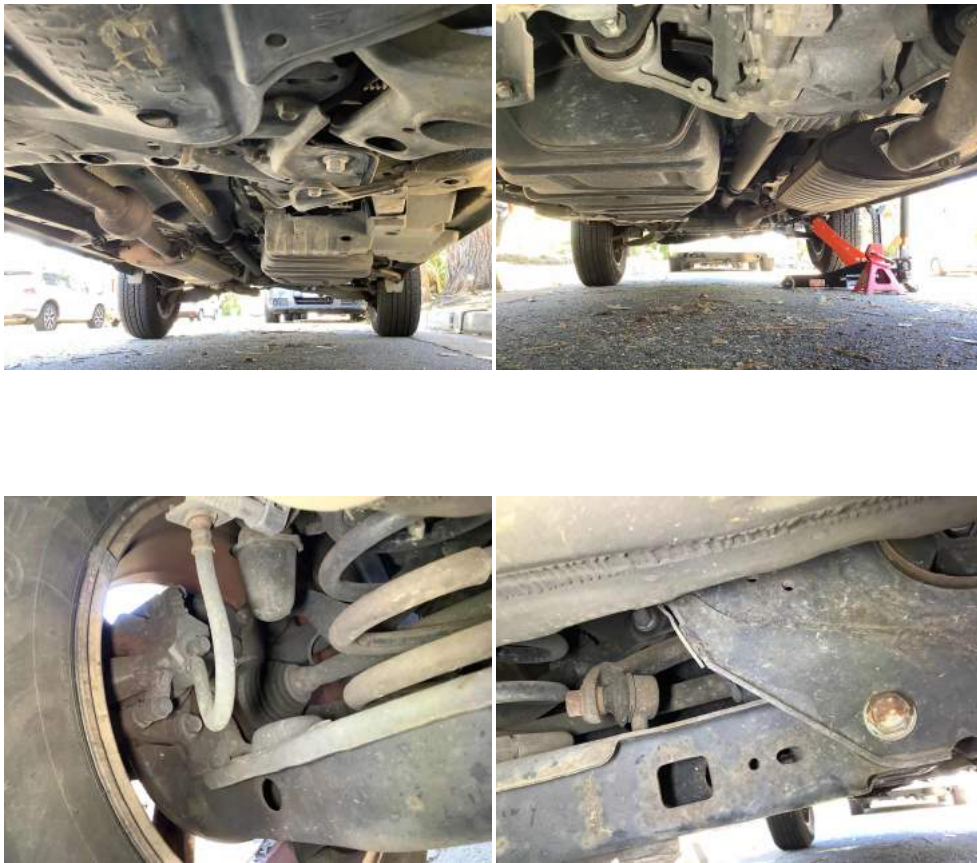
**Underbody.**

Some minor surface rust visible at underbody and is consistent with age and type of vehicle.

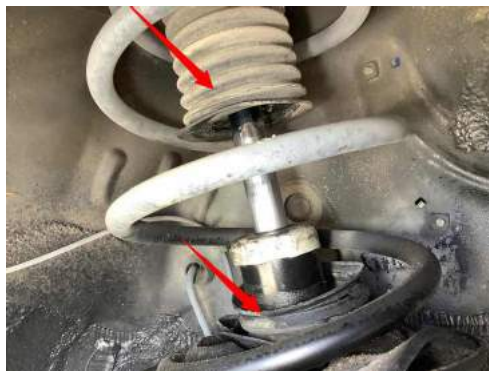
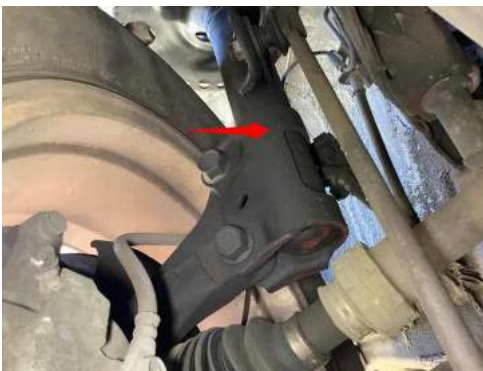
### Steering and suspension recommendations

Shock absorber is leaking, replace as required-front and rear.

Shock absorber dust boot split-replace as required.

Front link pins worn-replace.

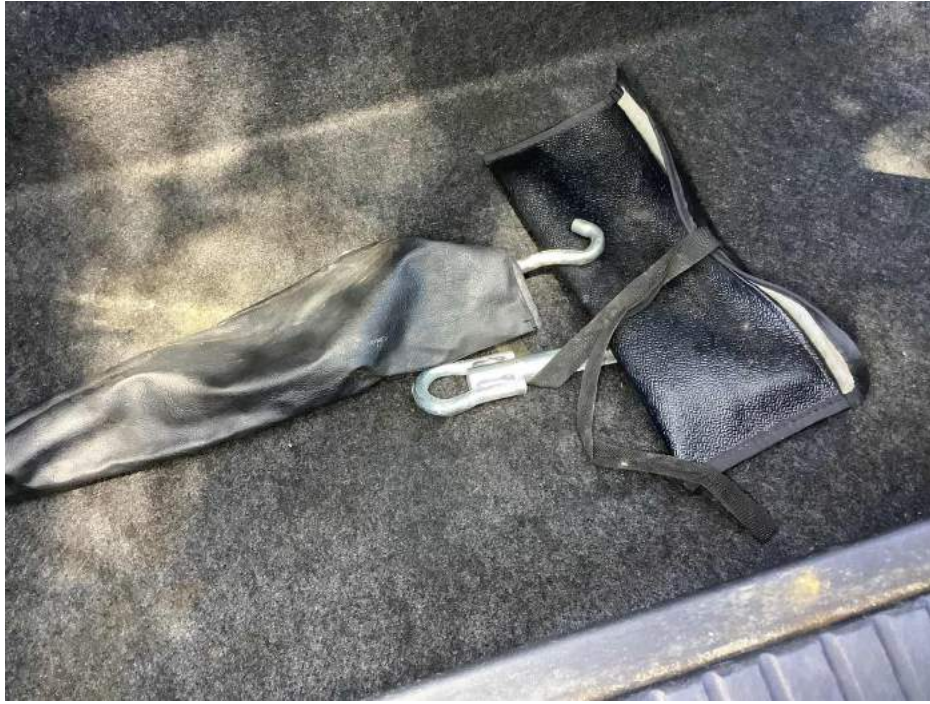
### Wheels and Tyres.

Gutter rash/kerb marks to wheel rims.

Jack not in designated location-missing.

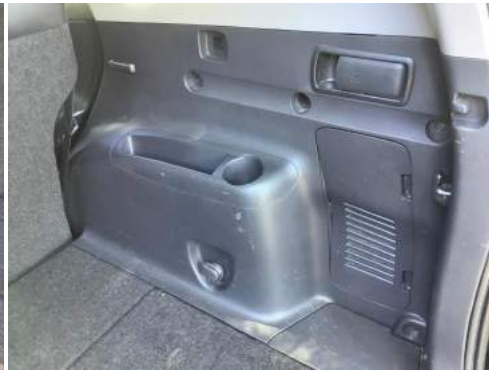
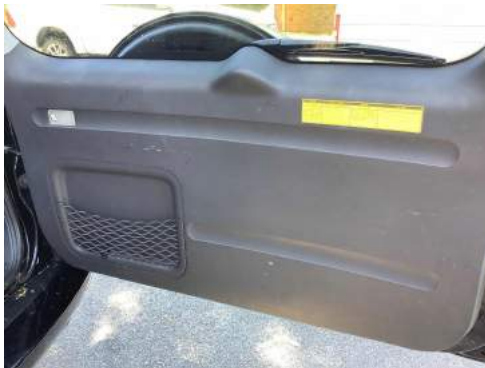
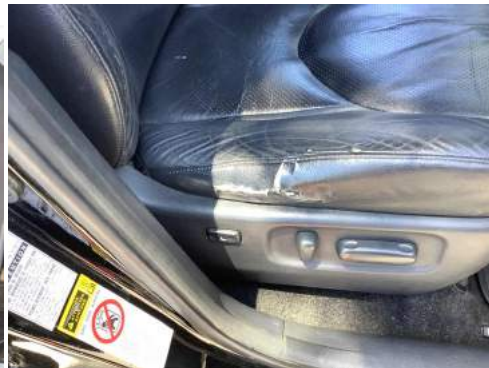
### Interior comments (General)

Interior trims & seats have light marks.  
 Interior trim & carpet is dirty recommend full interior detailing.  
 Rear cargo cover not fitted at this time.  
 Baby seat previous fitted-impressions to seat trim evident.  
 Head restraint missing.  
 Seat belt twisted.  
 Air vent slats damaged.

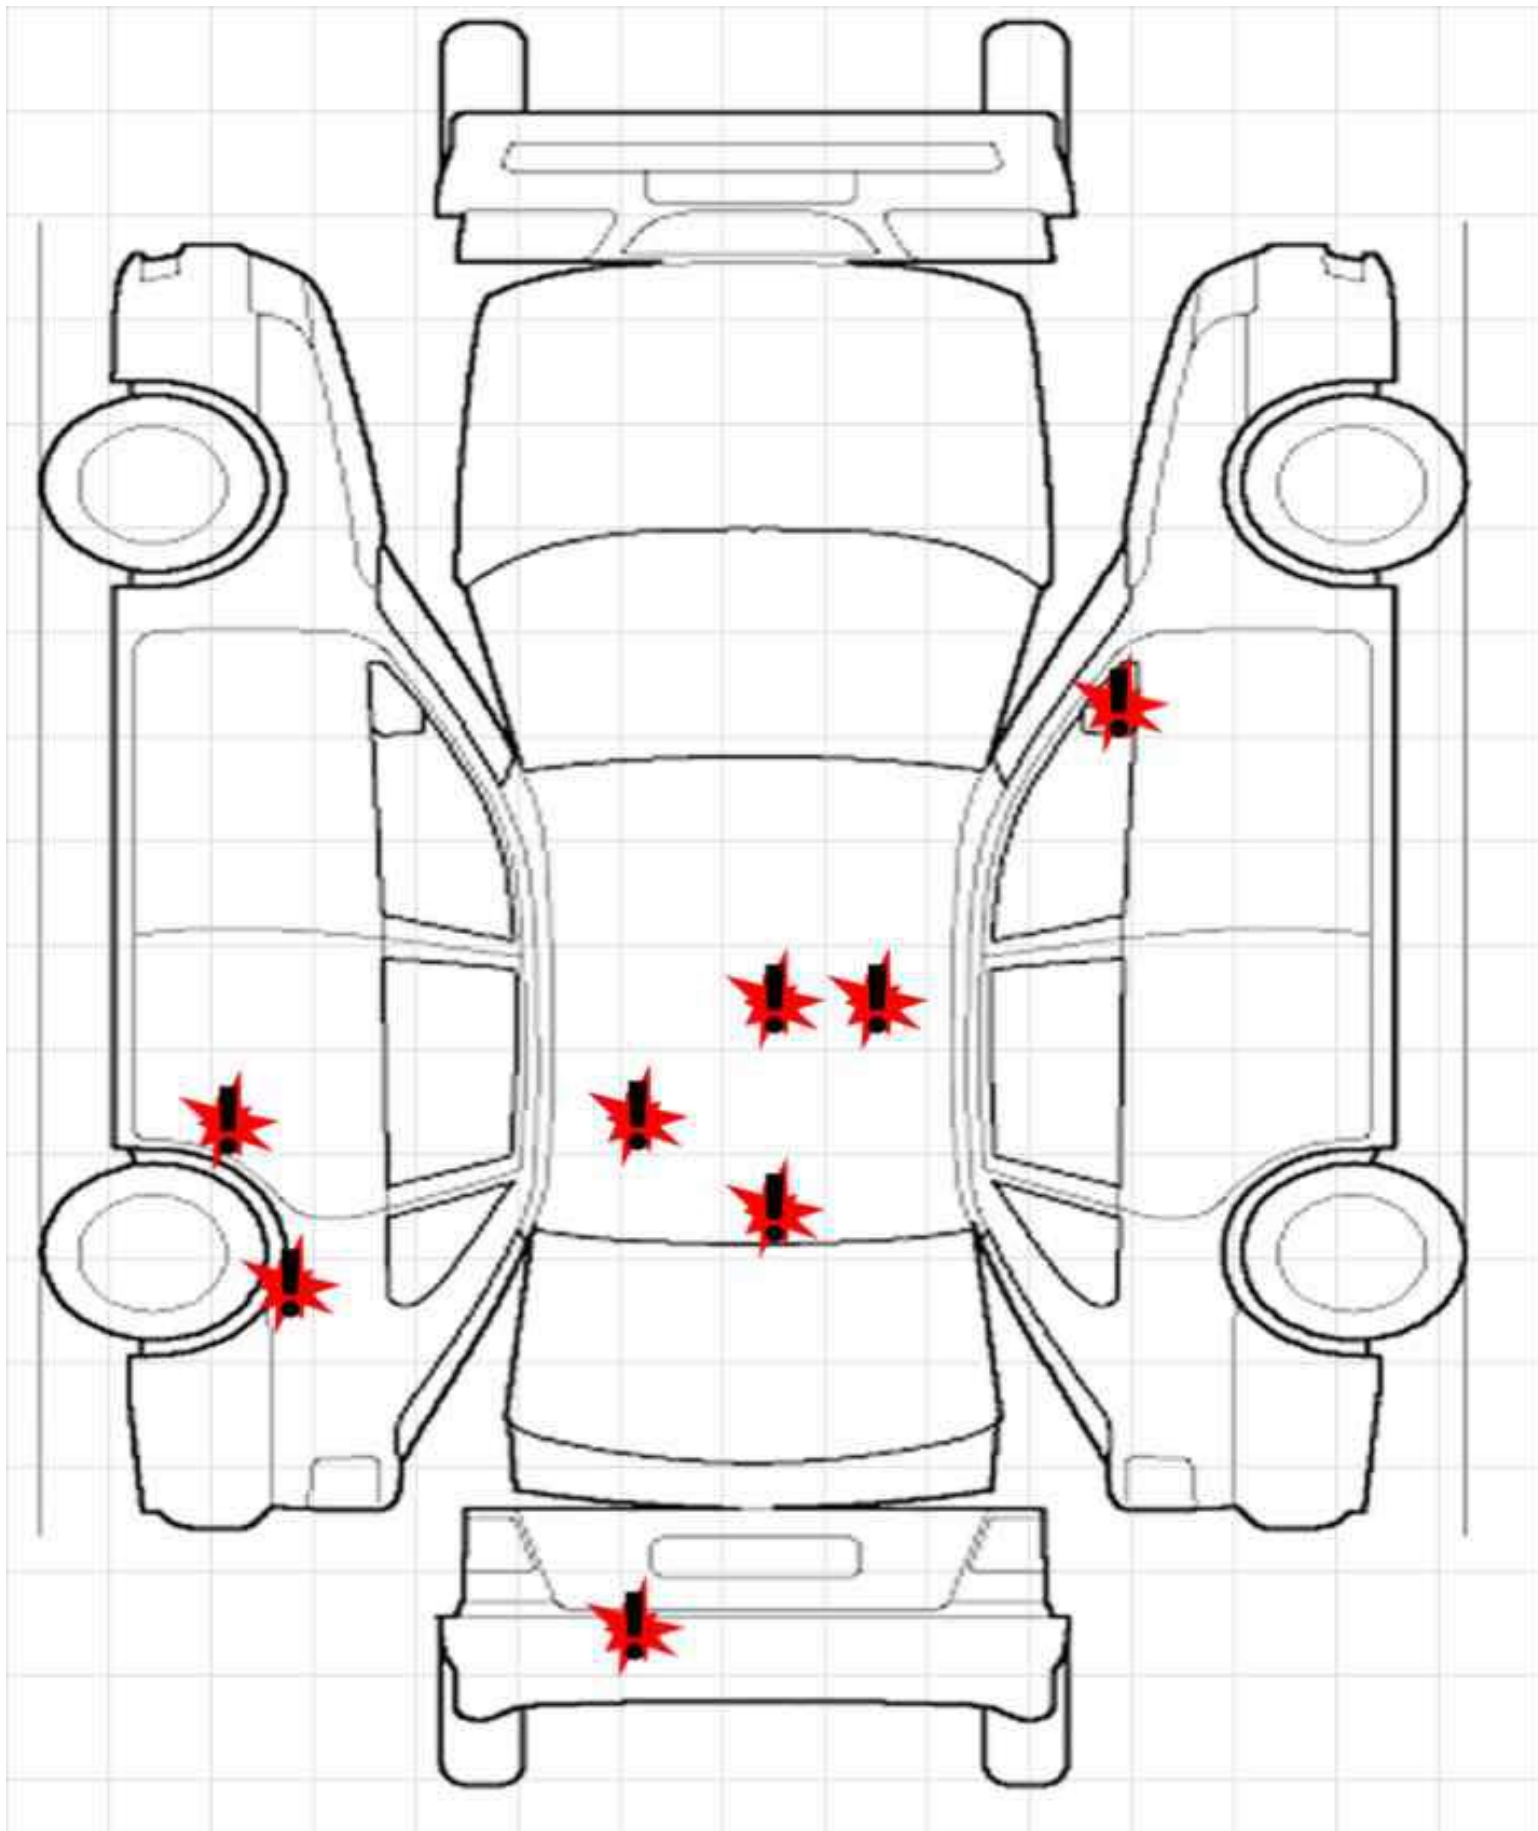
## DIAGRAMS

**See mud map last page of report after terms and conditions**
