Inspection Report

MTA Pre Purchase Inspections ABN 72158123418

Client Name	Stewart XXXXXXX
Inspection Ordered By	Phil
Client Email	piacxxx@xxxxxxxxxxcom.au
Vehicle Make and Model	Volkswagen
Variant	Tiguan Type R
Year of Manufacture	2017
Registration Number	NBT31T
Booking Reference	CAM8xxxxD
Total Fee	\$295.00

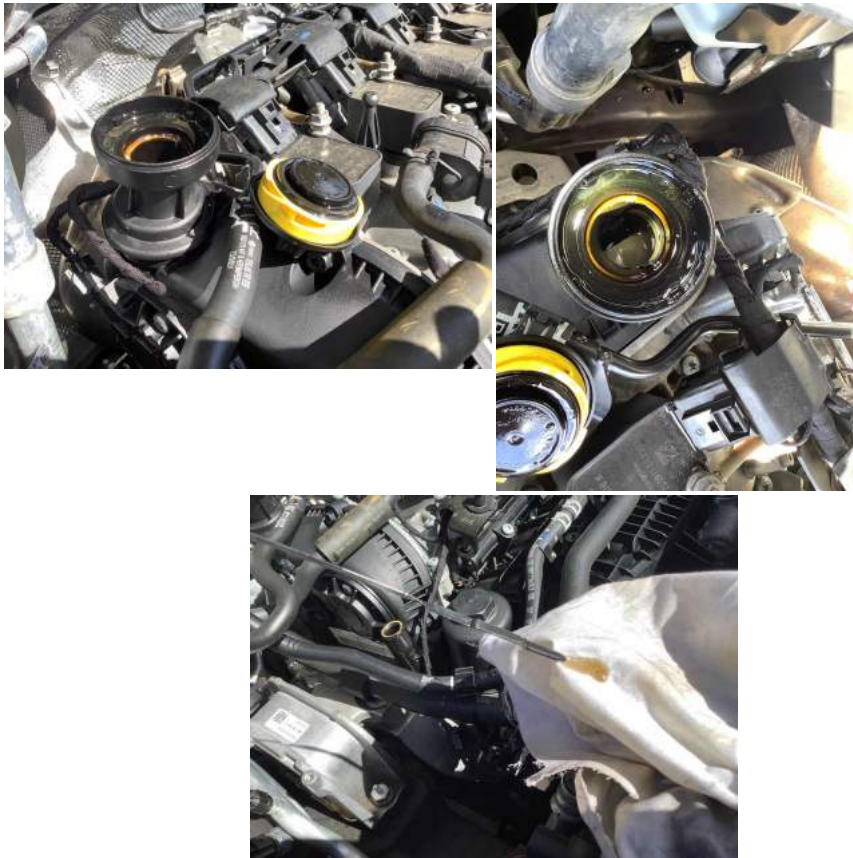
Oil and lubrication

An inspection of the oil filler shows no sign of internal lubricant breakdown.
Oil level is correct and appears to have been recently serviced.

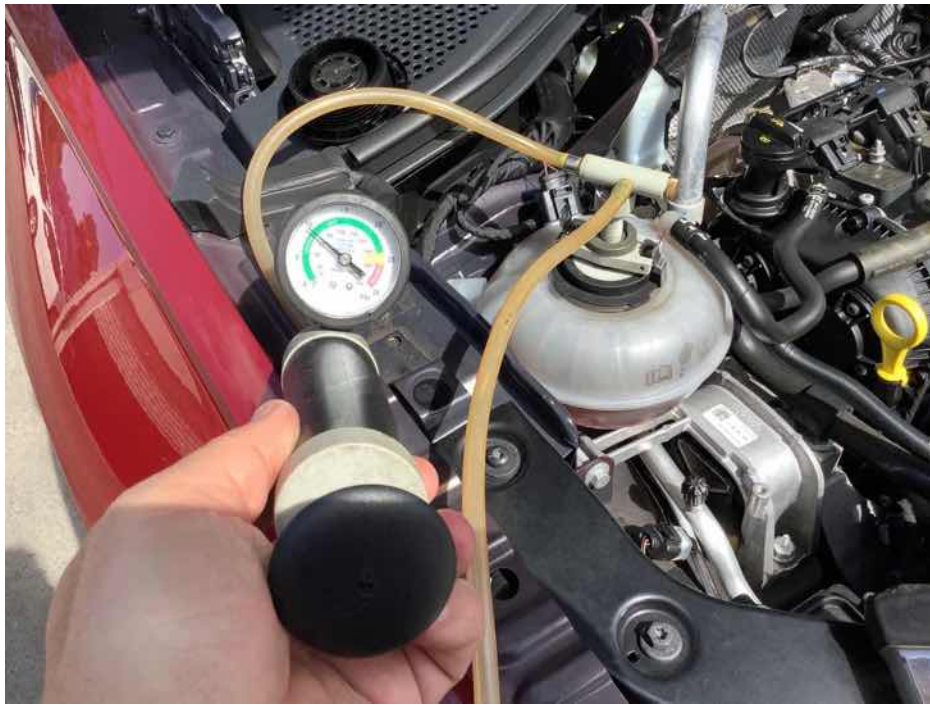
The cooling system and its components visually appear in good order of service at the time of inspection. The cooling system has passed a pressure test. The engine is running at normal operating temperature. The radiator corrosion inhibitor concentrate level has been measured and is at serviceable level.

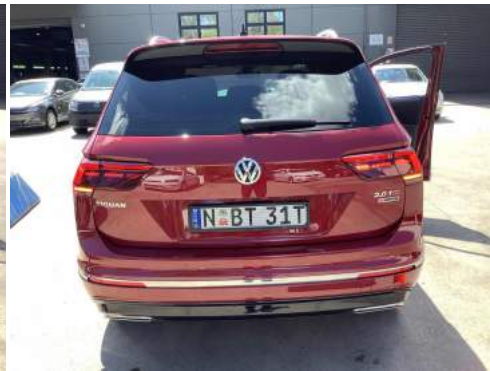
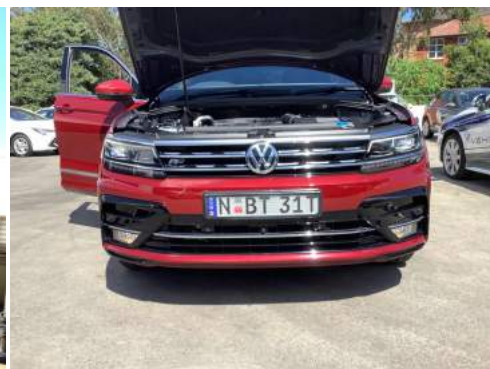
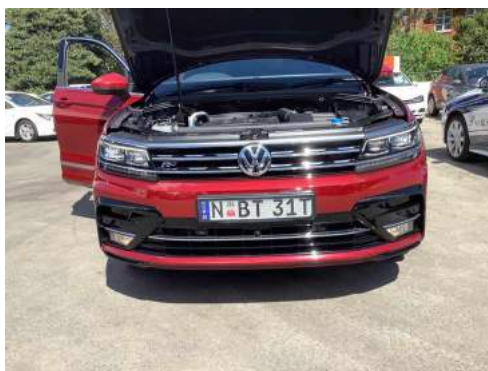
Lights and lenses

Front and rear lights have been tested-all working at time of inspection.

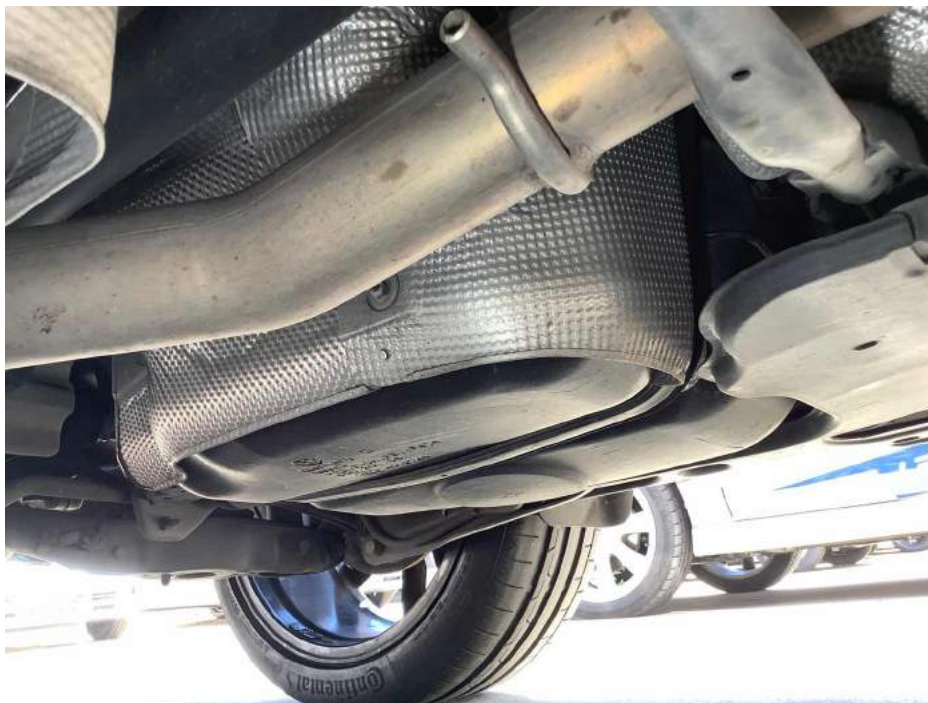
The fuel system visually appears to have no faults and is in good condition at time of inspection. No fuel leaks evident.

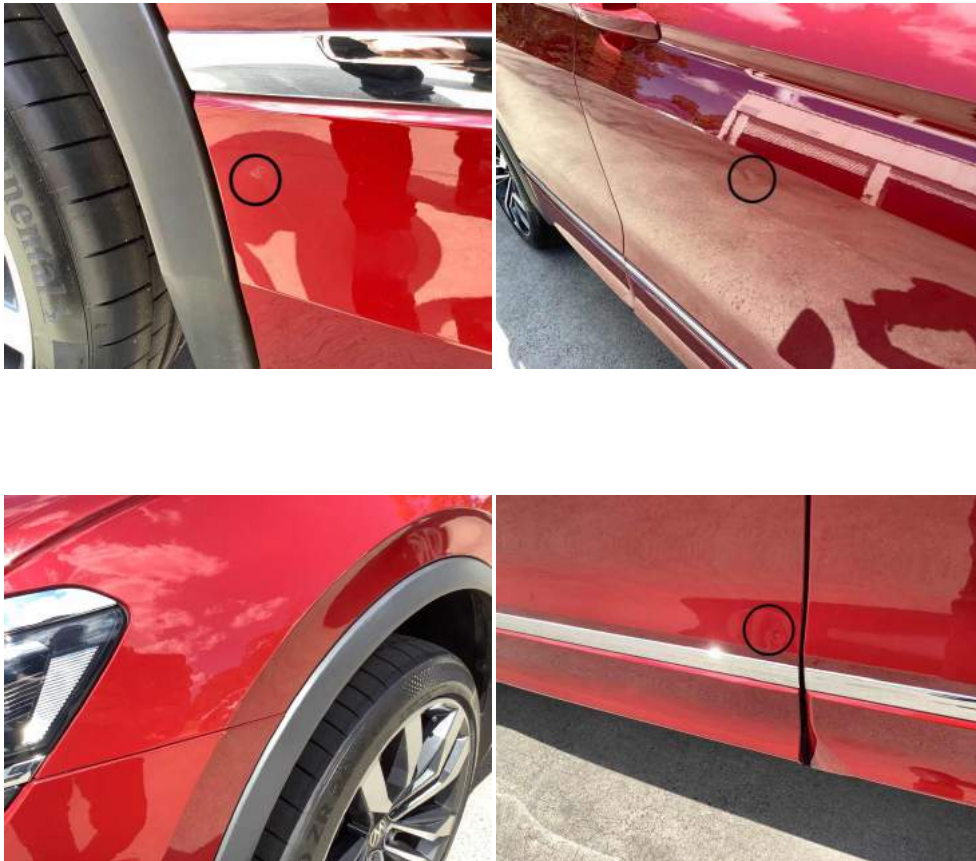
External appearance

Carpark type dents, chips, scratches and marks to various panels and bumpers however external presentation is good.

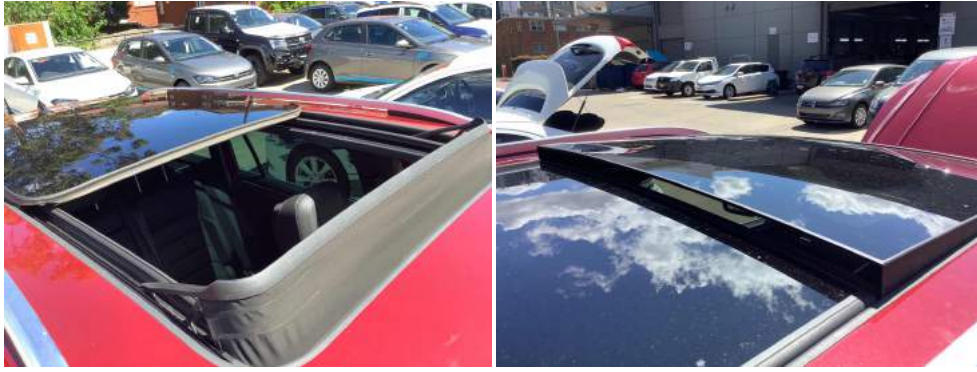
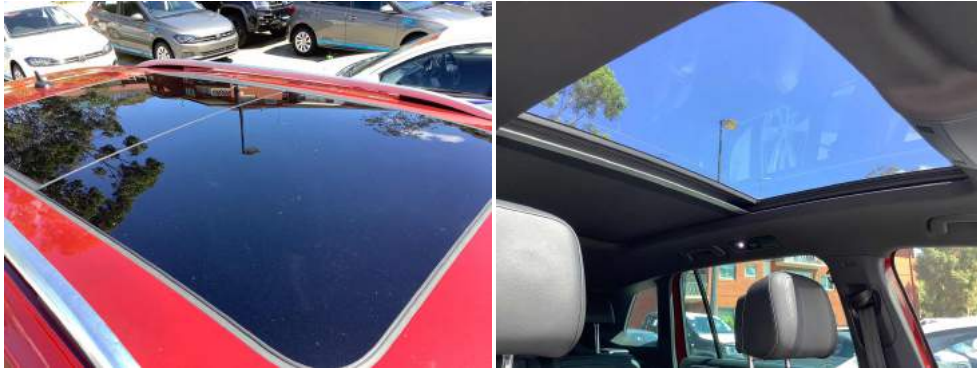
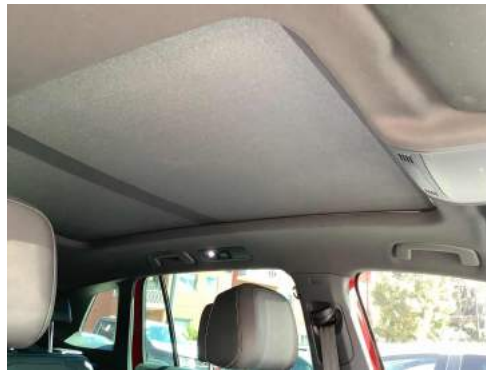
Sunroof and convertible roof

Sunroof operates correctly.

Internal sunshade operates correctly.

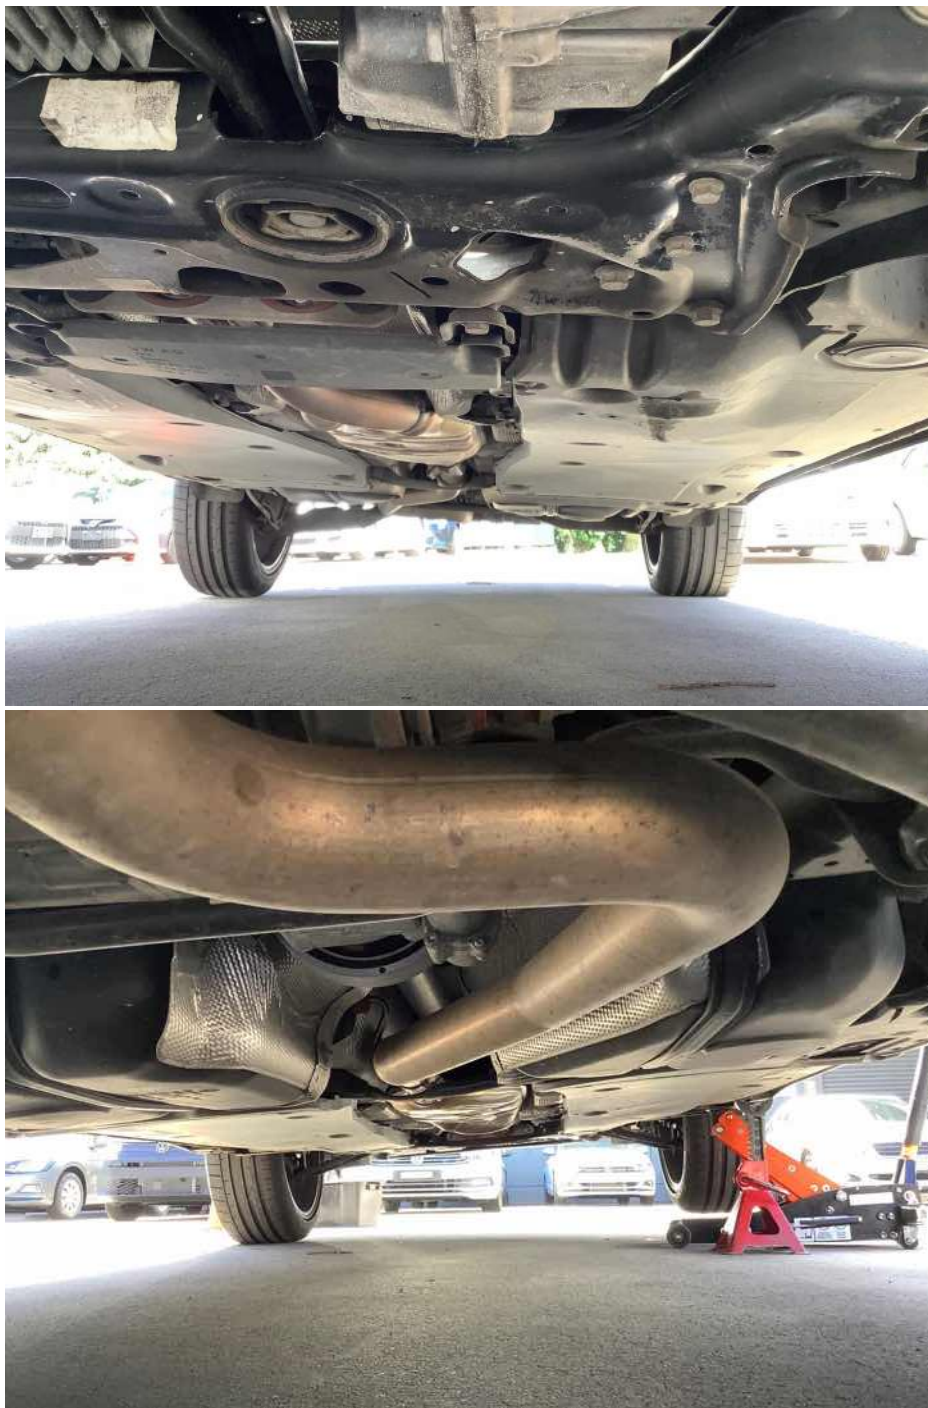
Underbody.

The underbody of the vehicle is in good order at the time of inspection

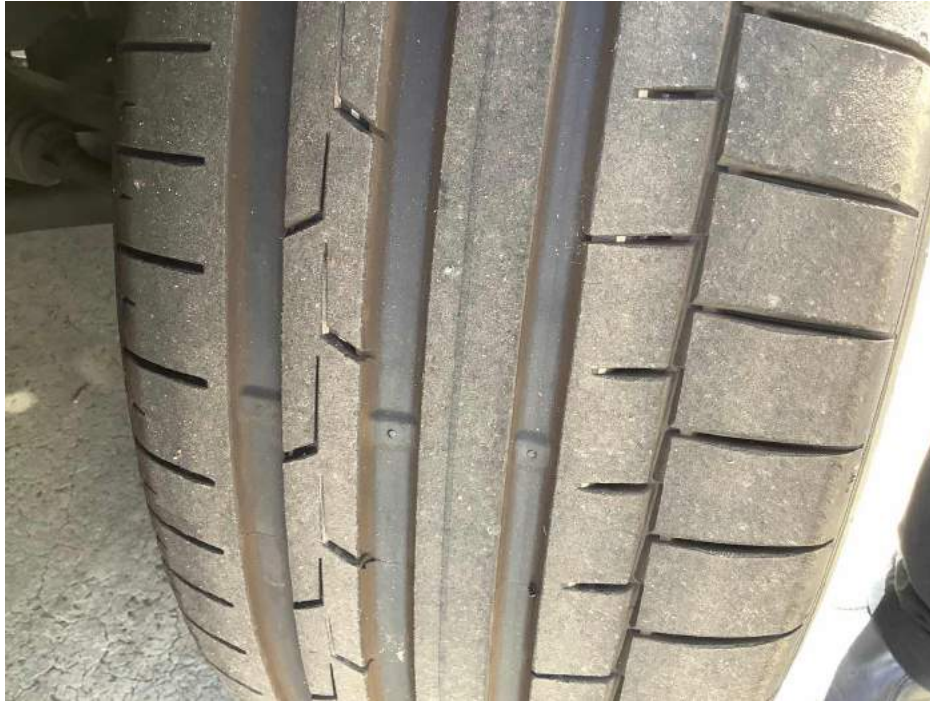
Drivers front

Approximately 100% remaining.

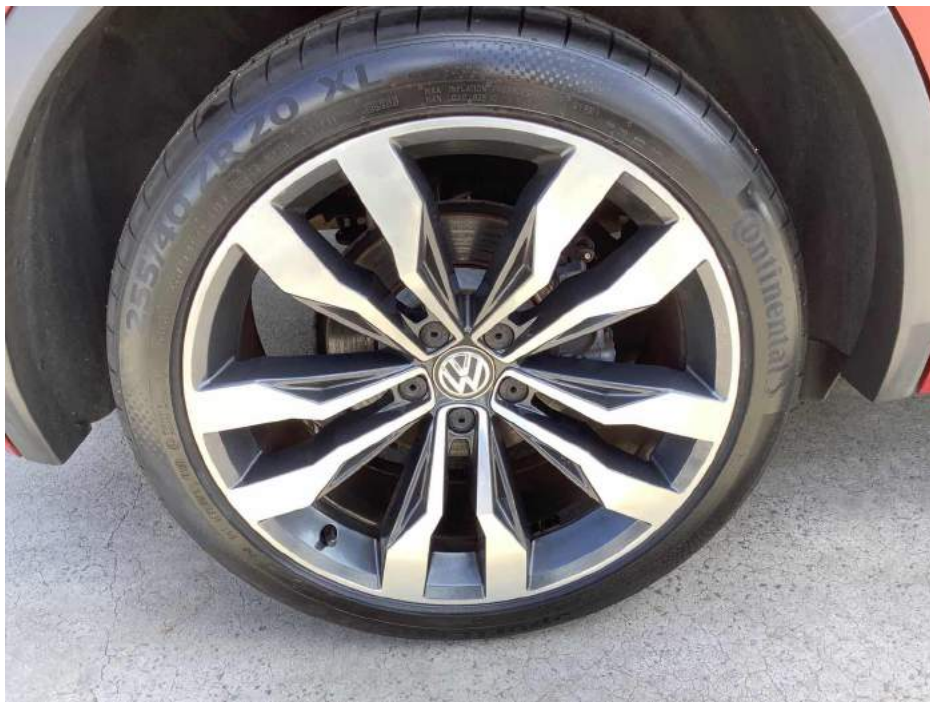
Drivers rear

Approximately 100% remaining.

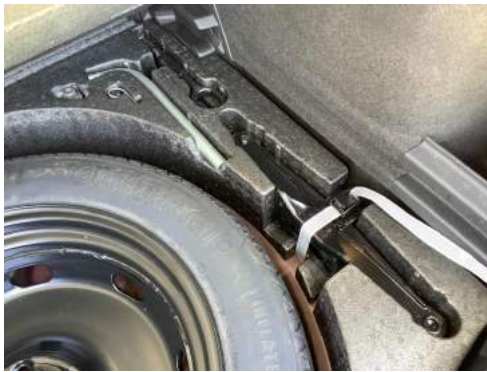
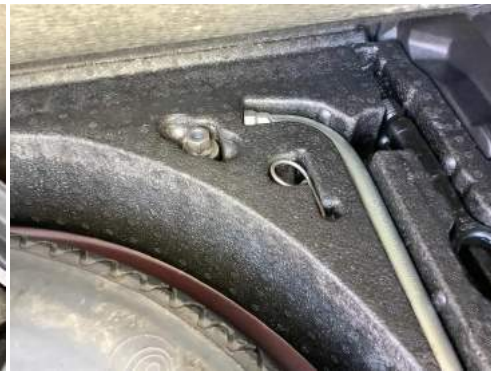
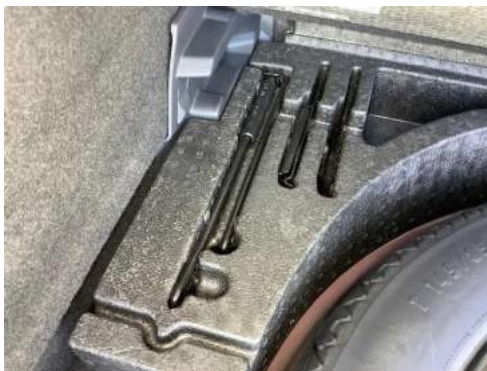
Spare

Approximately 100% remaining.
Temporary spare as standard

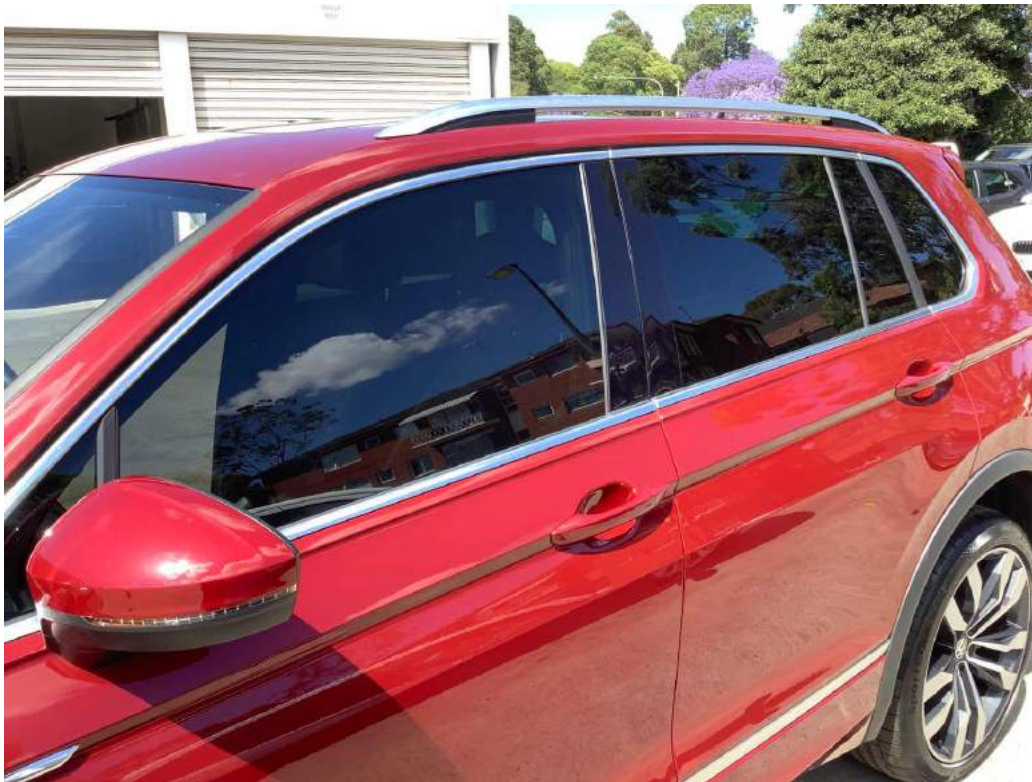
Window tint and accessories.

Windows have been tinted.
