Inspection Report

MTA Pre Purchase Inspections ABN 72158123418

Client Name	Stewart XXXXXXX
Inspection Ordered By	Phil
Client Email	piacxxx@xxxxxxxxxxcom.au
Vehicle Make and Model	Volkswagen
Variant	Tiguan Type R
Year of Manufacture	2017
Registration Number	NBT31T
Booking Reference	CAM8xxxxD

Inspection Date:	06 Nov 2021
Inspection Time:	09:30 am

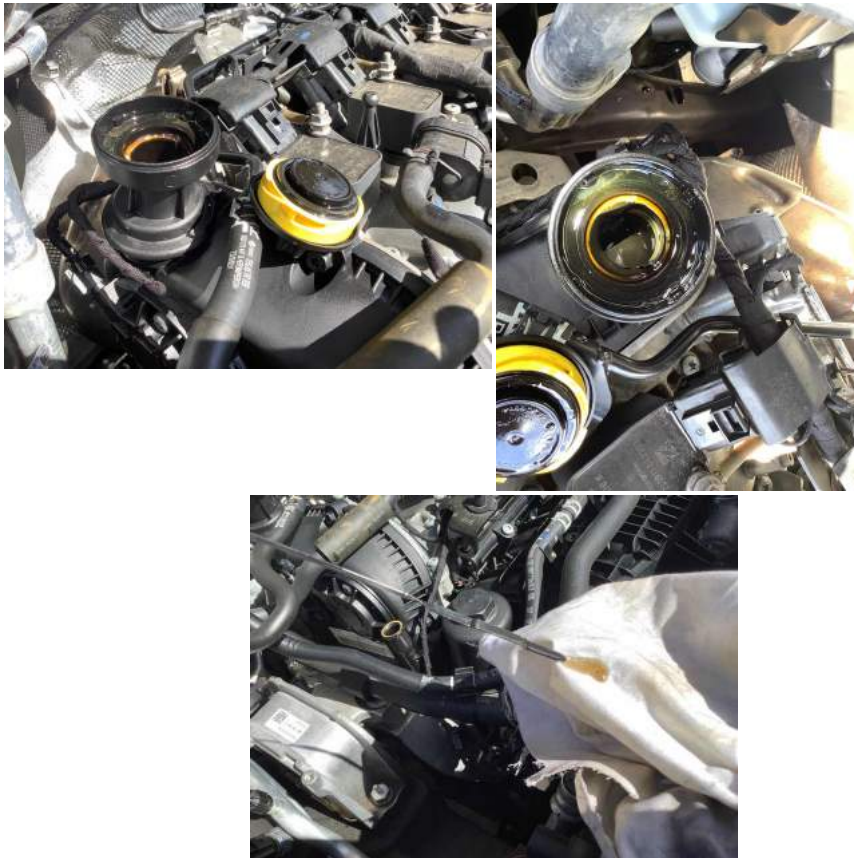
Oil and lubrication

An inspection of the oil filler shows no sign of internal lubricant breakdown.
Oil level is correct and appears to have been recently serviced.

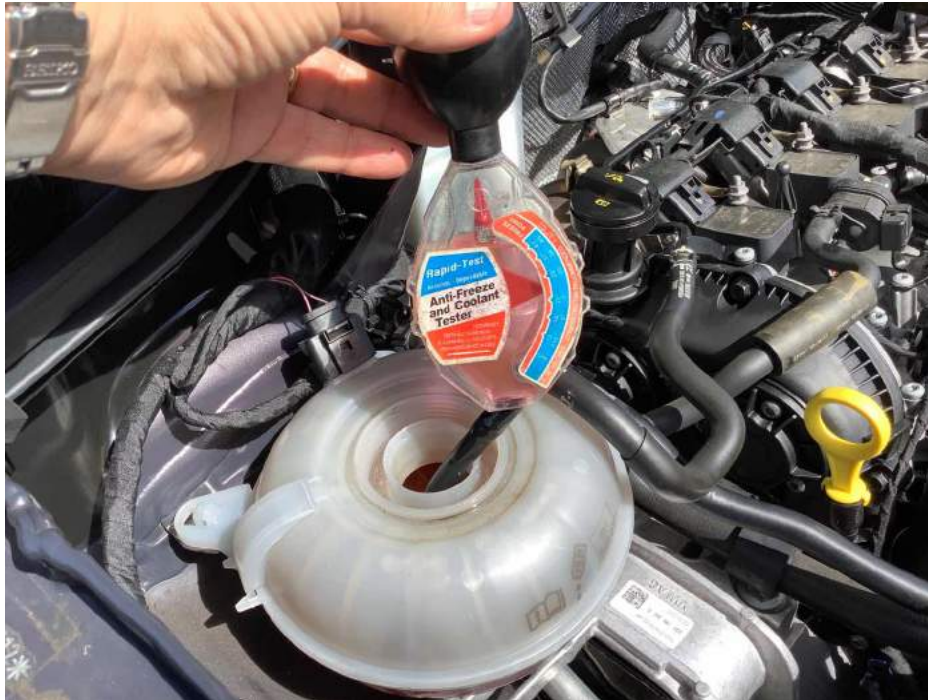
The cooling system and its components visually appear in good order of service at the time of inspection. The cooling system has passed a pressure test. The engine is running at normal operating temperature. The radiator corrosion inhibitor concentrate level has been measured and is at serviceable level.

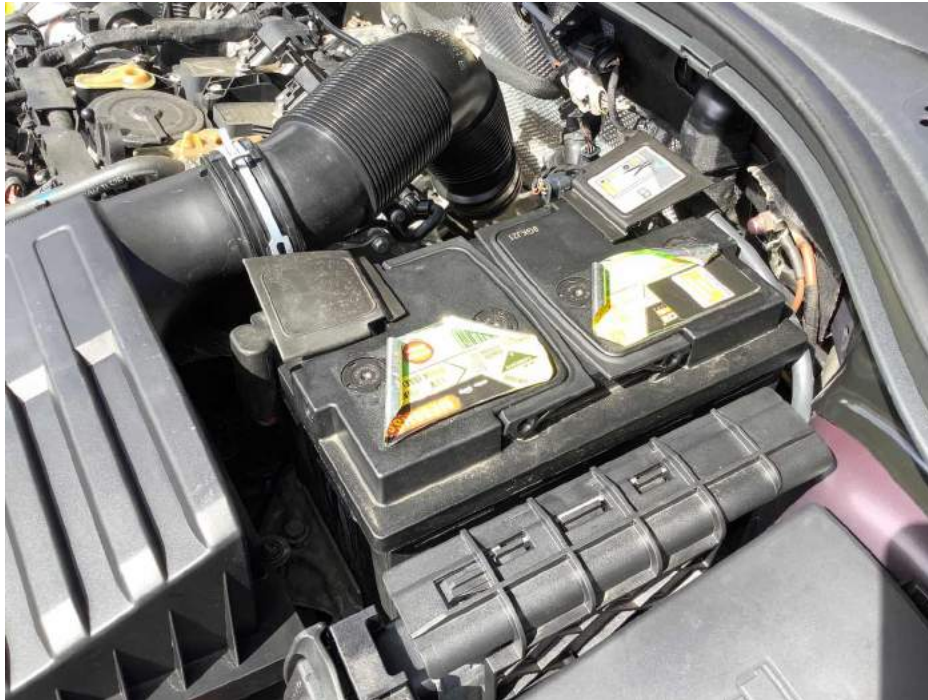
The electrical system visually appears to be in good working order at the time of inspection.

Charge rate is within manufactures specifications.

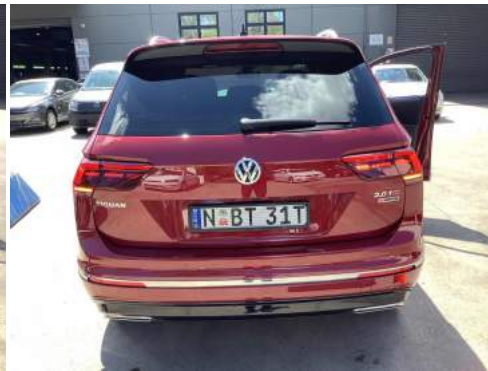
Lights and lenses

Front and rear lights have been tested-all working at time of inspection.

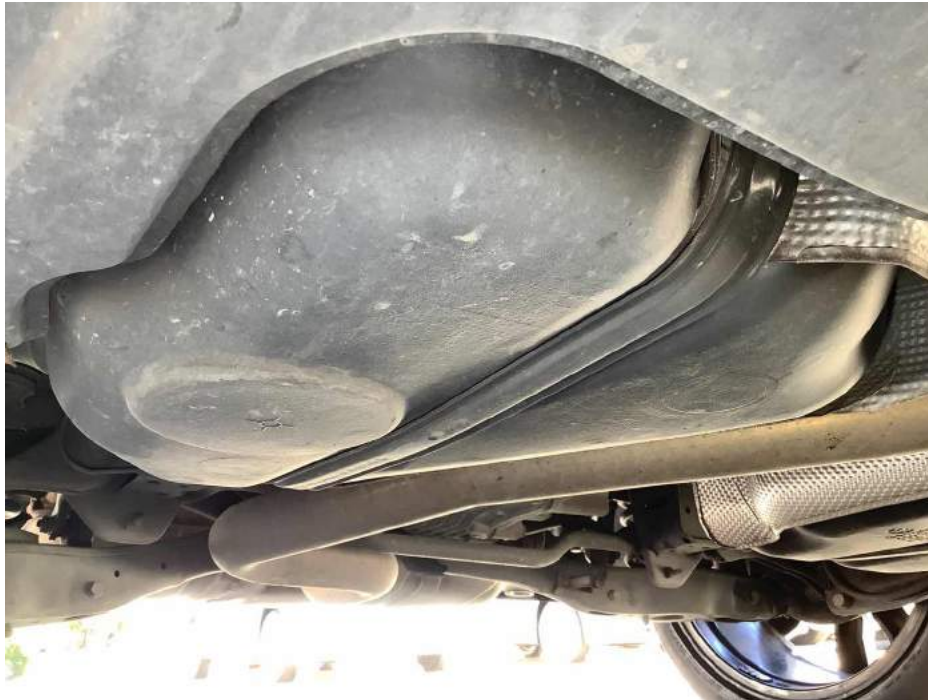
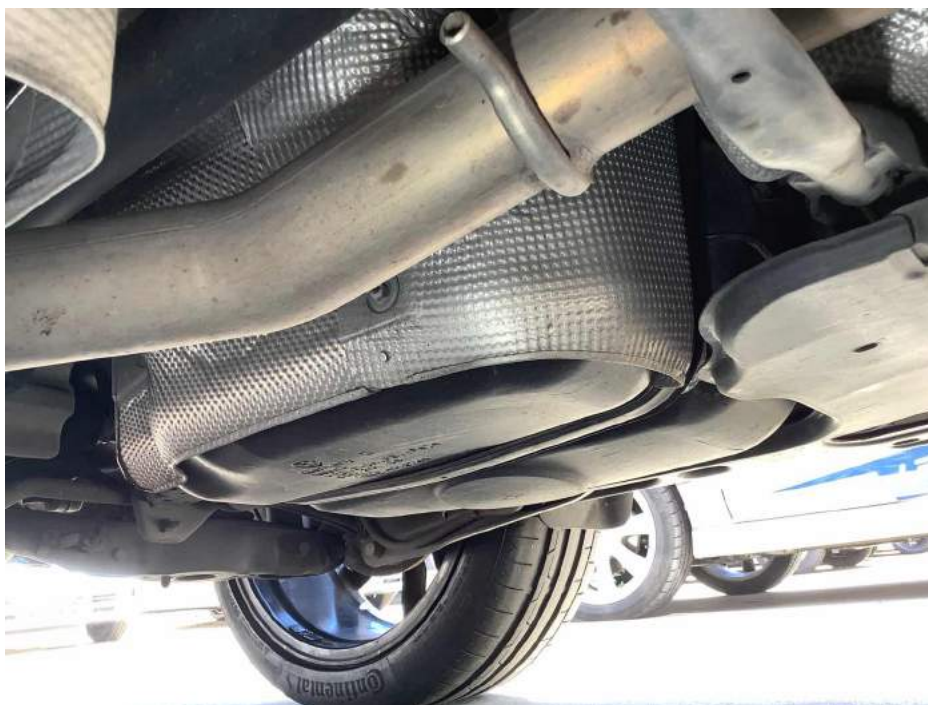
The fuel system visually appears to have no faults and is in good condition at time of inspection. No fuel leaks evident.

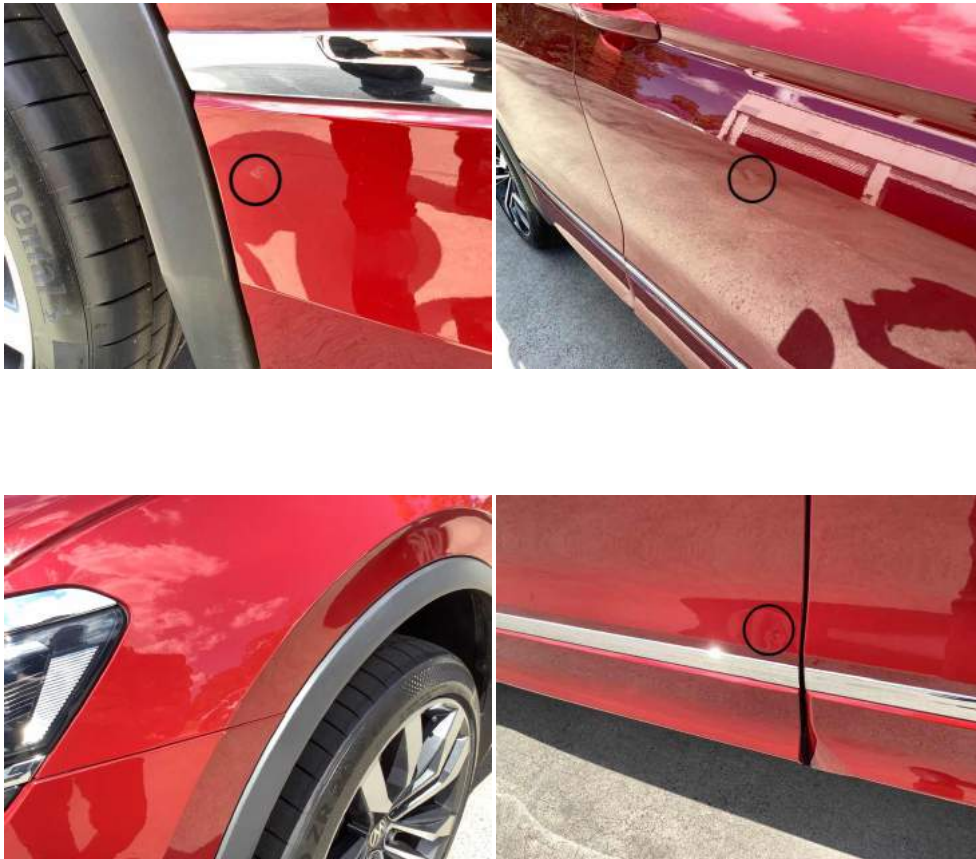
External appearance

Carpark type dents, chips, scratches and marks to various panels and bumpers however external presentation is good.

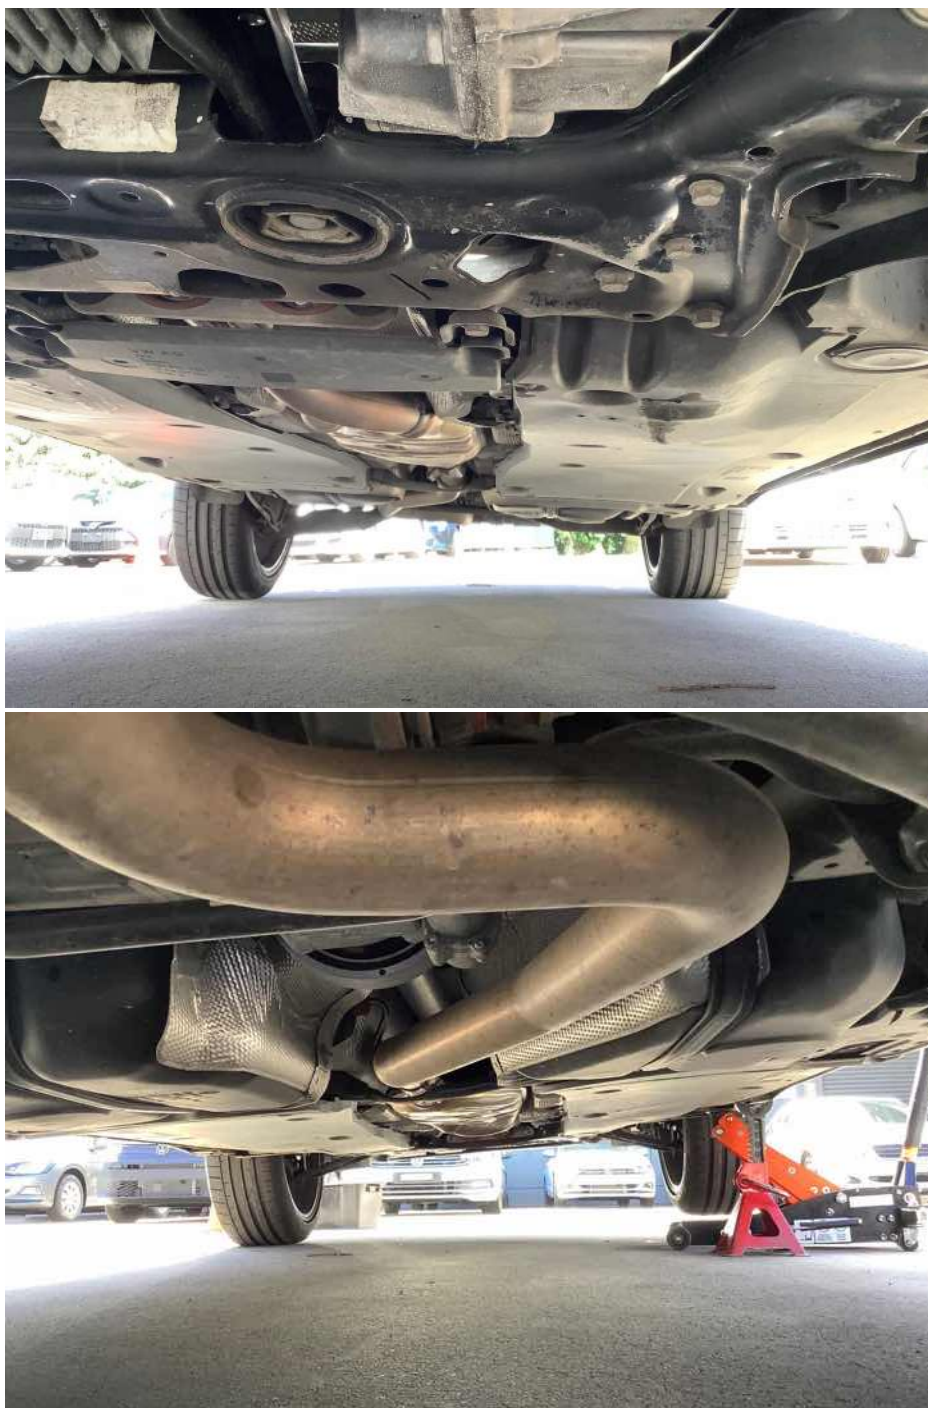
Underbody.

The underbody of the vehicle is in good order at the time of inspection

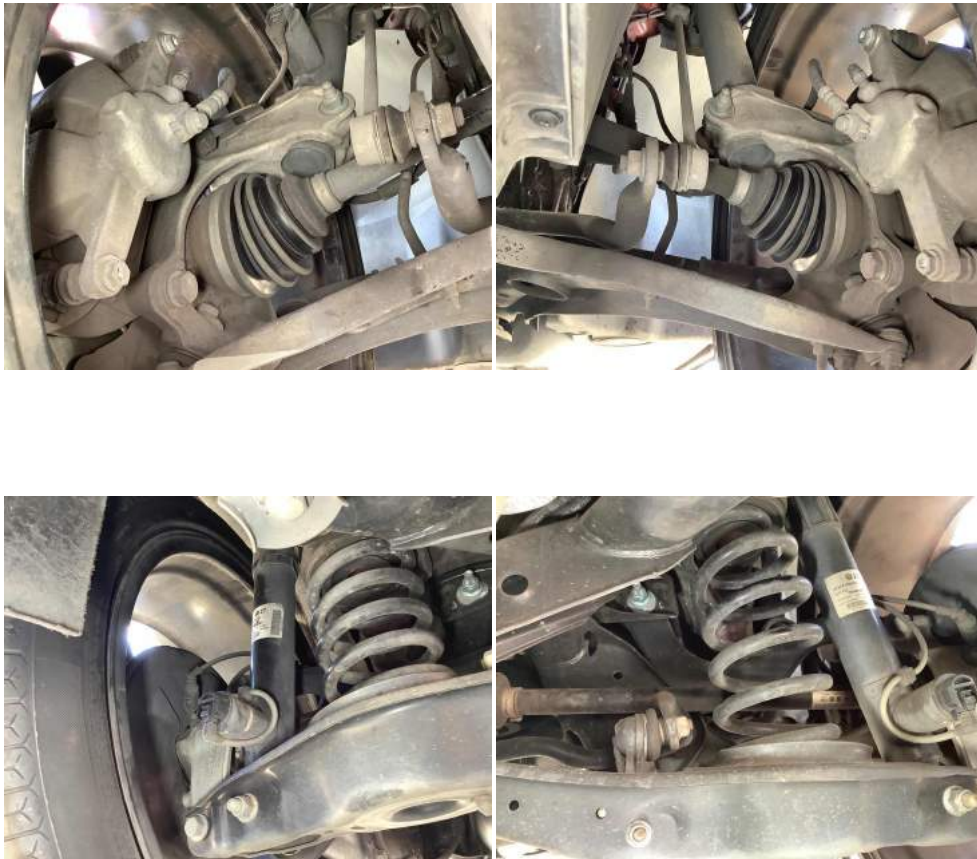
No major issues noted during inspection.

Steering suspension and rubber bushes showing typical wear for kilometres, some components will require replacing as needed during vehicles service life-ok at this stage.

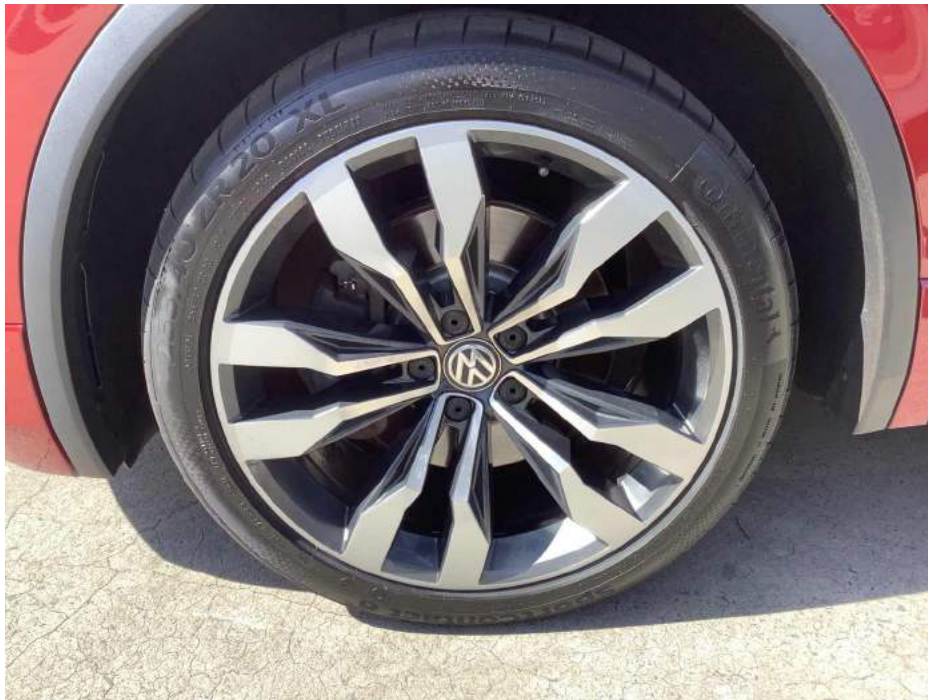
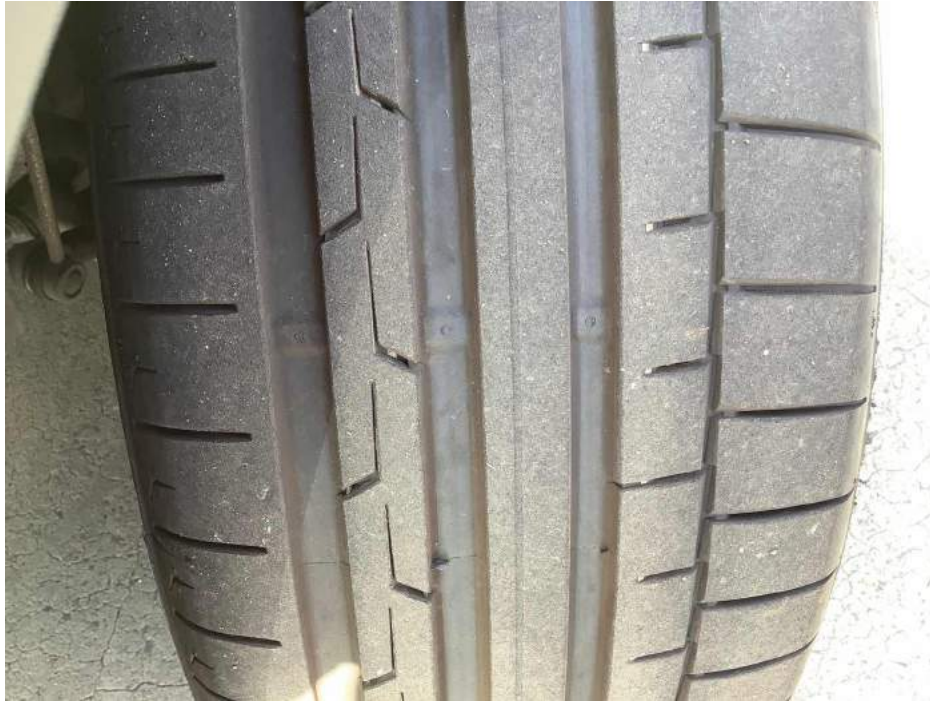
Passanger front

Approximately 100% remaining.

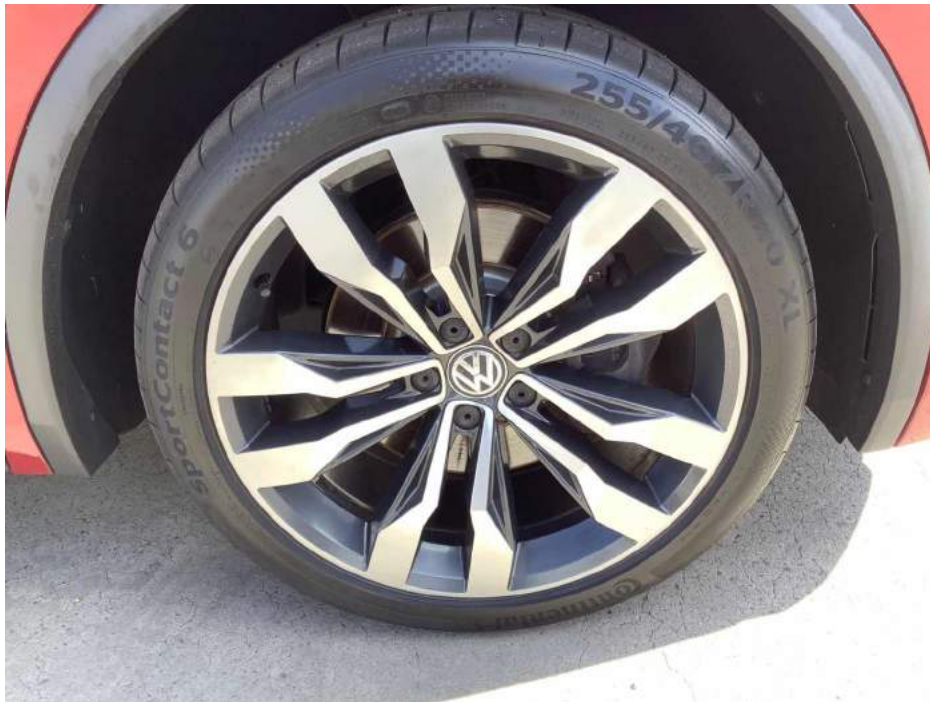
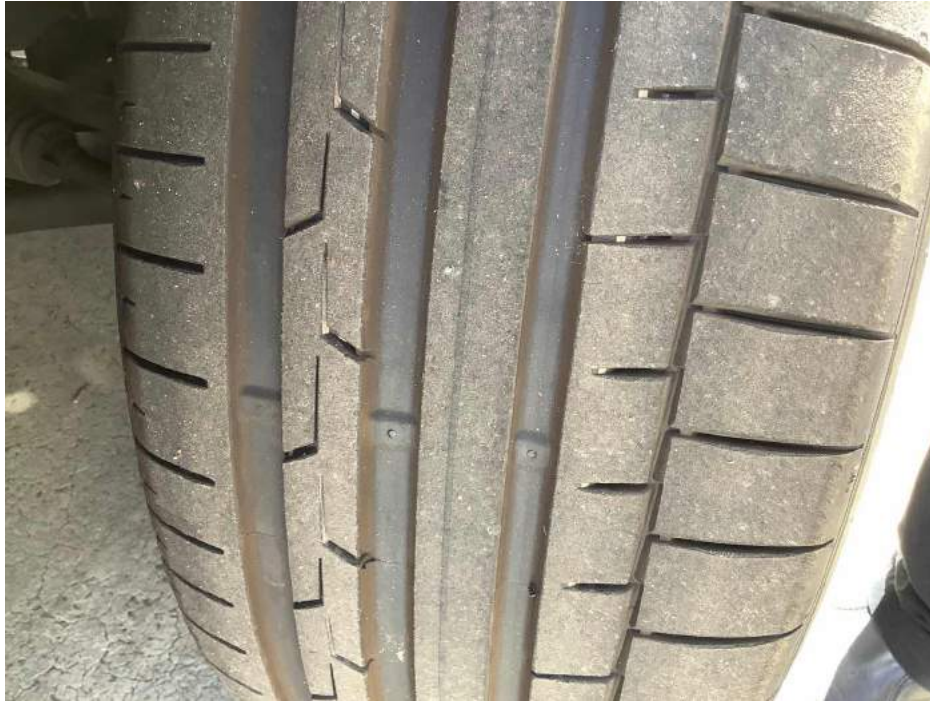
Drivers front

Approximately 100% remaining.

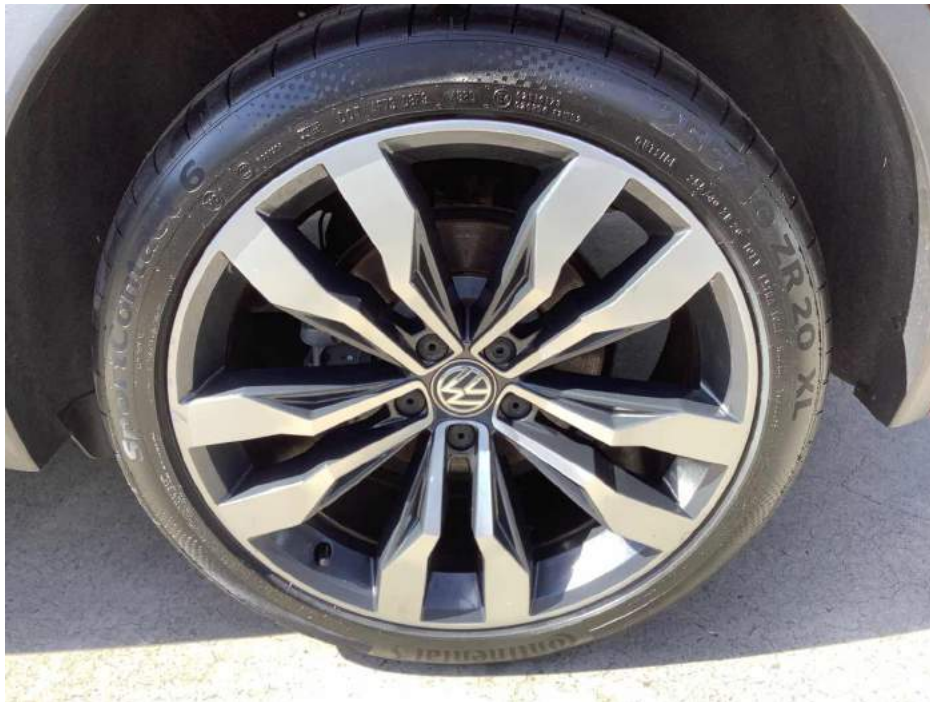
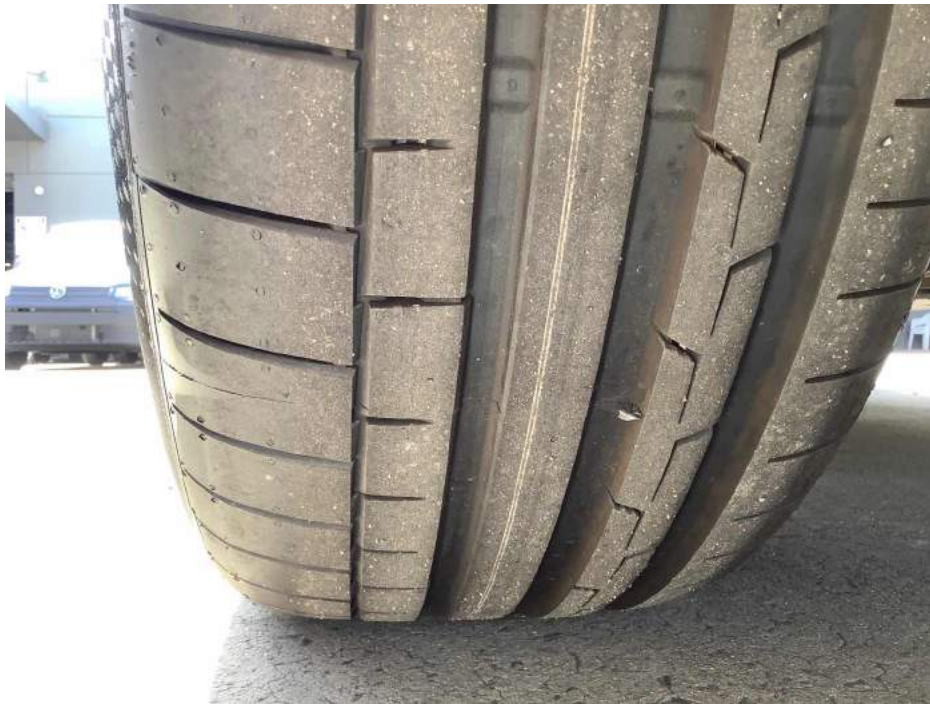
Passanger rear

Approximately 100% remaining.

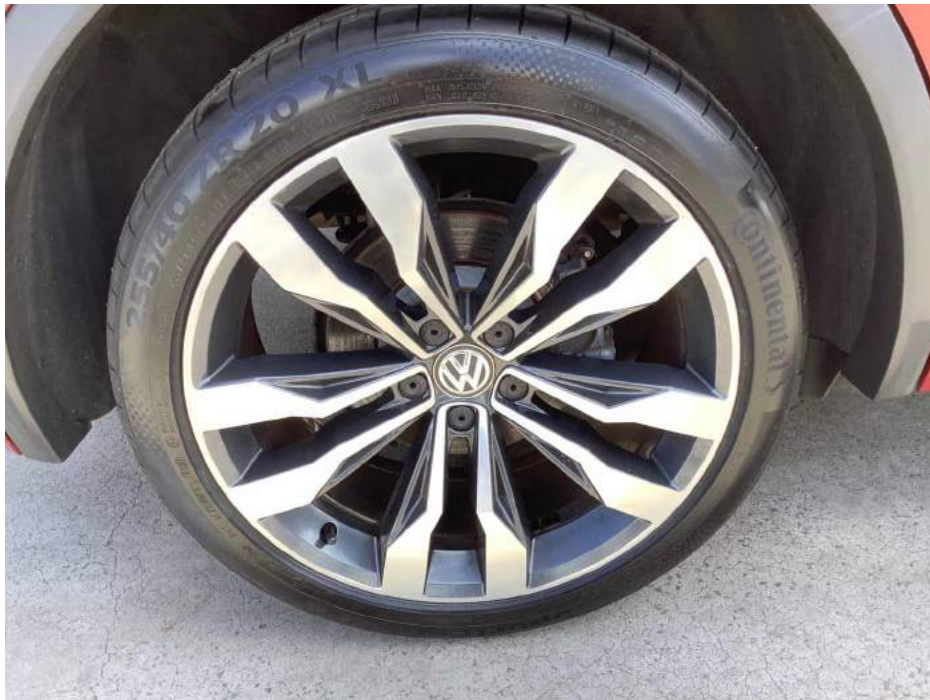
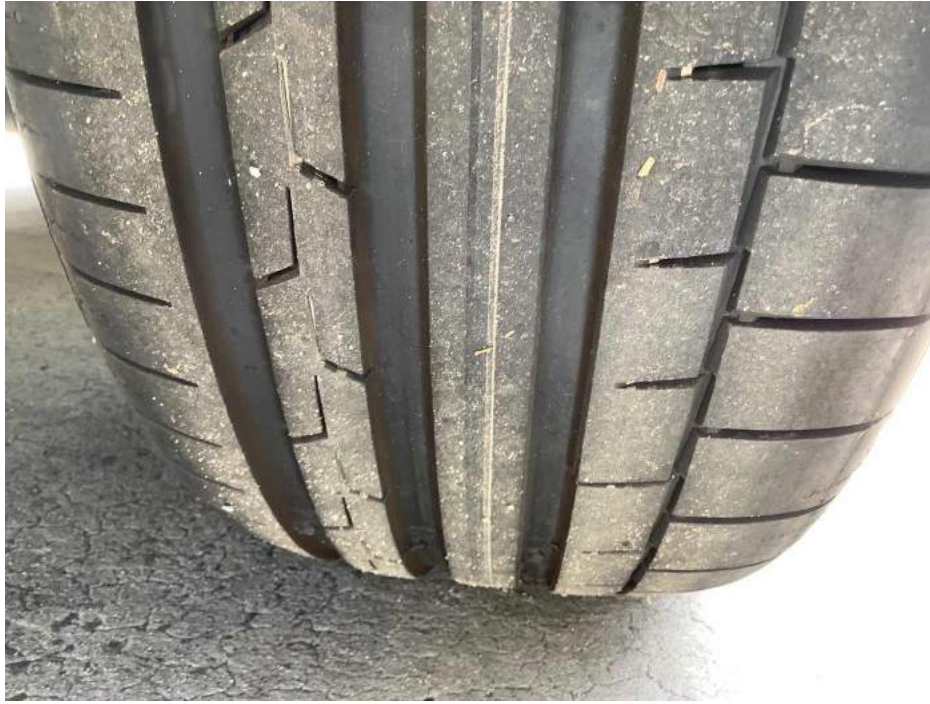
Drivers rear

Approximately 100% remaining.

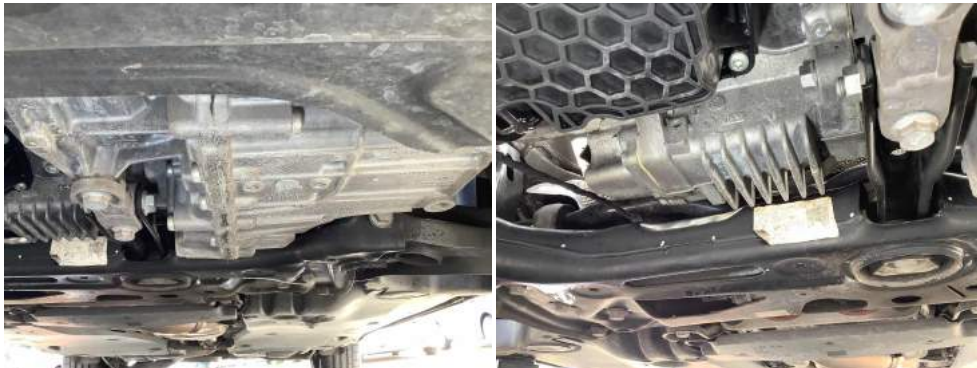
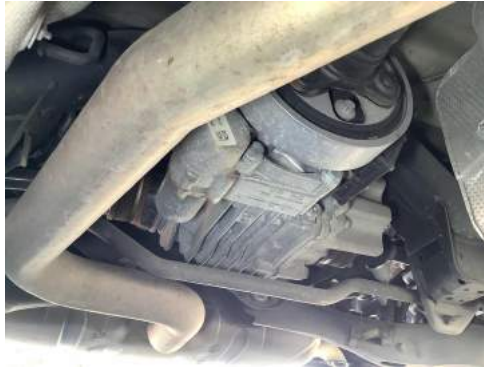
No faults or issues found with external driveline and transmission components, visually appears to be in good order at the time of inspection. This is subject to test drive outcomes. Refer to road test for transmission and driveline operation.

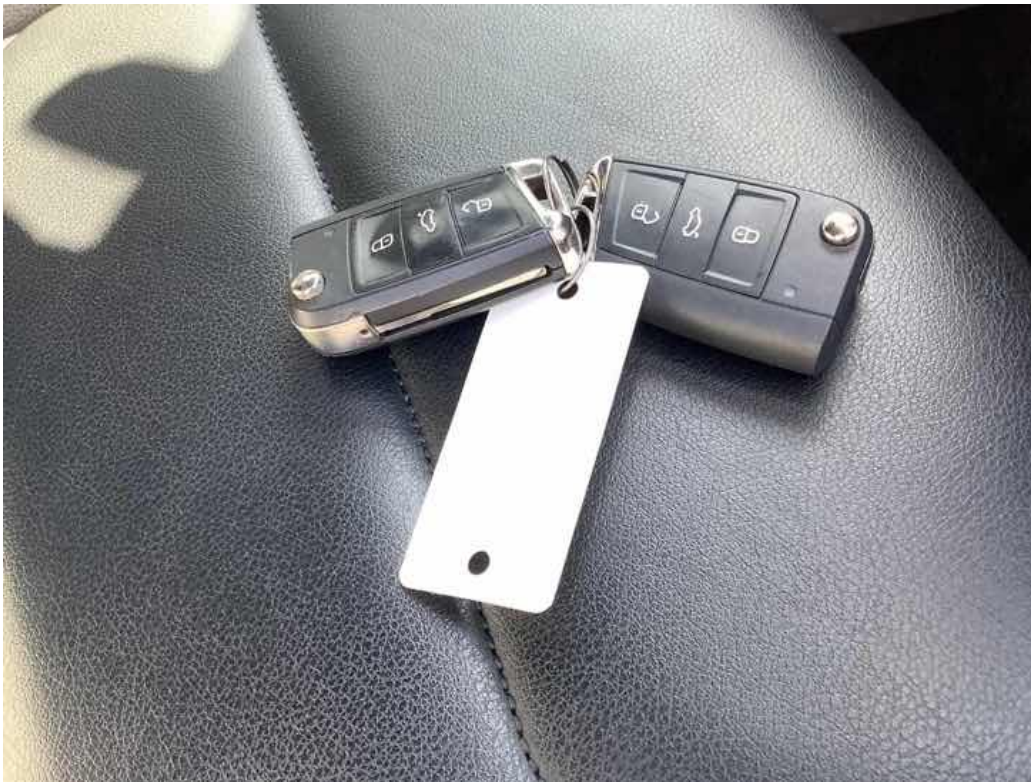
Keys and remotes

Two keys sighted.

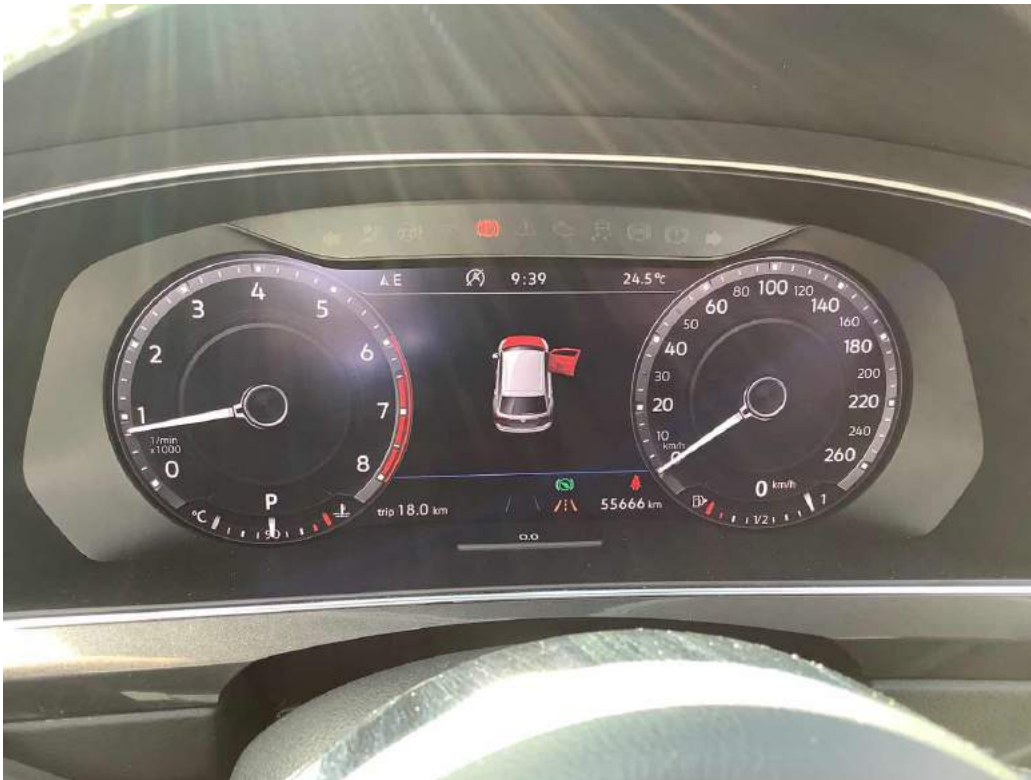
Warning lights / Cluster

No warning lights illuminated at time of inspection.

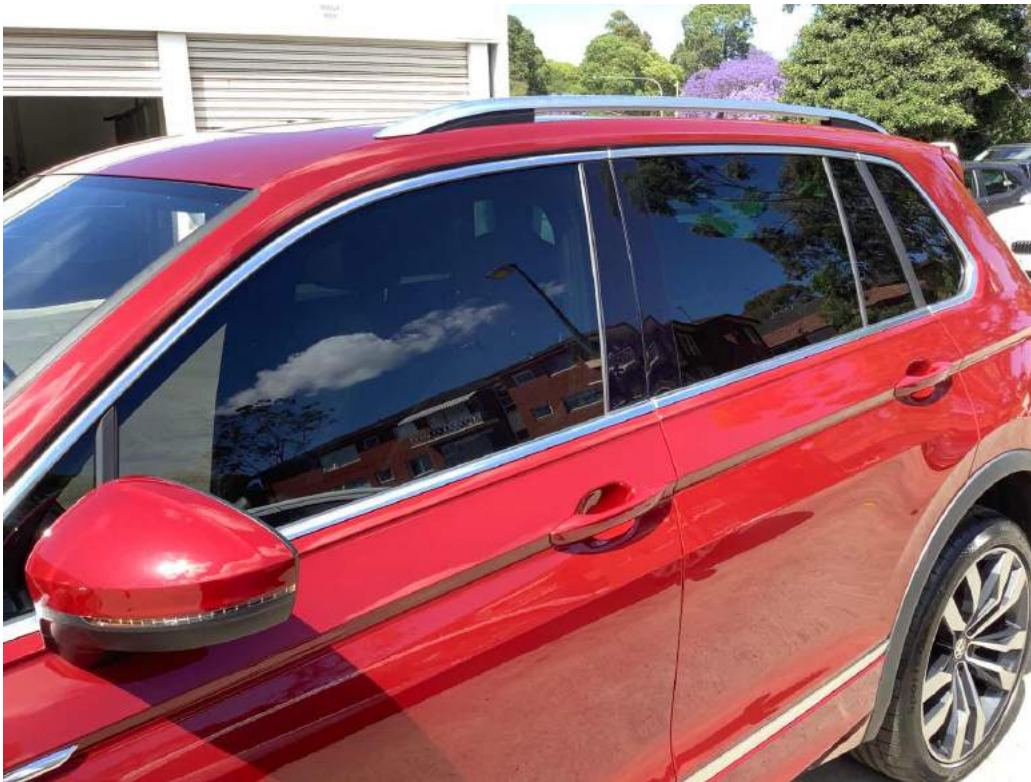
Window tint and accessories.

Windows have been tinted.
