Inspection Report

MTA Pre Purchase Inspections ABN 72158123418

Client Name	Stewart XXXXXXXX
Inspection Ordered By	Phil
Client Email	piacxxx@xxxxxx.com.au
Vehicle Make and Model	Volkswagen Tiguan Type R
Year of Manufacture	2017
Registration Number	NBT31T
Booking Reference	CAM8xxxxD

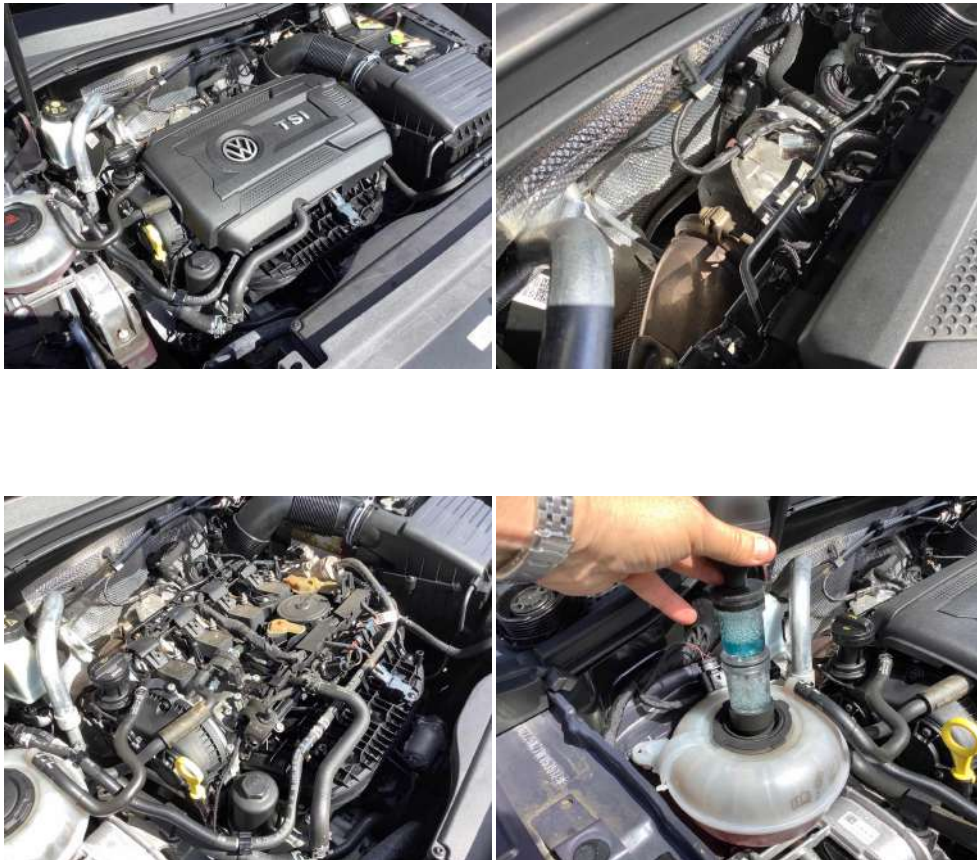
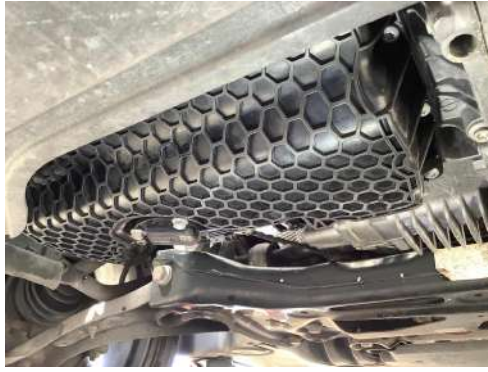
The engine and its components appear to be in good order of service at the time of inspection.

Engine runs and sounds good with no internal running faults.

No engine oil leaks were visible at the time of inspection. The engine may have been degreased as part of preparation of sale.

No oil leaks visible at the turbo charger or the induction system.

The exhaust system is in good general condition for its age and kilometres. No leaks or damage evident.

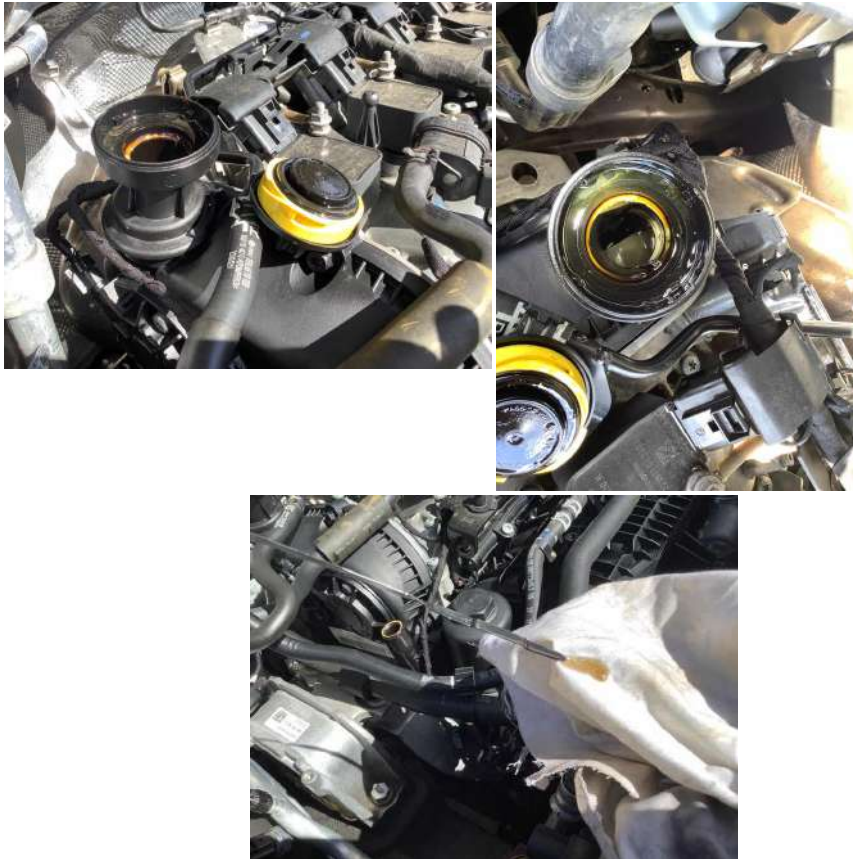
Oil and lubrication

An inspection of the oil filler shows no sign of internal lubricant breakdown.

Oil level is correct and appears to have been recently serviced.

Oil level is within manufacturers specifications.

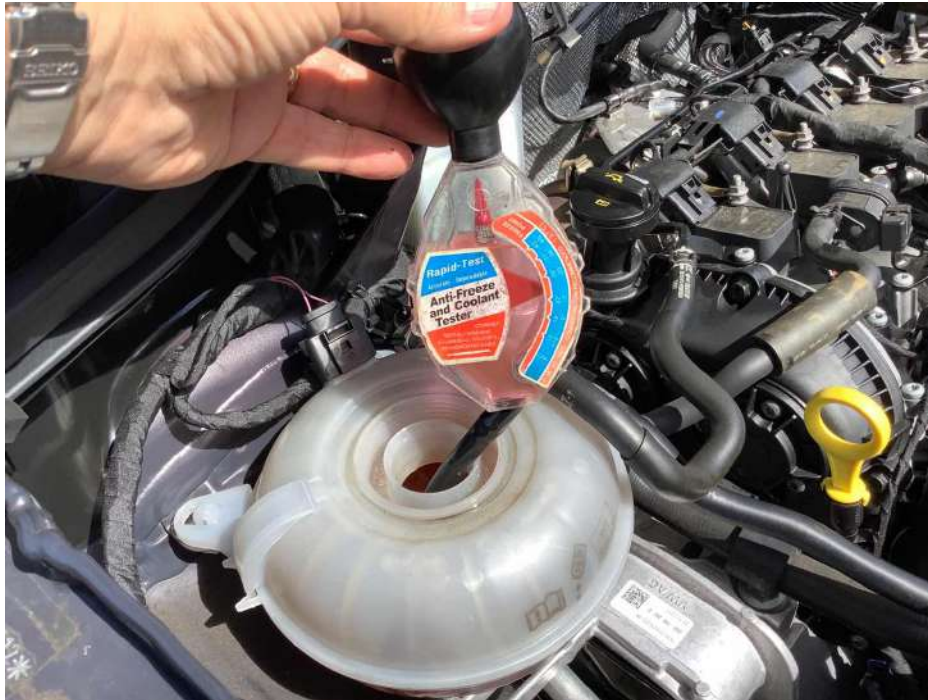
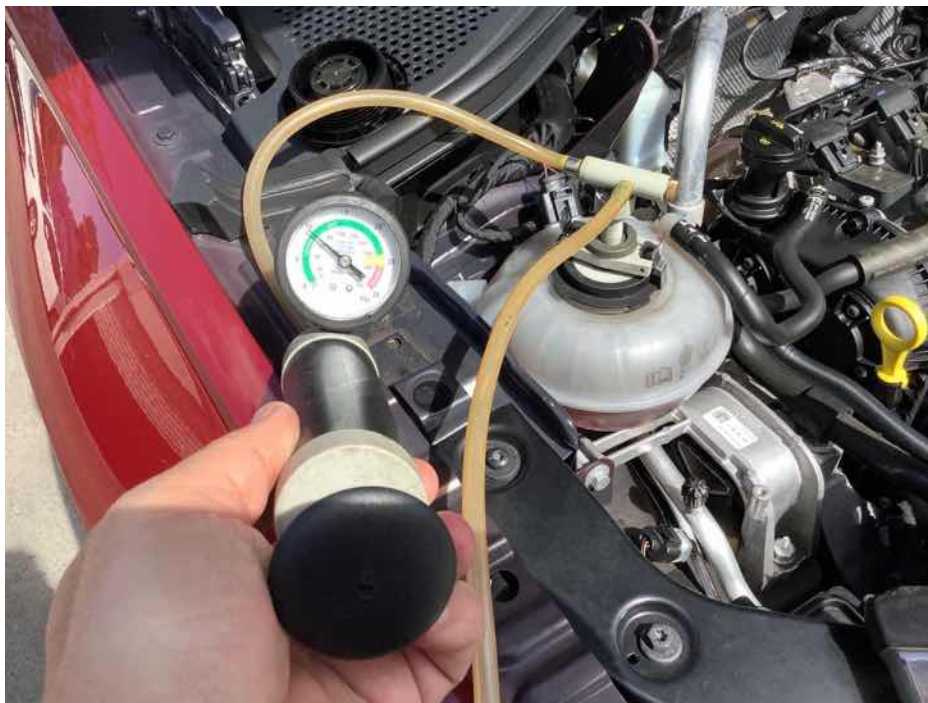
The cooling system and its components visually appear in good order of service at the time of inspection. The cooling system has passed a pressure test. The engine is running at normal operating temperature. The radiator corrosion inhibitor concentrate level has been measured and is at serviceable level.

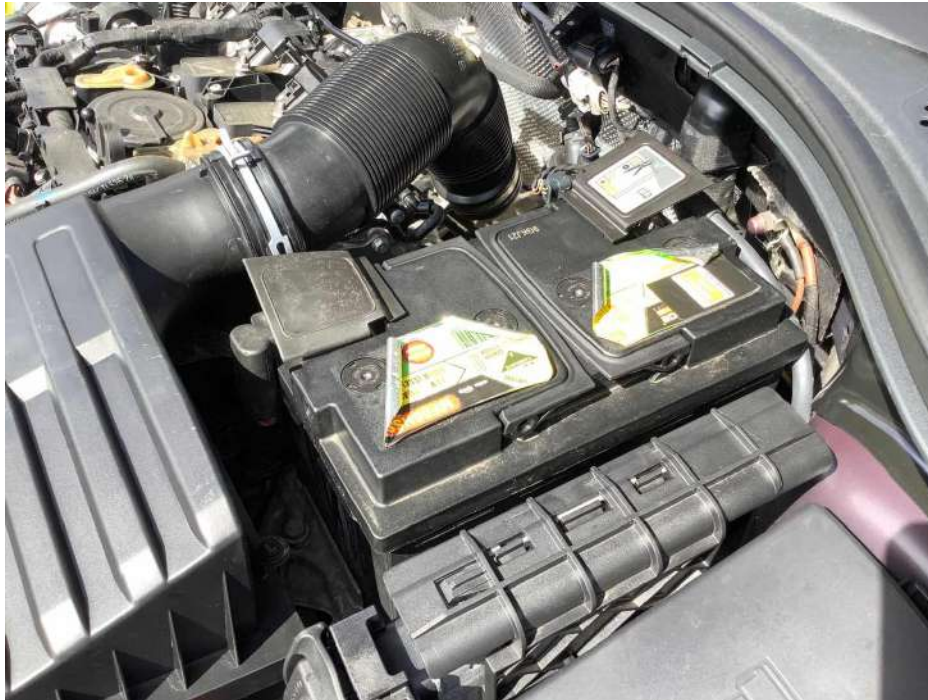
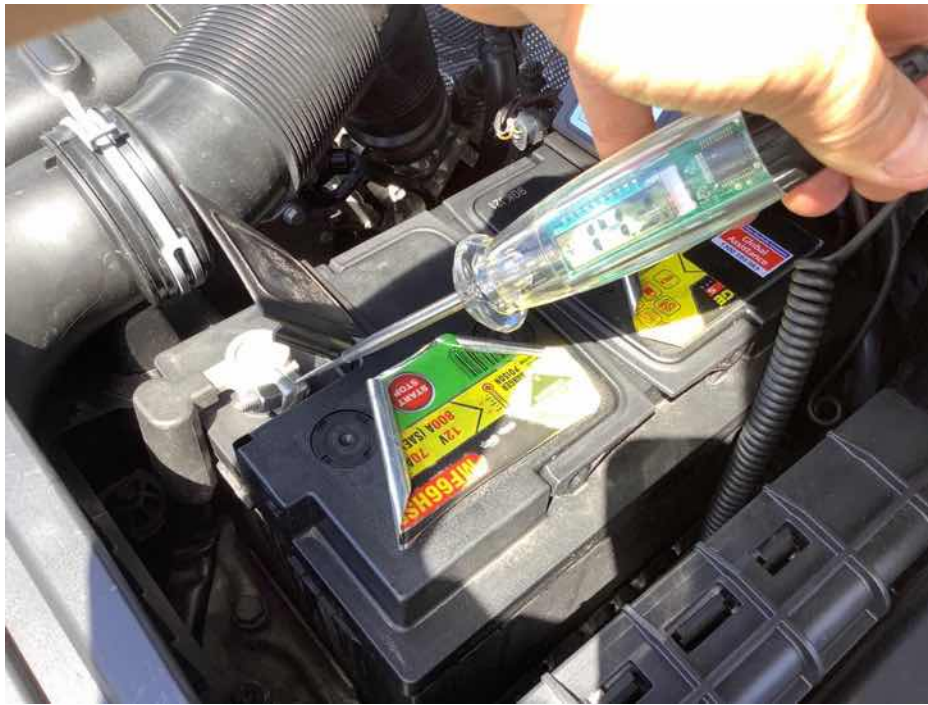
The electrical system visually appears to be in good working order at the time of inspection.

Charge rate is within manufactures specifications.

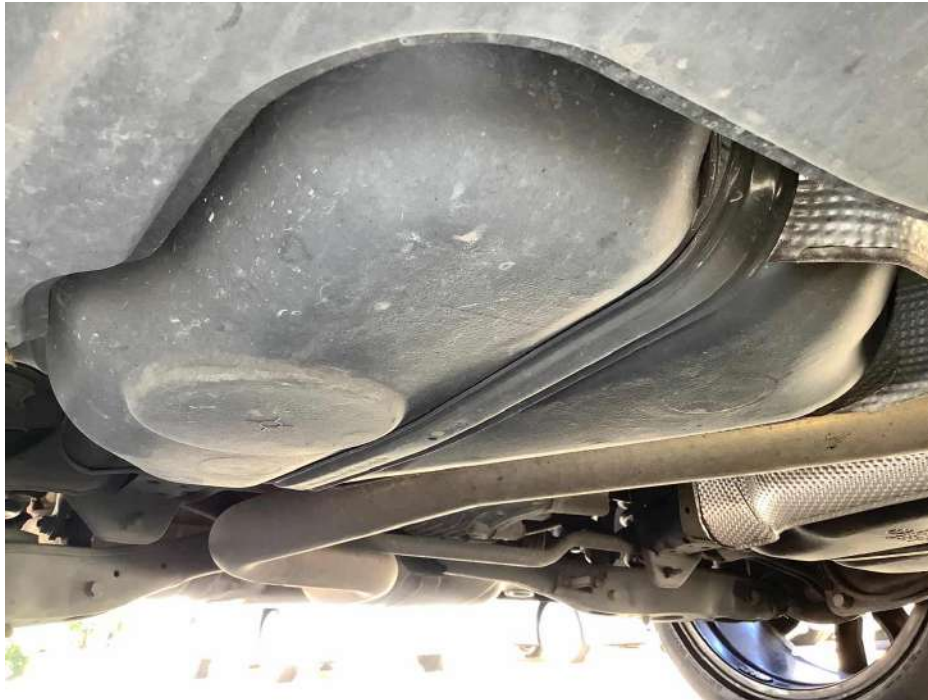
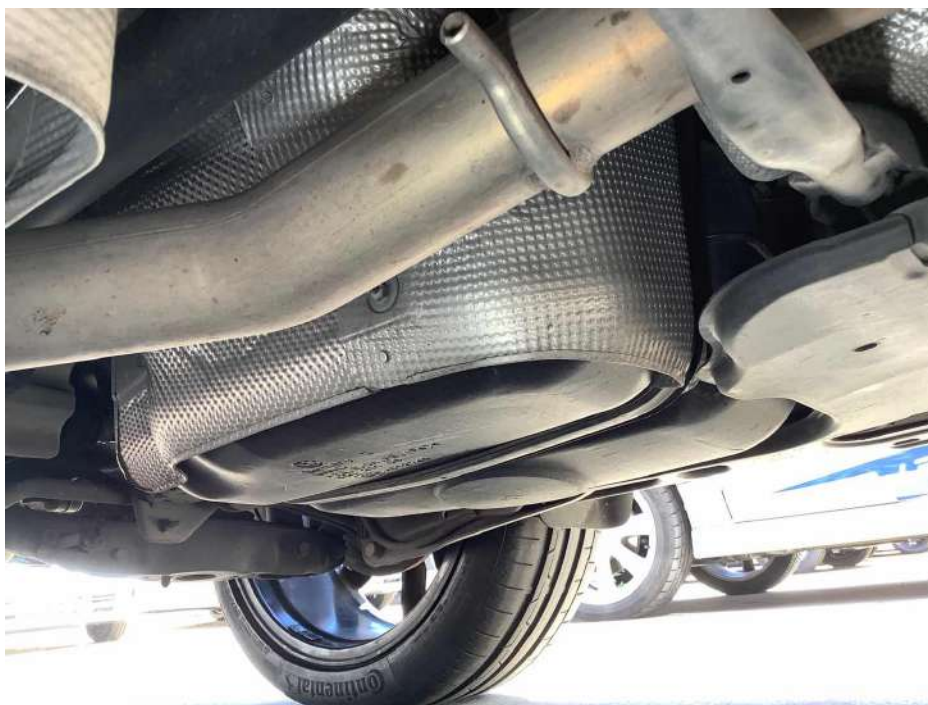
The fuel system visually appears to have no faults and is in good condition at time of inspection. No fuel leaks evident.

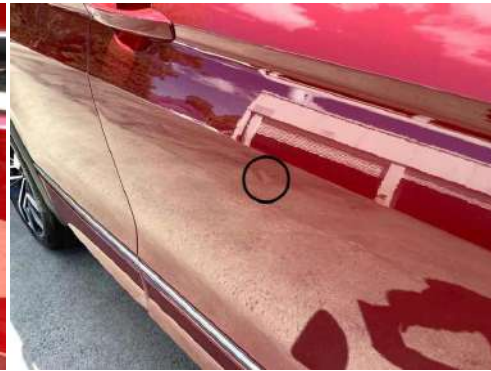
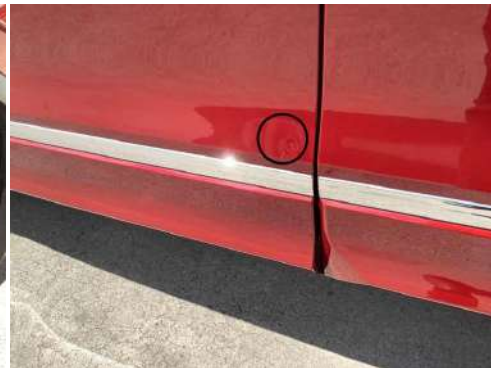
External appearance

Carpark type dents, chips, scratches and marks to various panels and bumpers however external presentation is good.

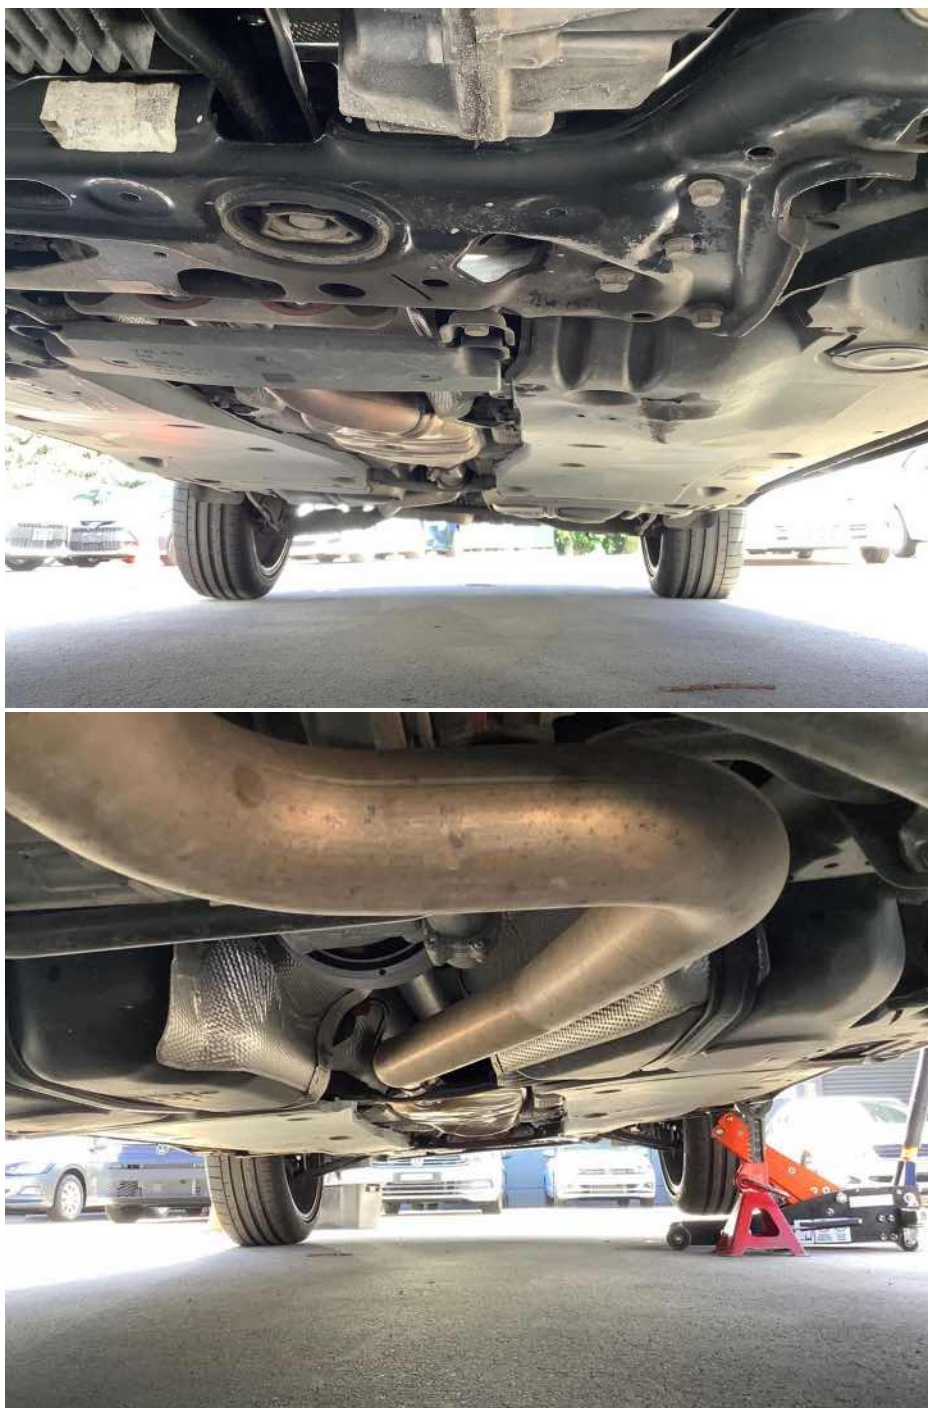
Underbody.

The underbody of the vehicle is in good order at the time of inspection

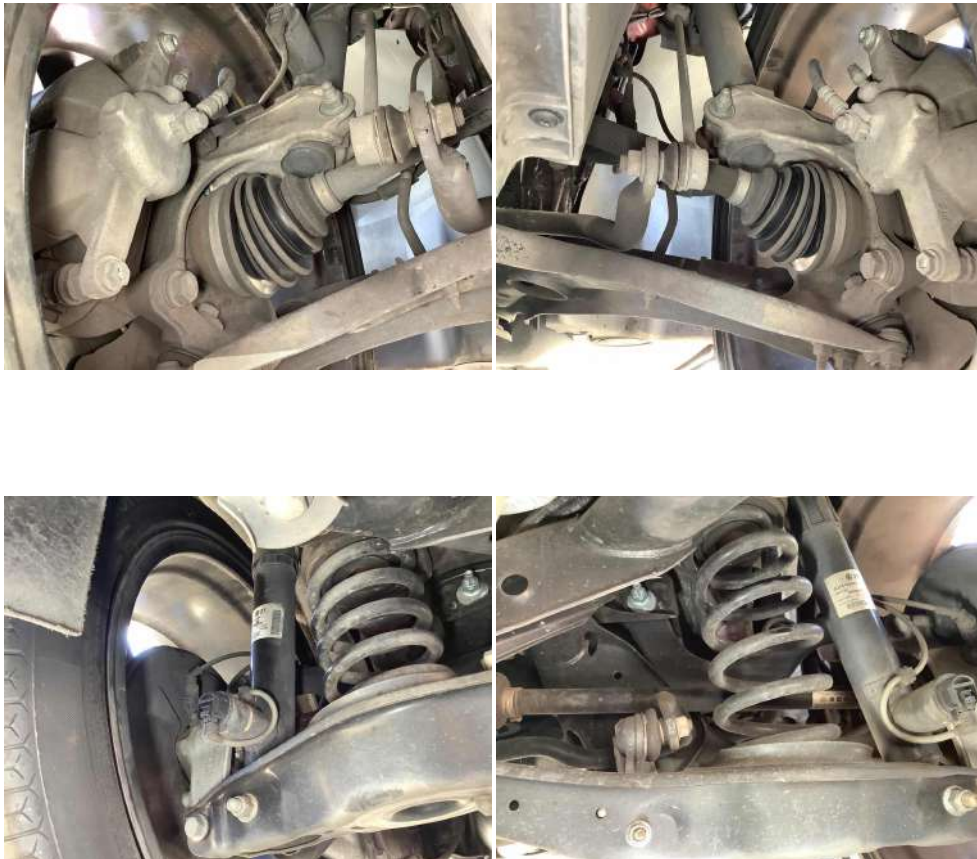
No major issues noted during inspection.

Steering suspension and rubber bushes showing typical wear for kilometres, some components will require replacing as needed during vehicles service life-ok at this stage.

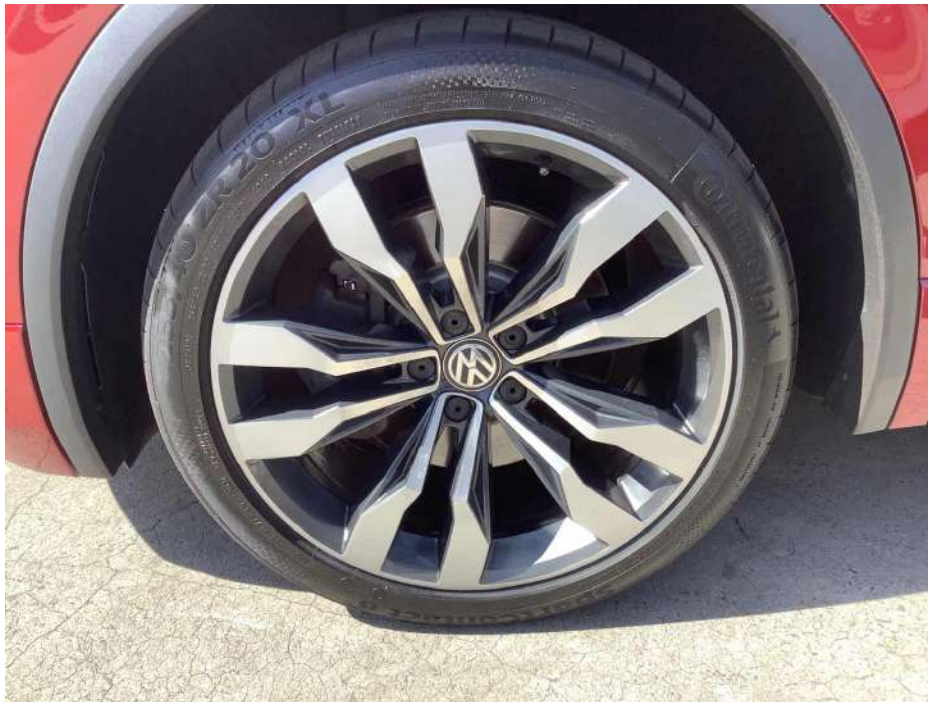
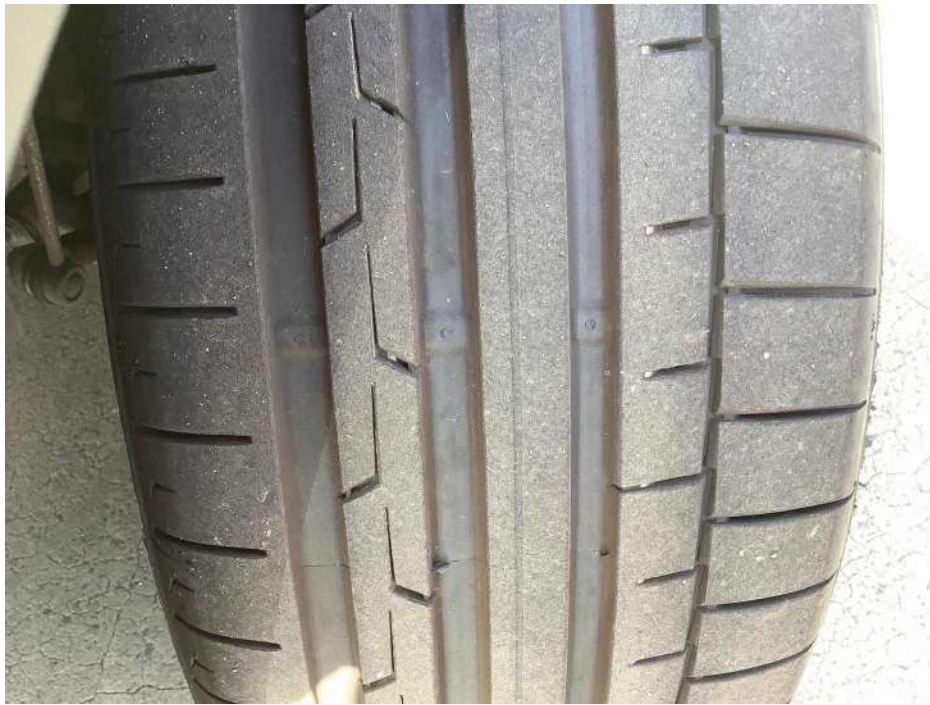
Passenger front

Approximately 100% remaining.

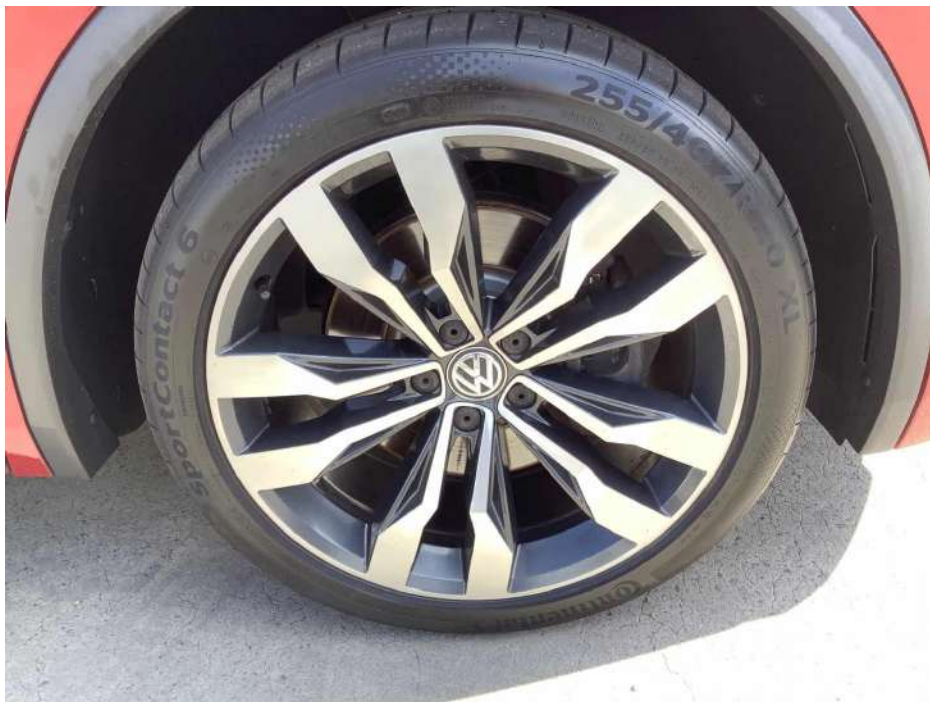
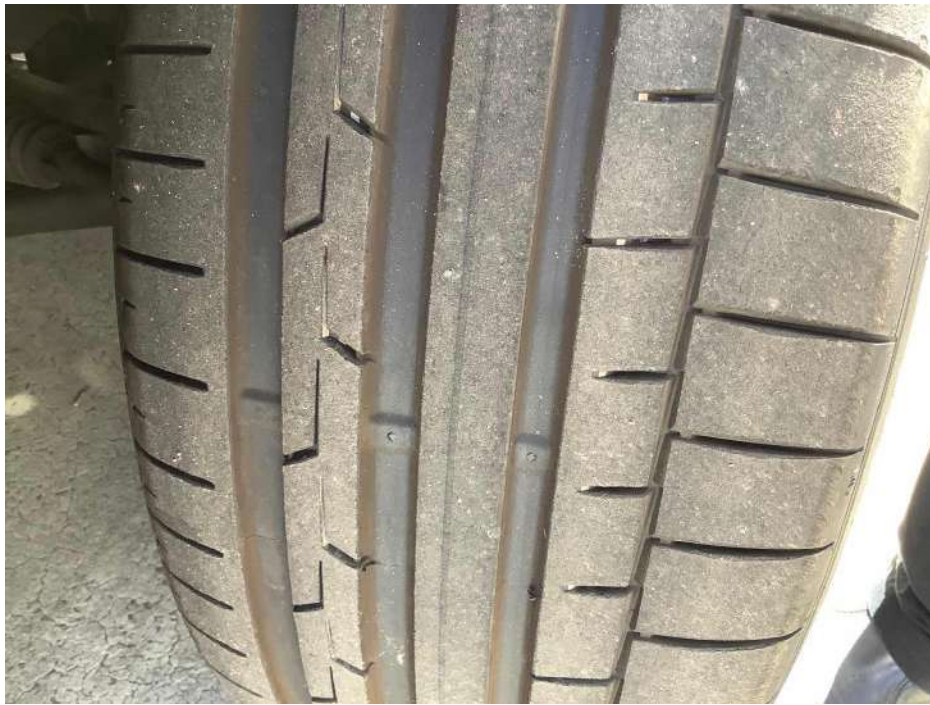
Drivers front

Approximately 100% remaining.

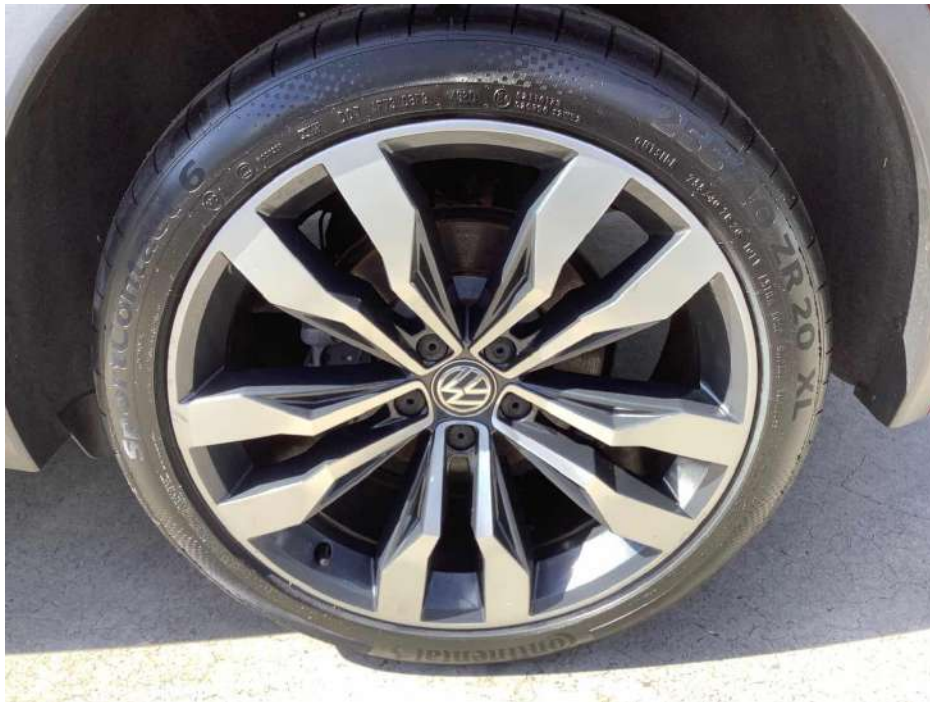
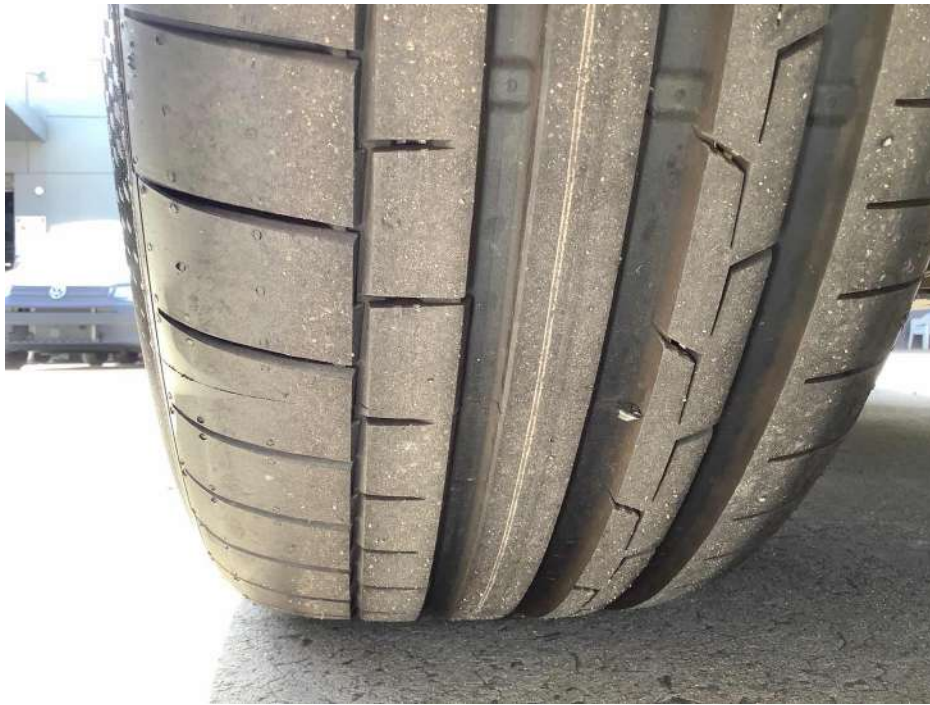
Passenger rear

Approximately 100% remaining.

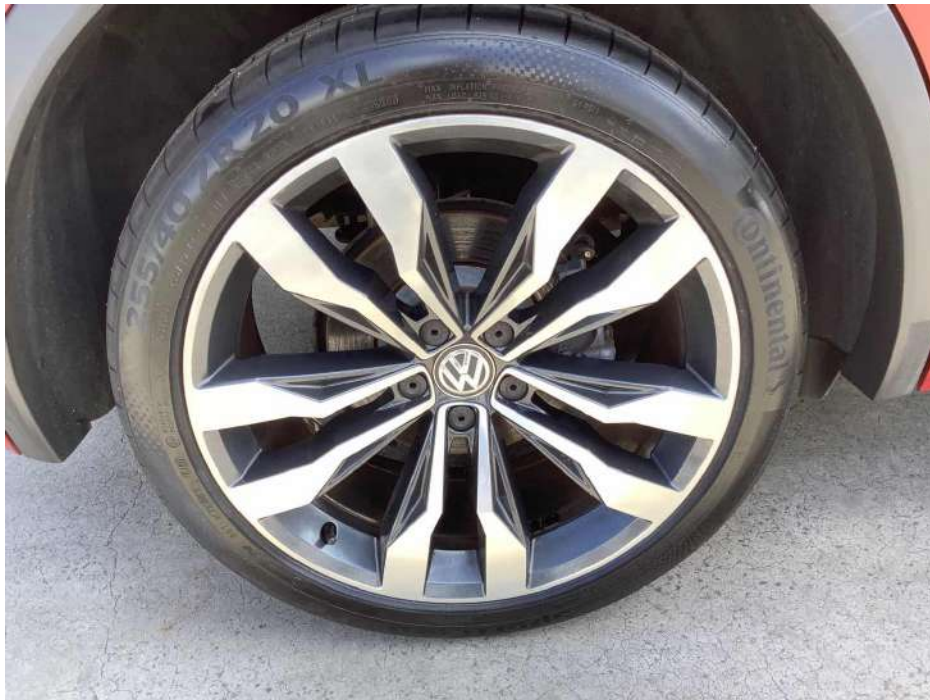
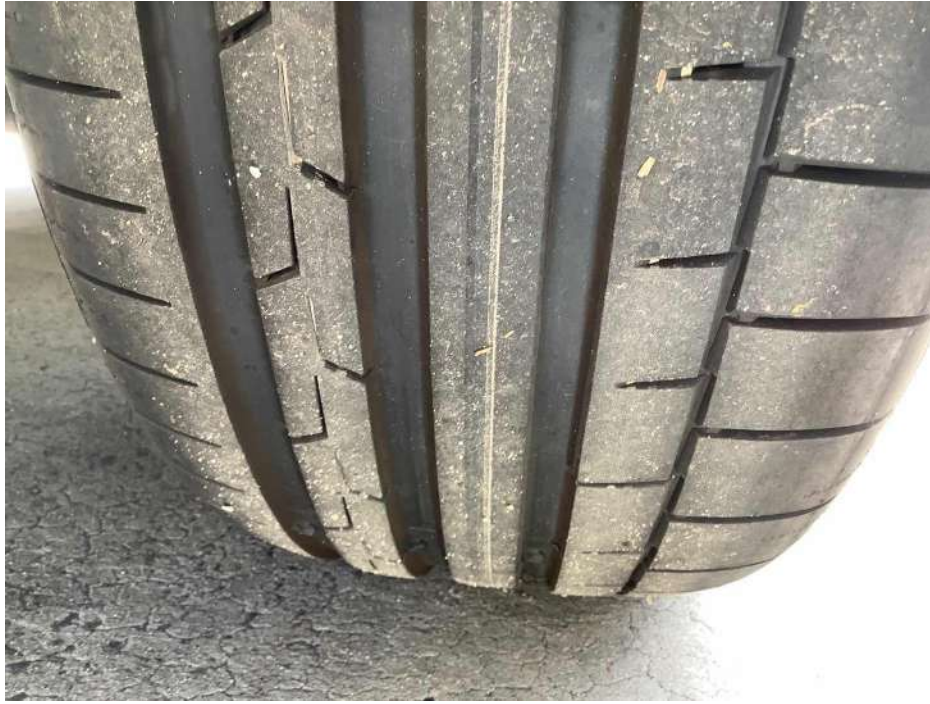
Drivers rear

Approximately 100% remaining.

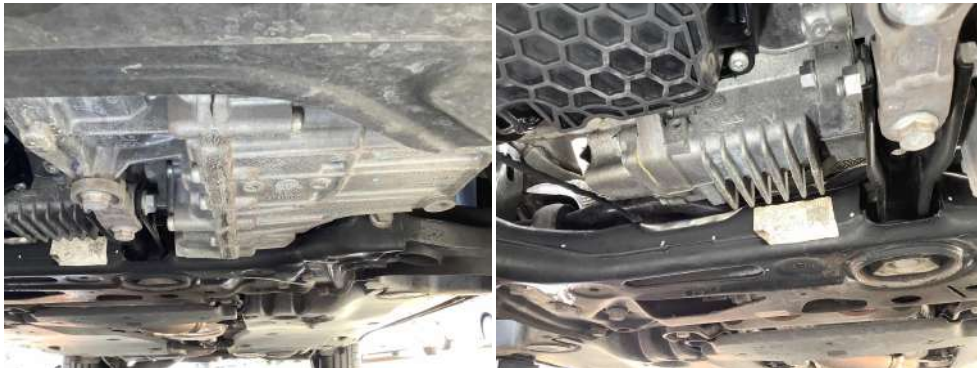
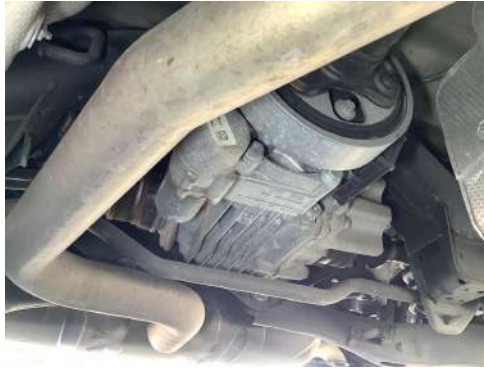
No faults or issues found with external driveline and transmission components, visually appears to be in good order at the time of inspection. This is subject to test drive outcomes. Refer to road test for transmission and driveline operation.

No oil leaks visible at underbody driveline.

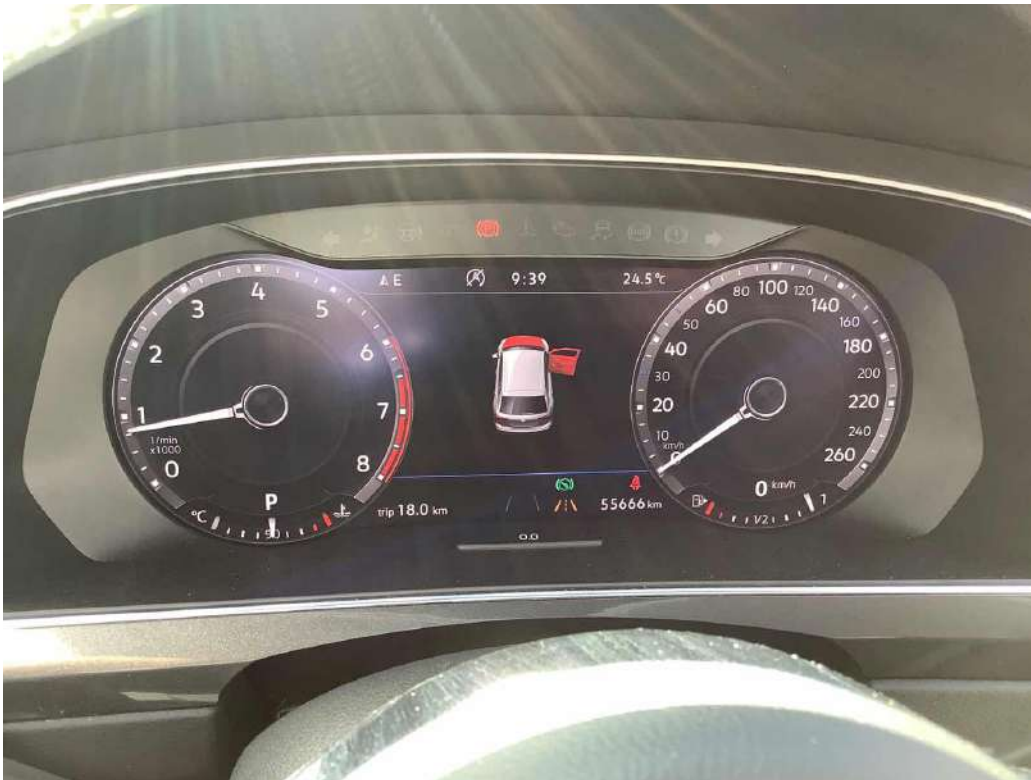
Warning lights / Cluster

No warning lights illuminated at time of inspection.
