Inspection Report

MTA Vehicle Inspections (ABN 72158123418)

Client Name	
Client Email	
Vehicle Make and Model	Volkswagen Tiguan
Variant	R-Line
Year of Manufacture	2020
Registration Number	
Booking Reference	CAM6XXXD

Inspection Date:	31 Oct 2024
Inspection Time:	08:10 am

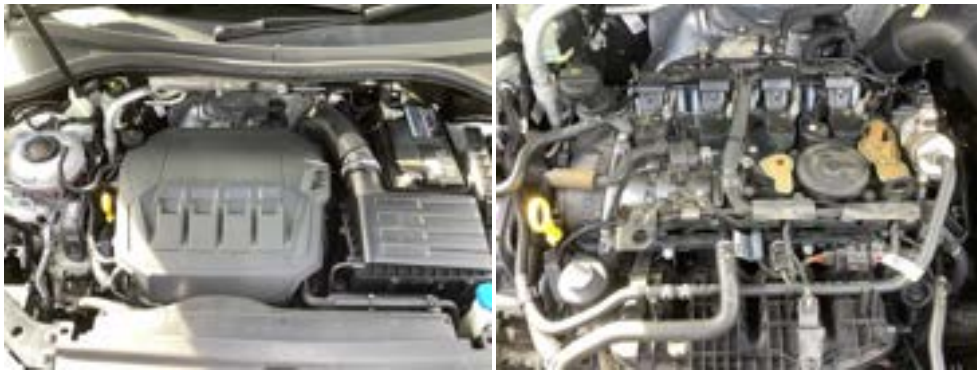
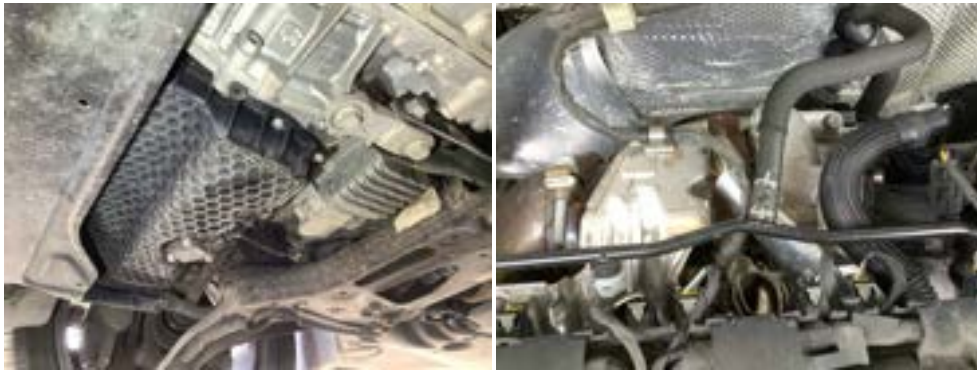
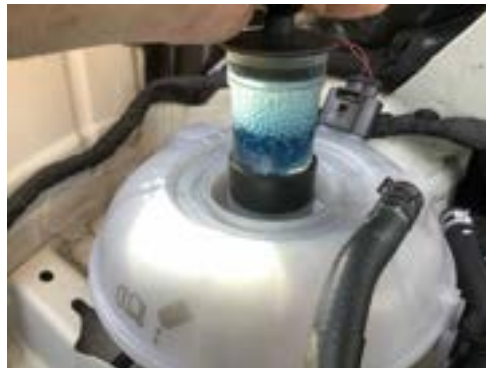
The engine and its components appear to be in good order of service at the time of inspection.

Engine runs and sounds good with no internal running faults.

No engine oil leaks were visible at the time of inspection. The engine may have been degreased as part of preparation of sale.

No oil leaks visible at the turbo charger or the induction system.

The exhaust system is in good general condition for its age and kilometres. No leaks or damage evident.

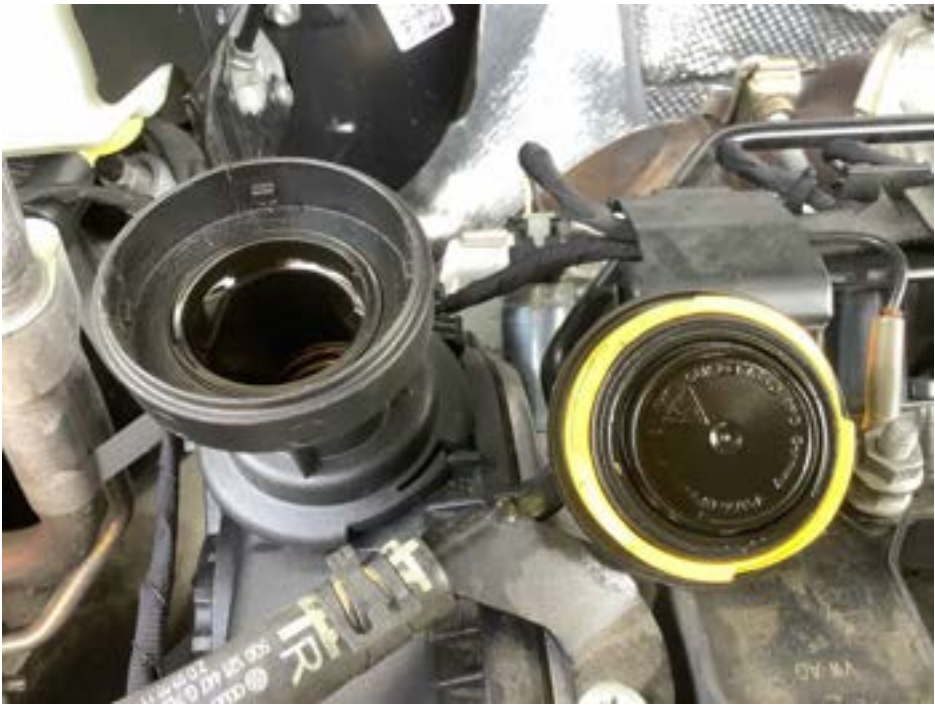
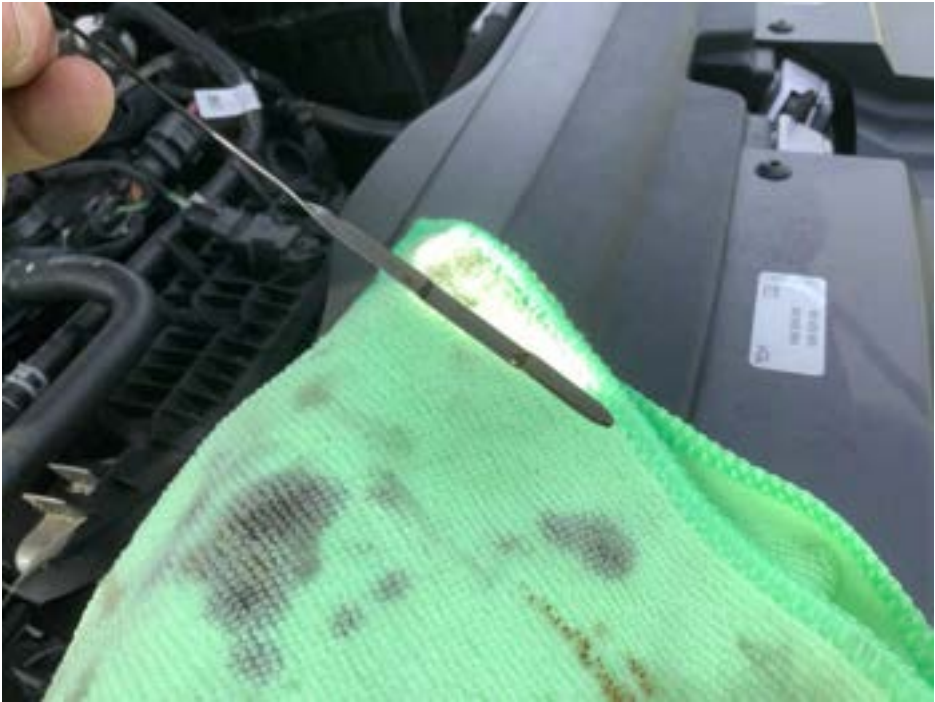
Oil and lubrication

Unable to assess condition of lubrication system for sludge-internals of engine cannot be viewed.

Oil level is within manufacturers specifications.

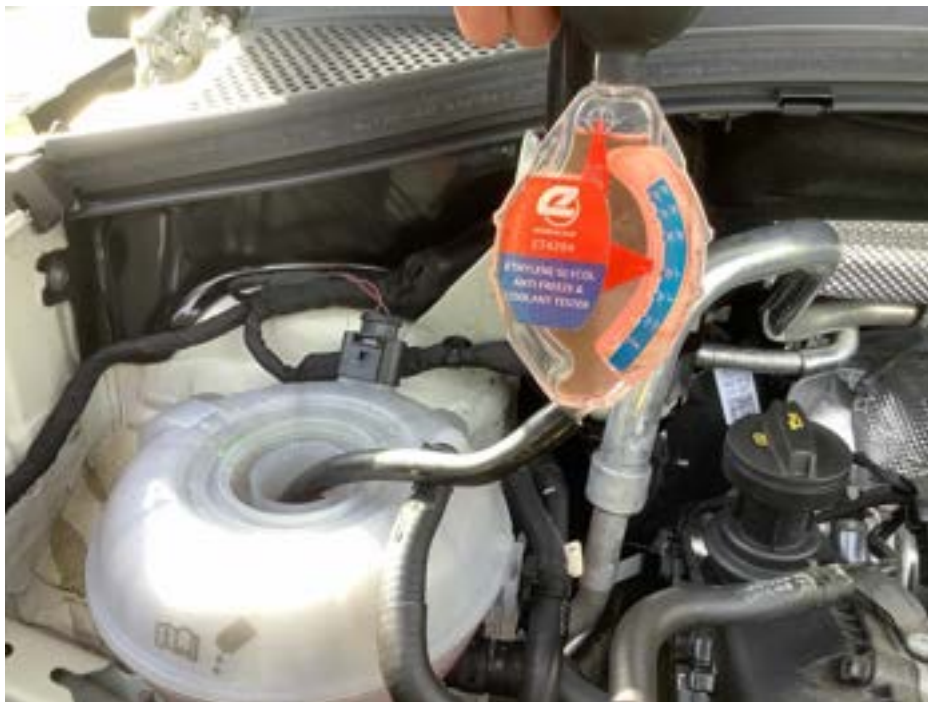
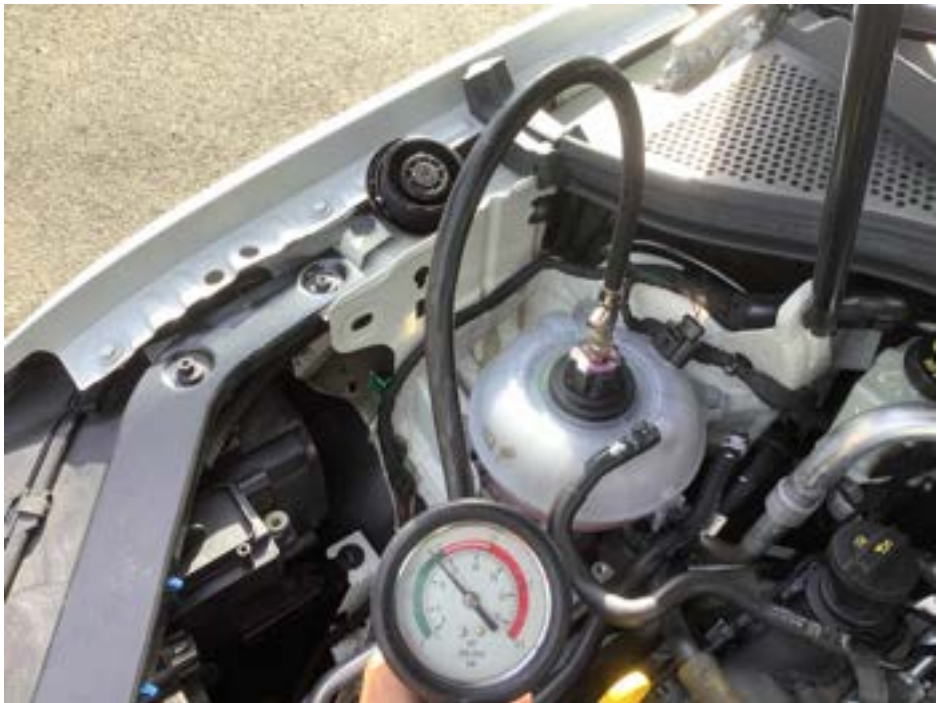
The cooling system and its components visually appear in good order of service at the time of inspection. The cooling system has passed a pressure test. The engine is running at normal operating temperature. The radiator corrosion inhibitor concentrate level has been measured and is at serviceable level.

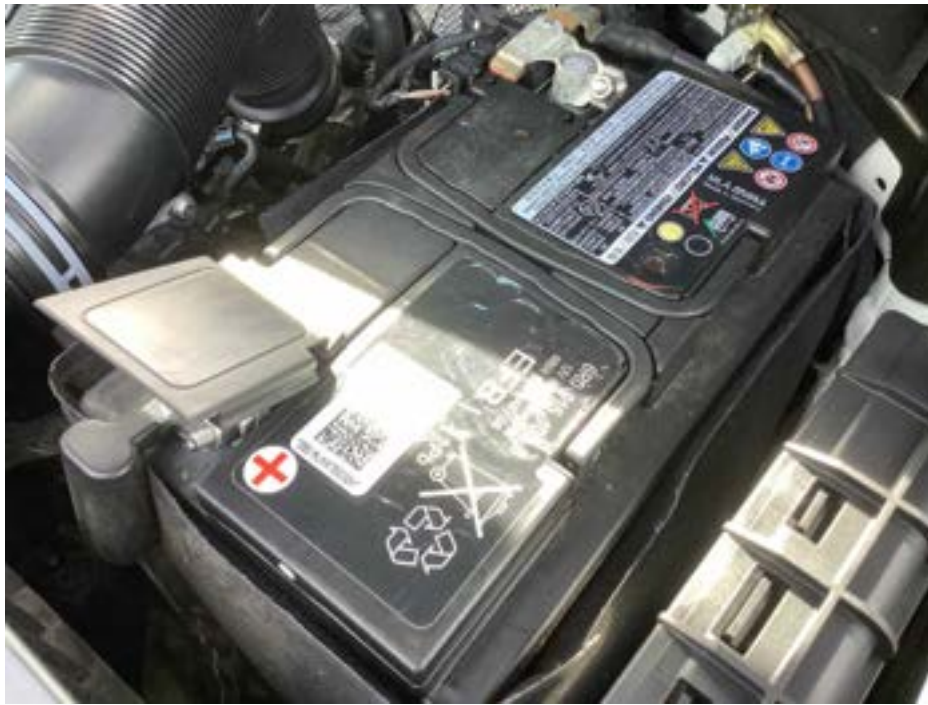
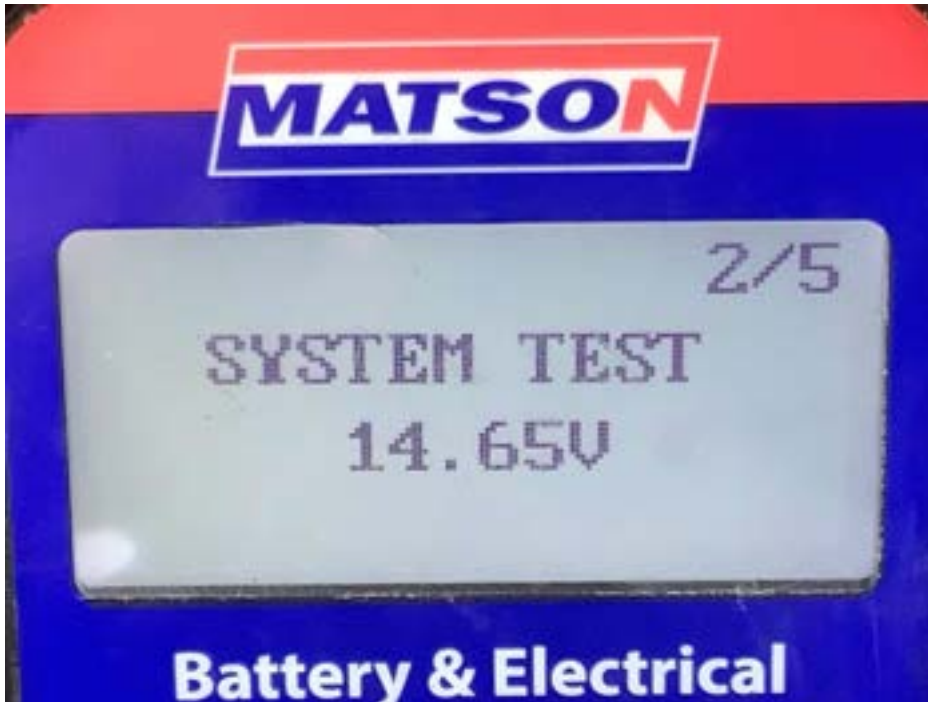
The electrical system visually appears to be in good working order at the time of inspection.

Charge rate is within manufactures specifications.

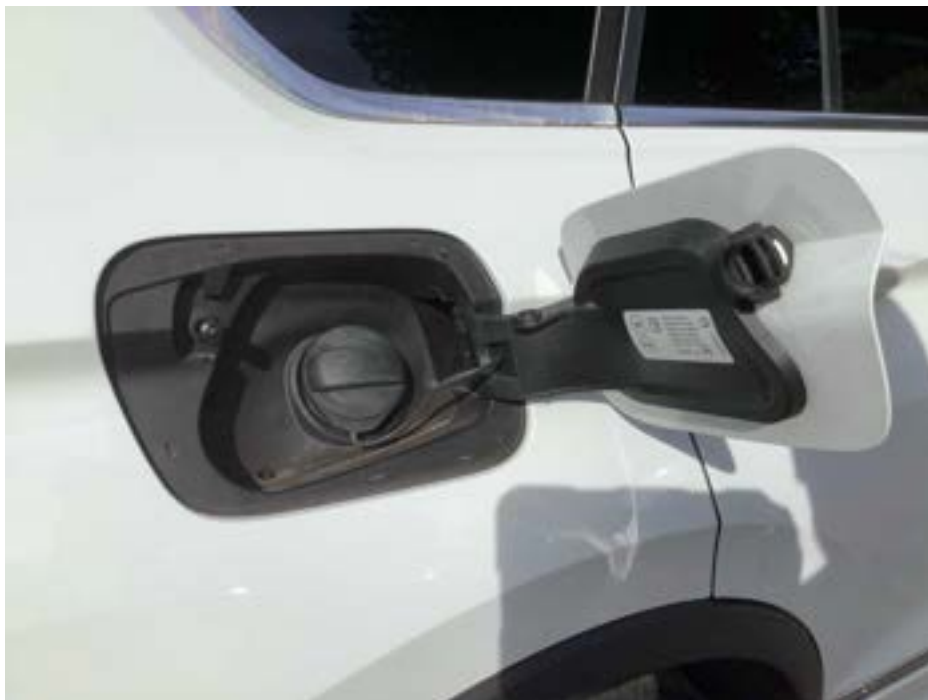
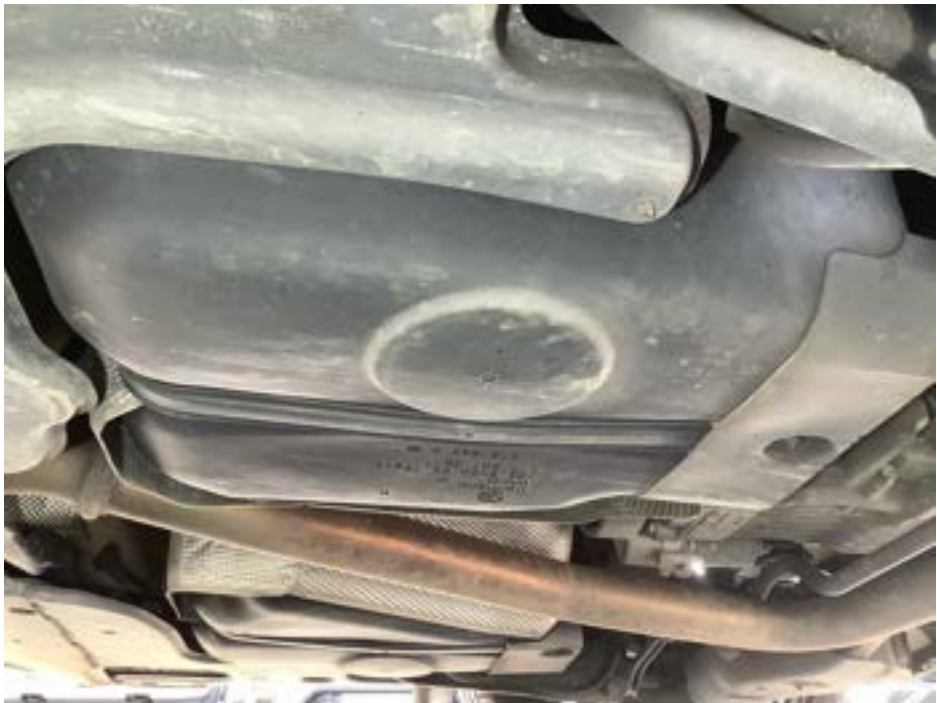
The fuel system visually appears to have no faults and is in good condition at time of inspection. No fuel leaks evident.

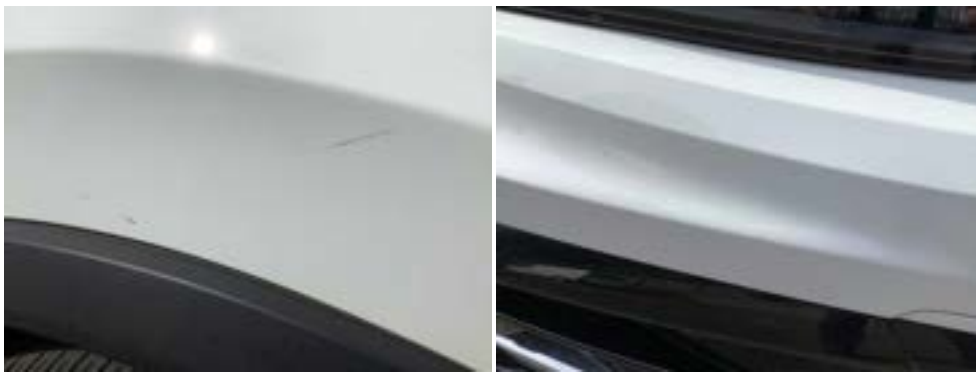
External appearance

Carpark type dents, chips, scratches and marks to various panels and bumpers however external presentation is good.

Stone chips to paint work on frontal panels/Bumper.

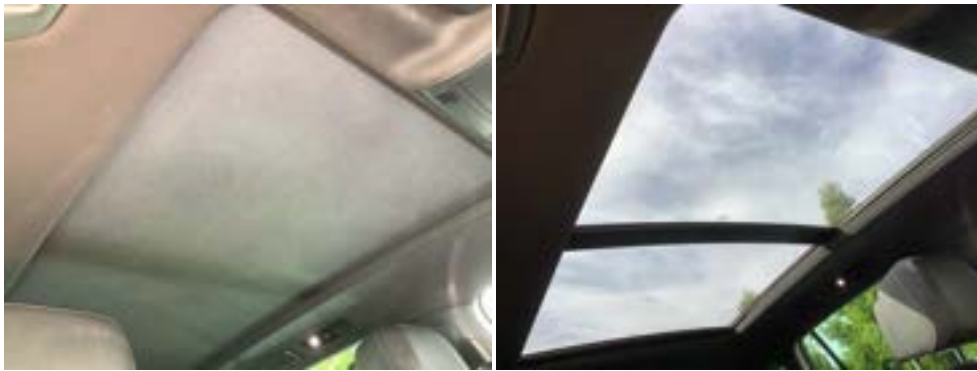
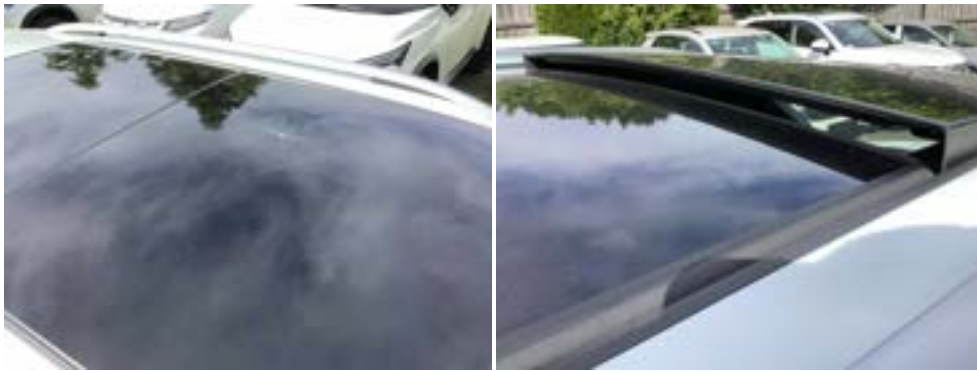
Sunroof and convertible roof

Sunroof operates correctly.

Internal sunshade operates correctly.

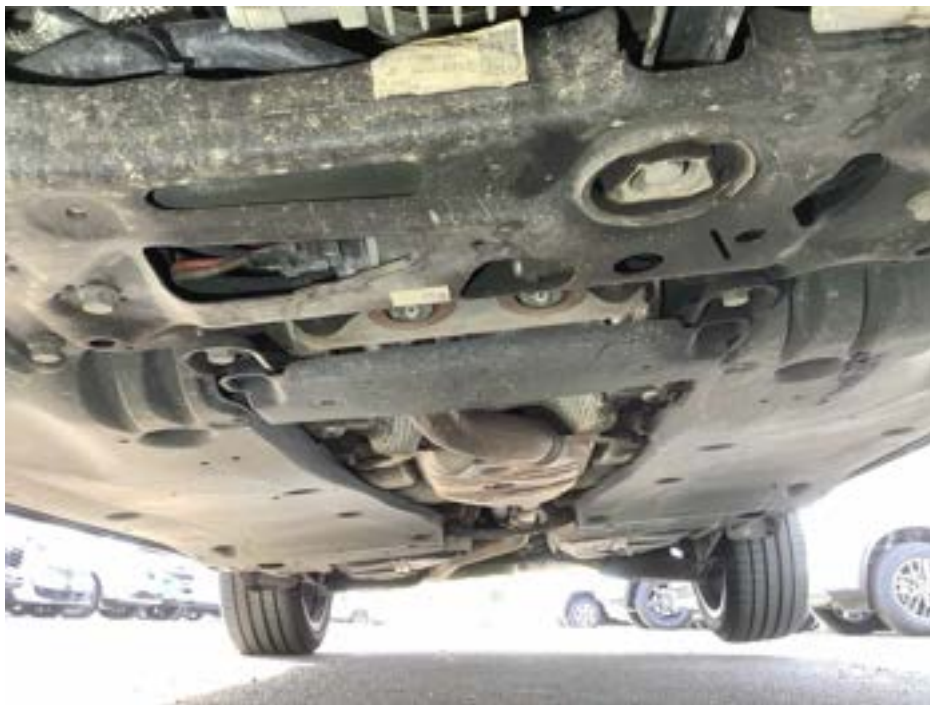
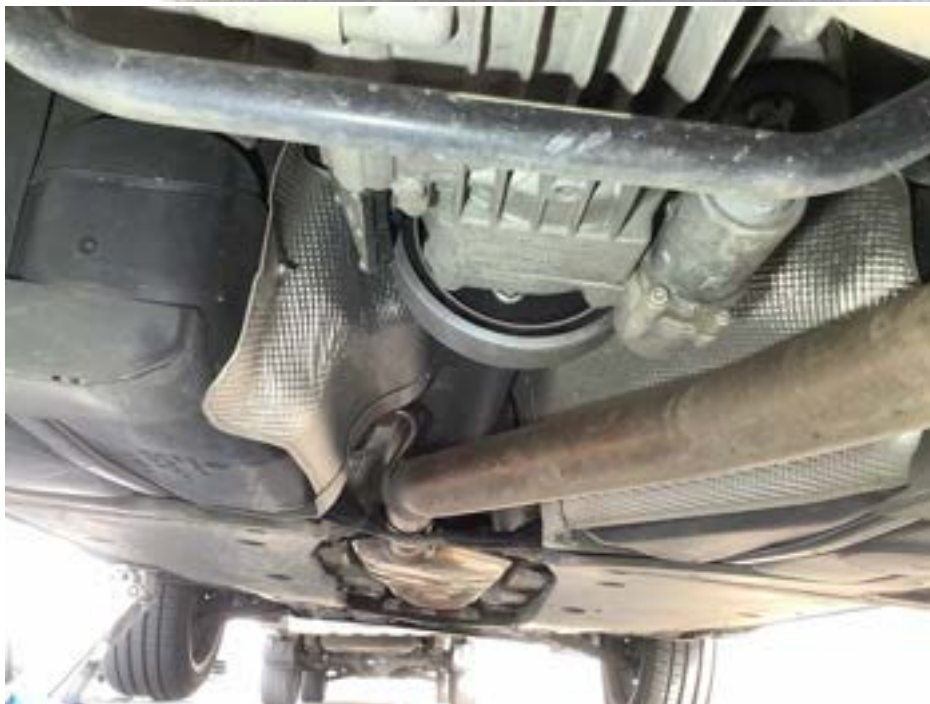
Underbody.

The underbody of the vehicle is in good order at the time of inspection

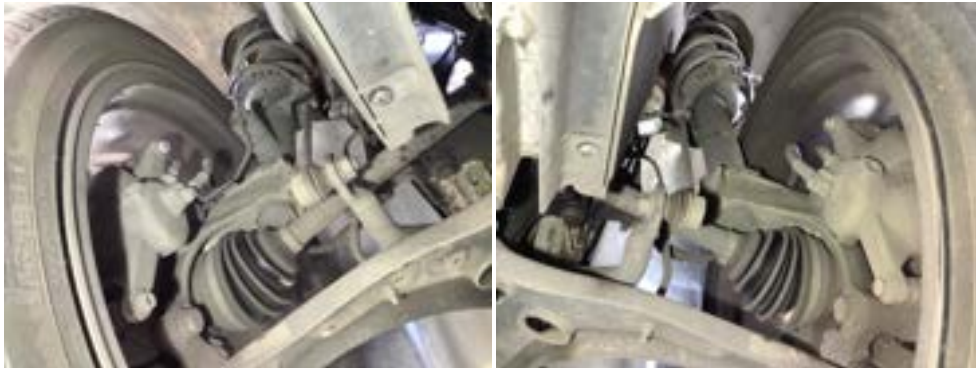
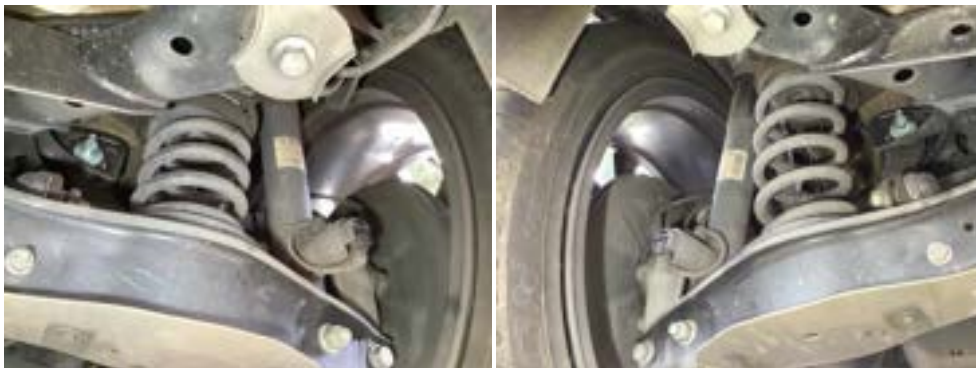
No major issues noted during inspection.

Steering suspension and rubber bushes showing typical wear for kilometres at time of inspection, some components will require replacing as needed during vehicles service life-ok at this stage.

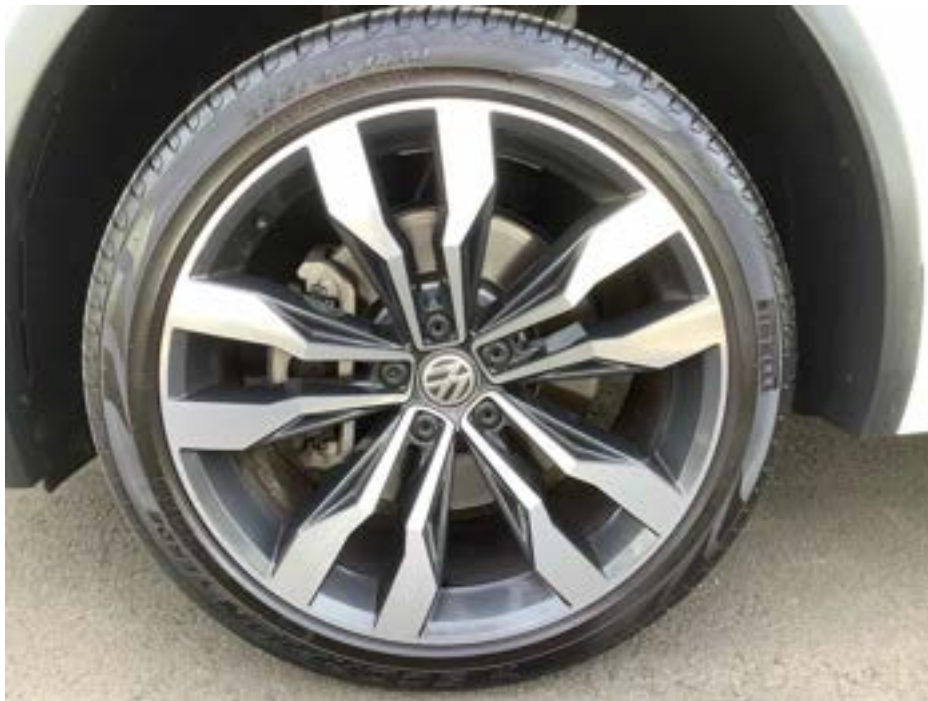
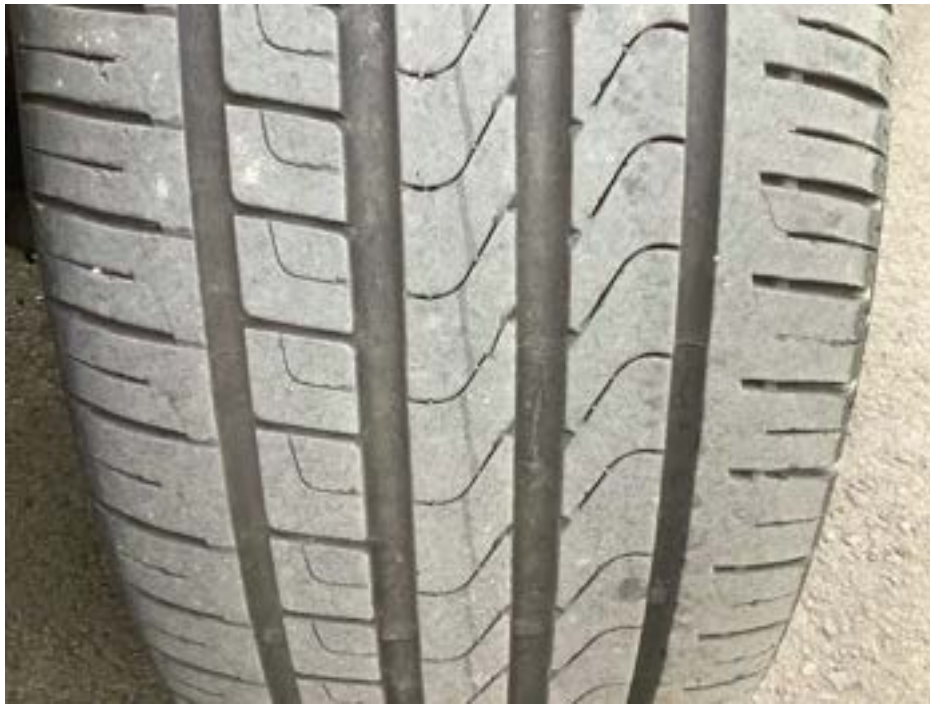
Passanger front

Approximately 90% remaining.

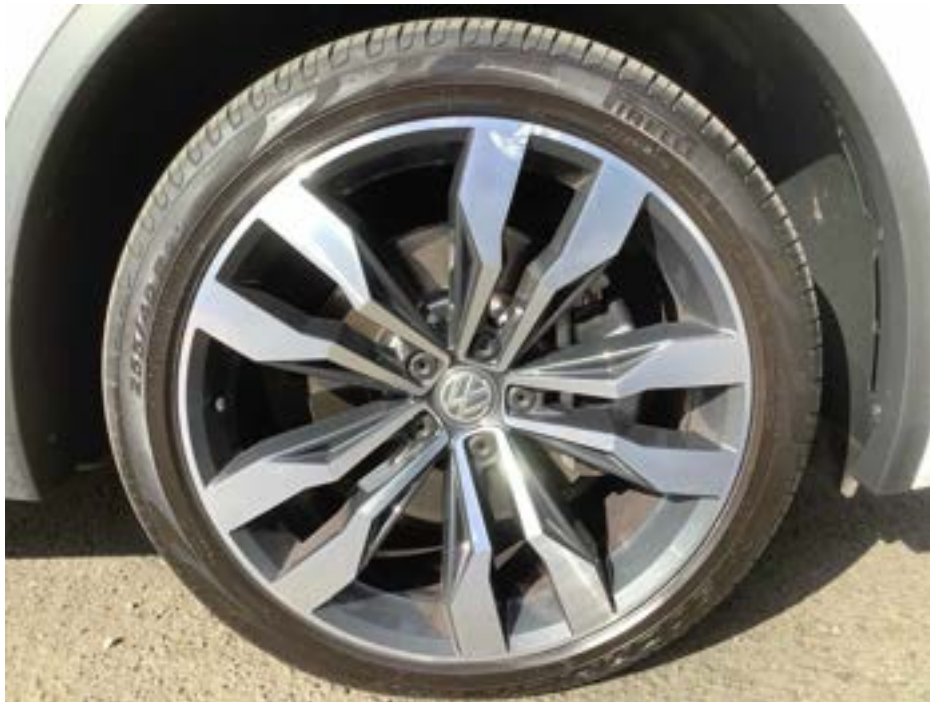
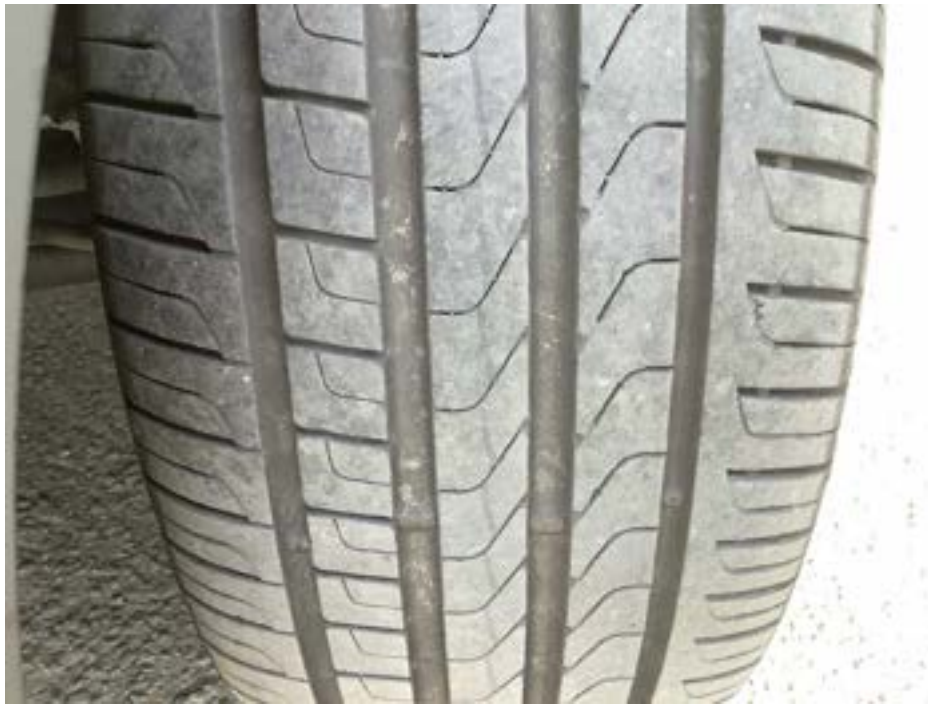
Drivers front

Approximately 90% remaining.

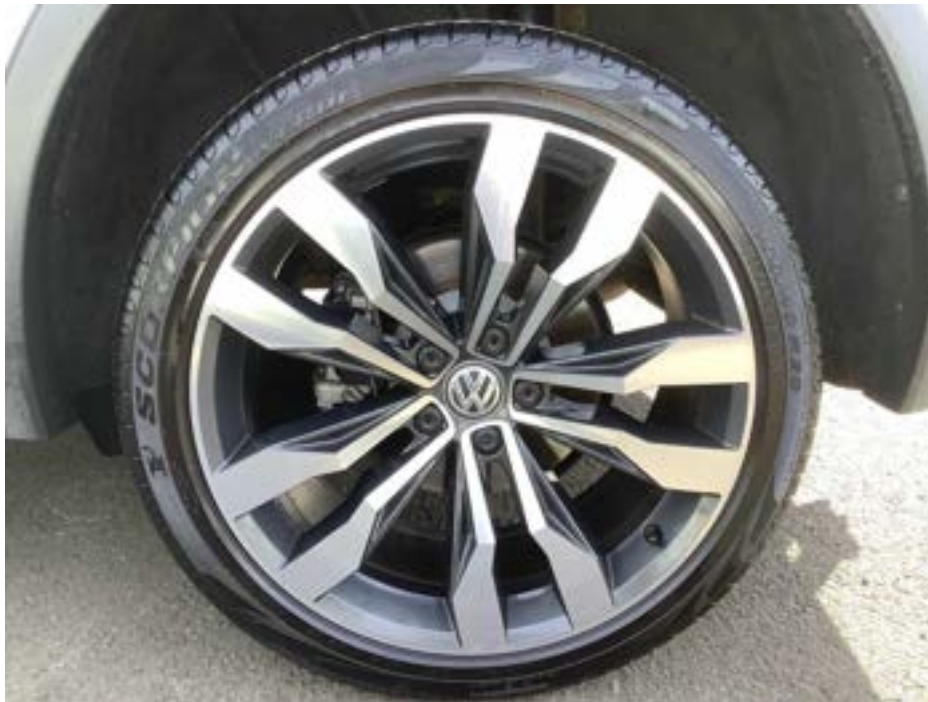
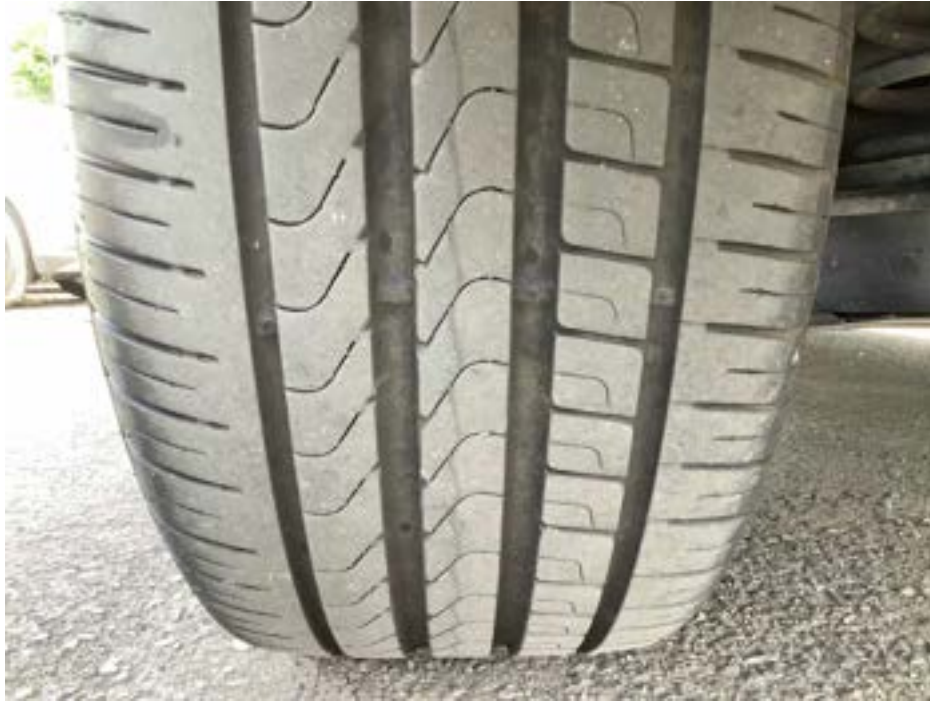
Passanger rear

Approximately 90% remaining.

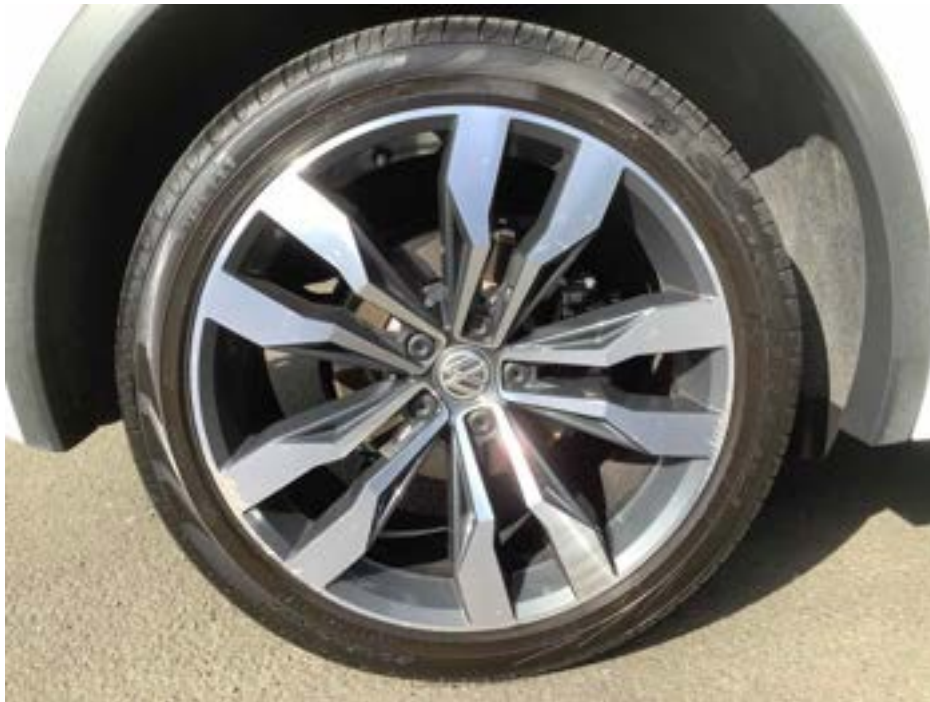
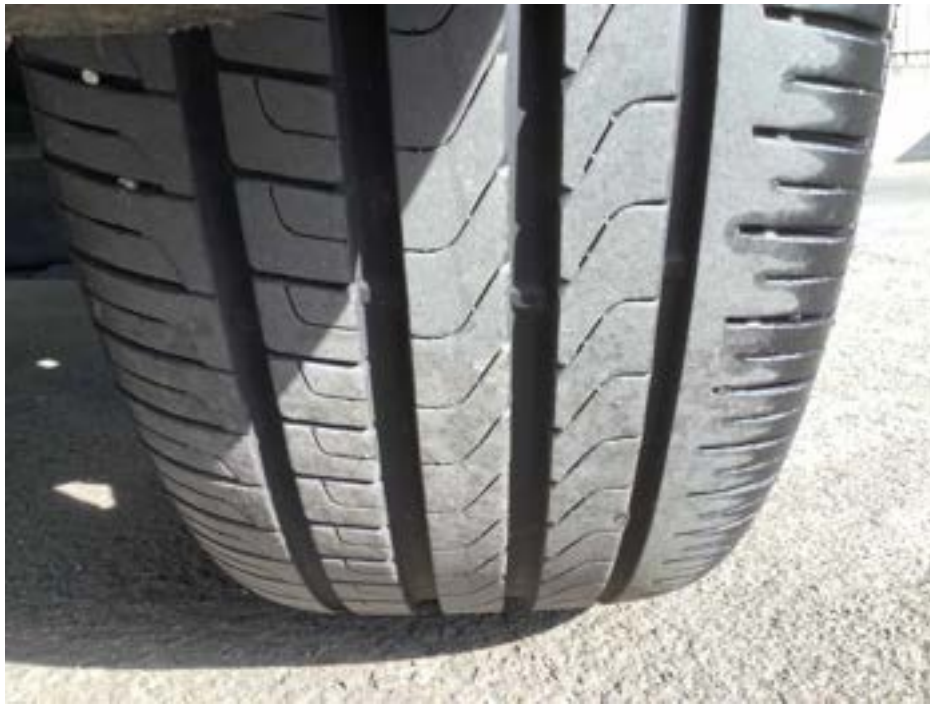
Drivers rear

Approximately 90% remaining.

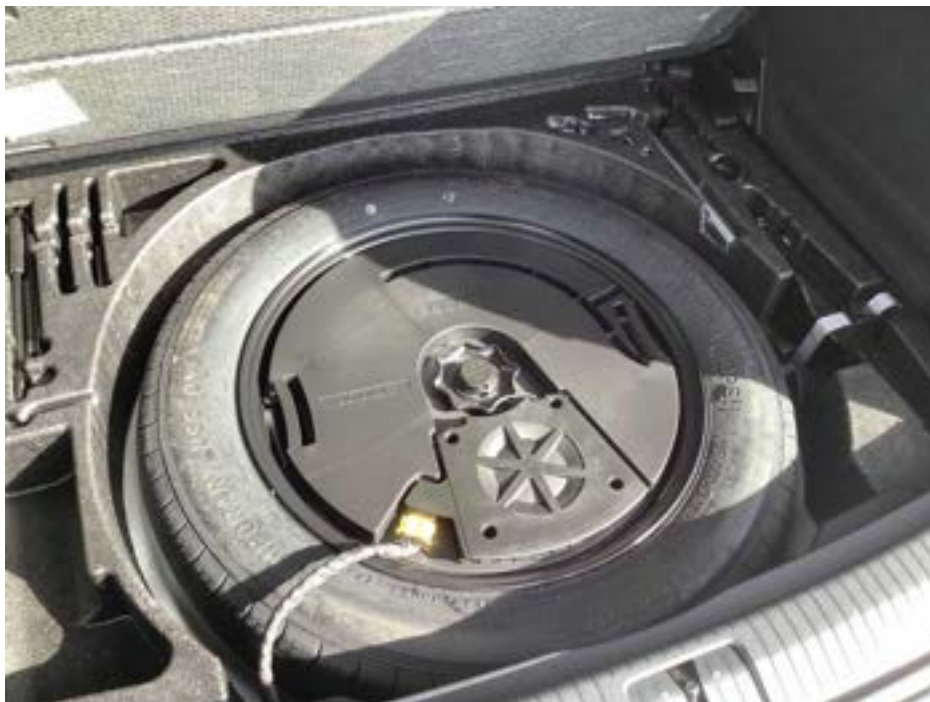
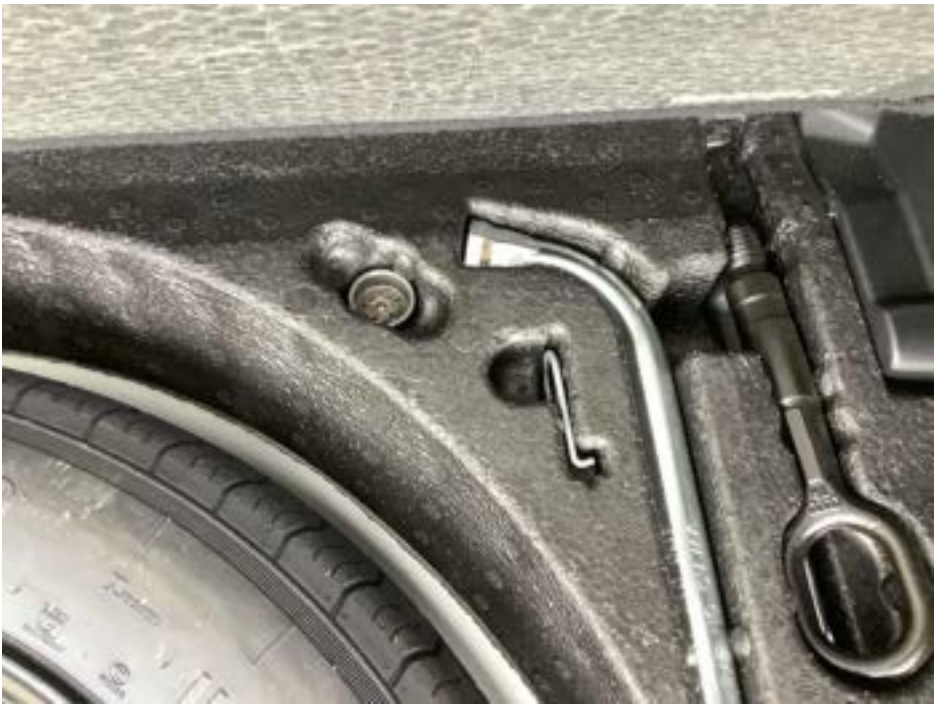
Spare

Approximately 100% remaining.

Temporary spare as standard

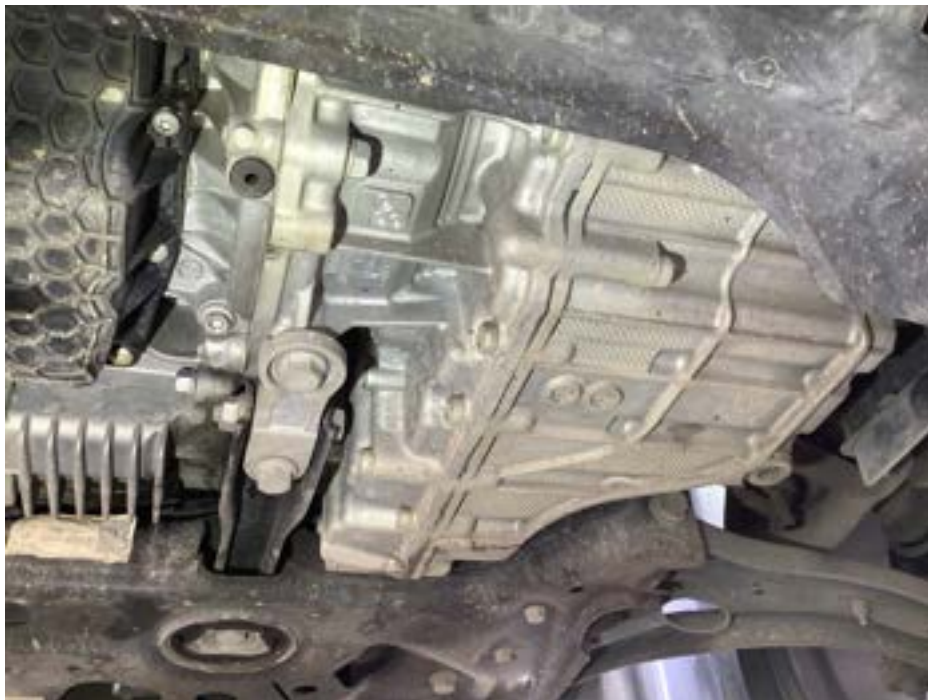
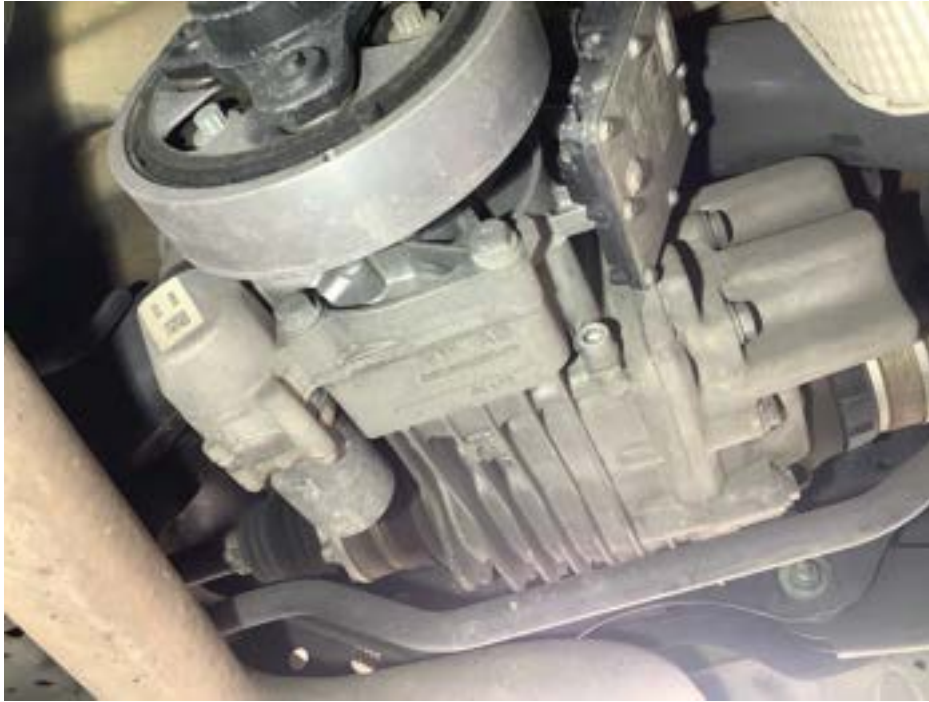
No faults or issues found with external driveline and transmission components, visually appears to be in good order at the time of inspection. This is subject to test drive outcomes. Refer to road test for transmission and driveline operation.

Transmission is a sealed unit, unable to check fluid for correct level, condition or contaminants.

No oil leaks visible at underbody driveline.

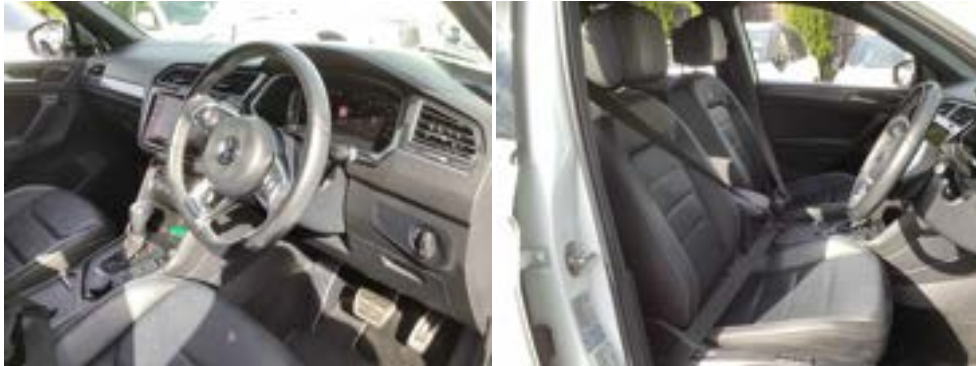
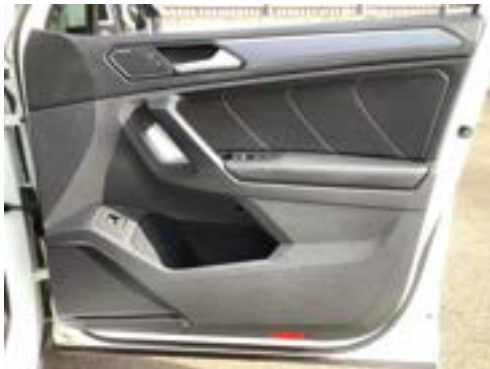
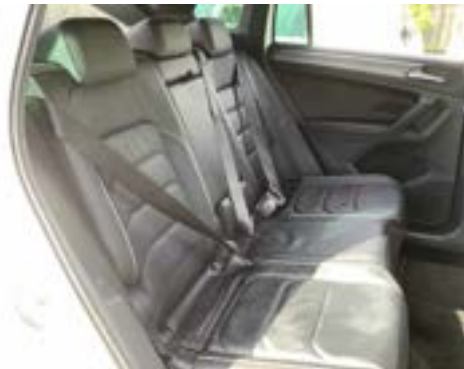
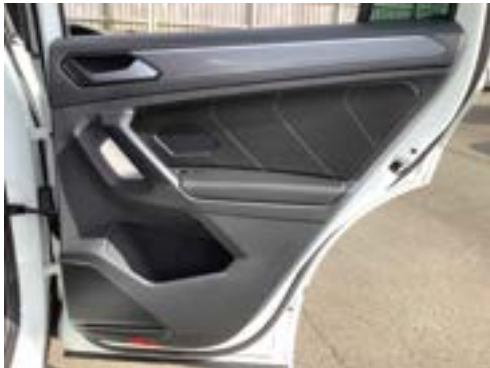
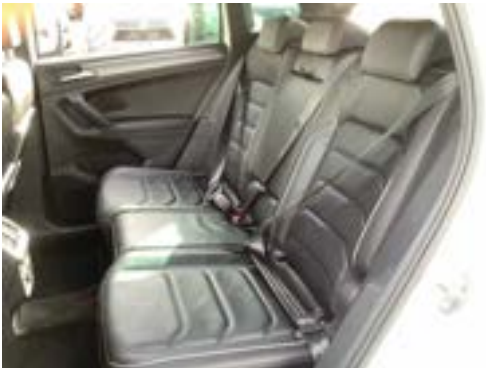
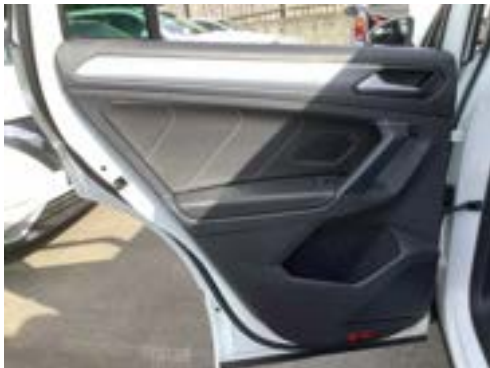
The interior trim and components appear to be in good order at the time of inspection.
General wear and tear to upholstery and trims mainly to contact areas.

Interior trims & seats have light marks.

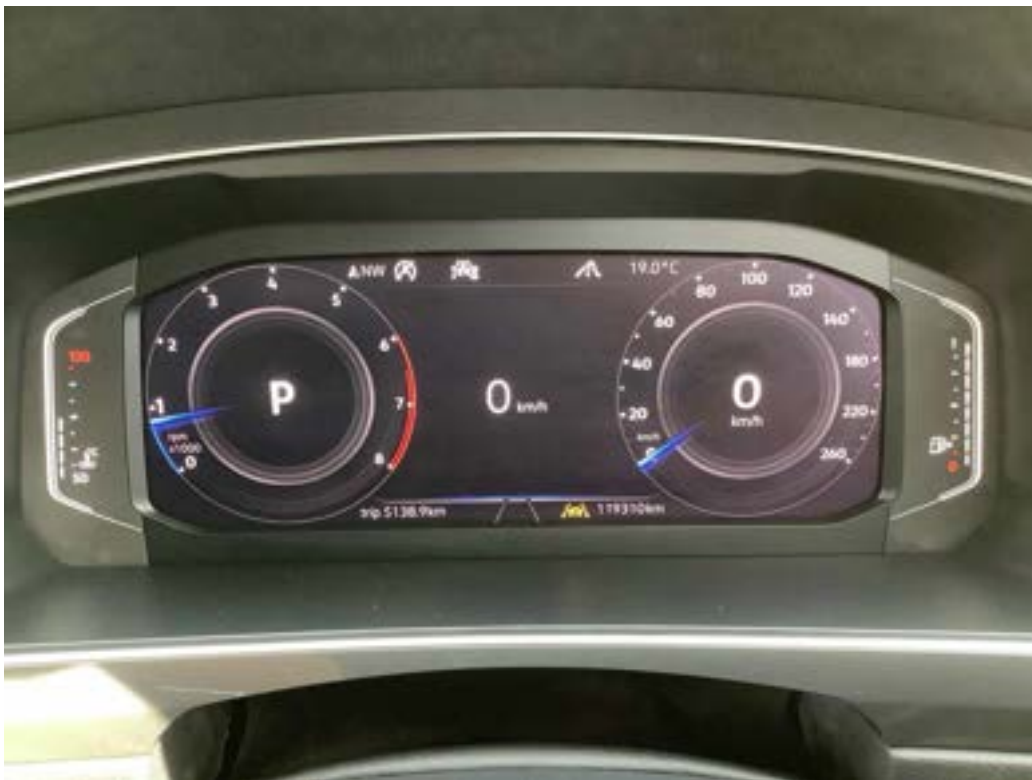
Warning lights / Cluster

No warning lights illuminated at time of inspection.

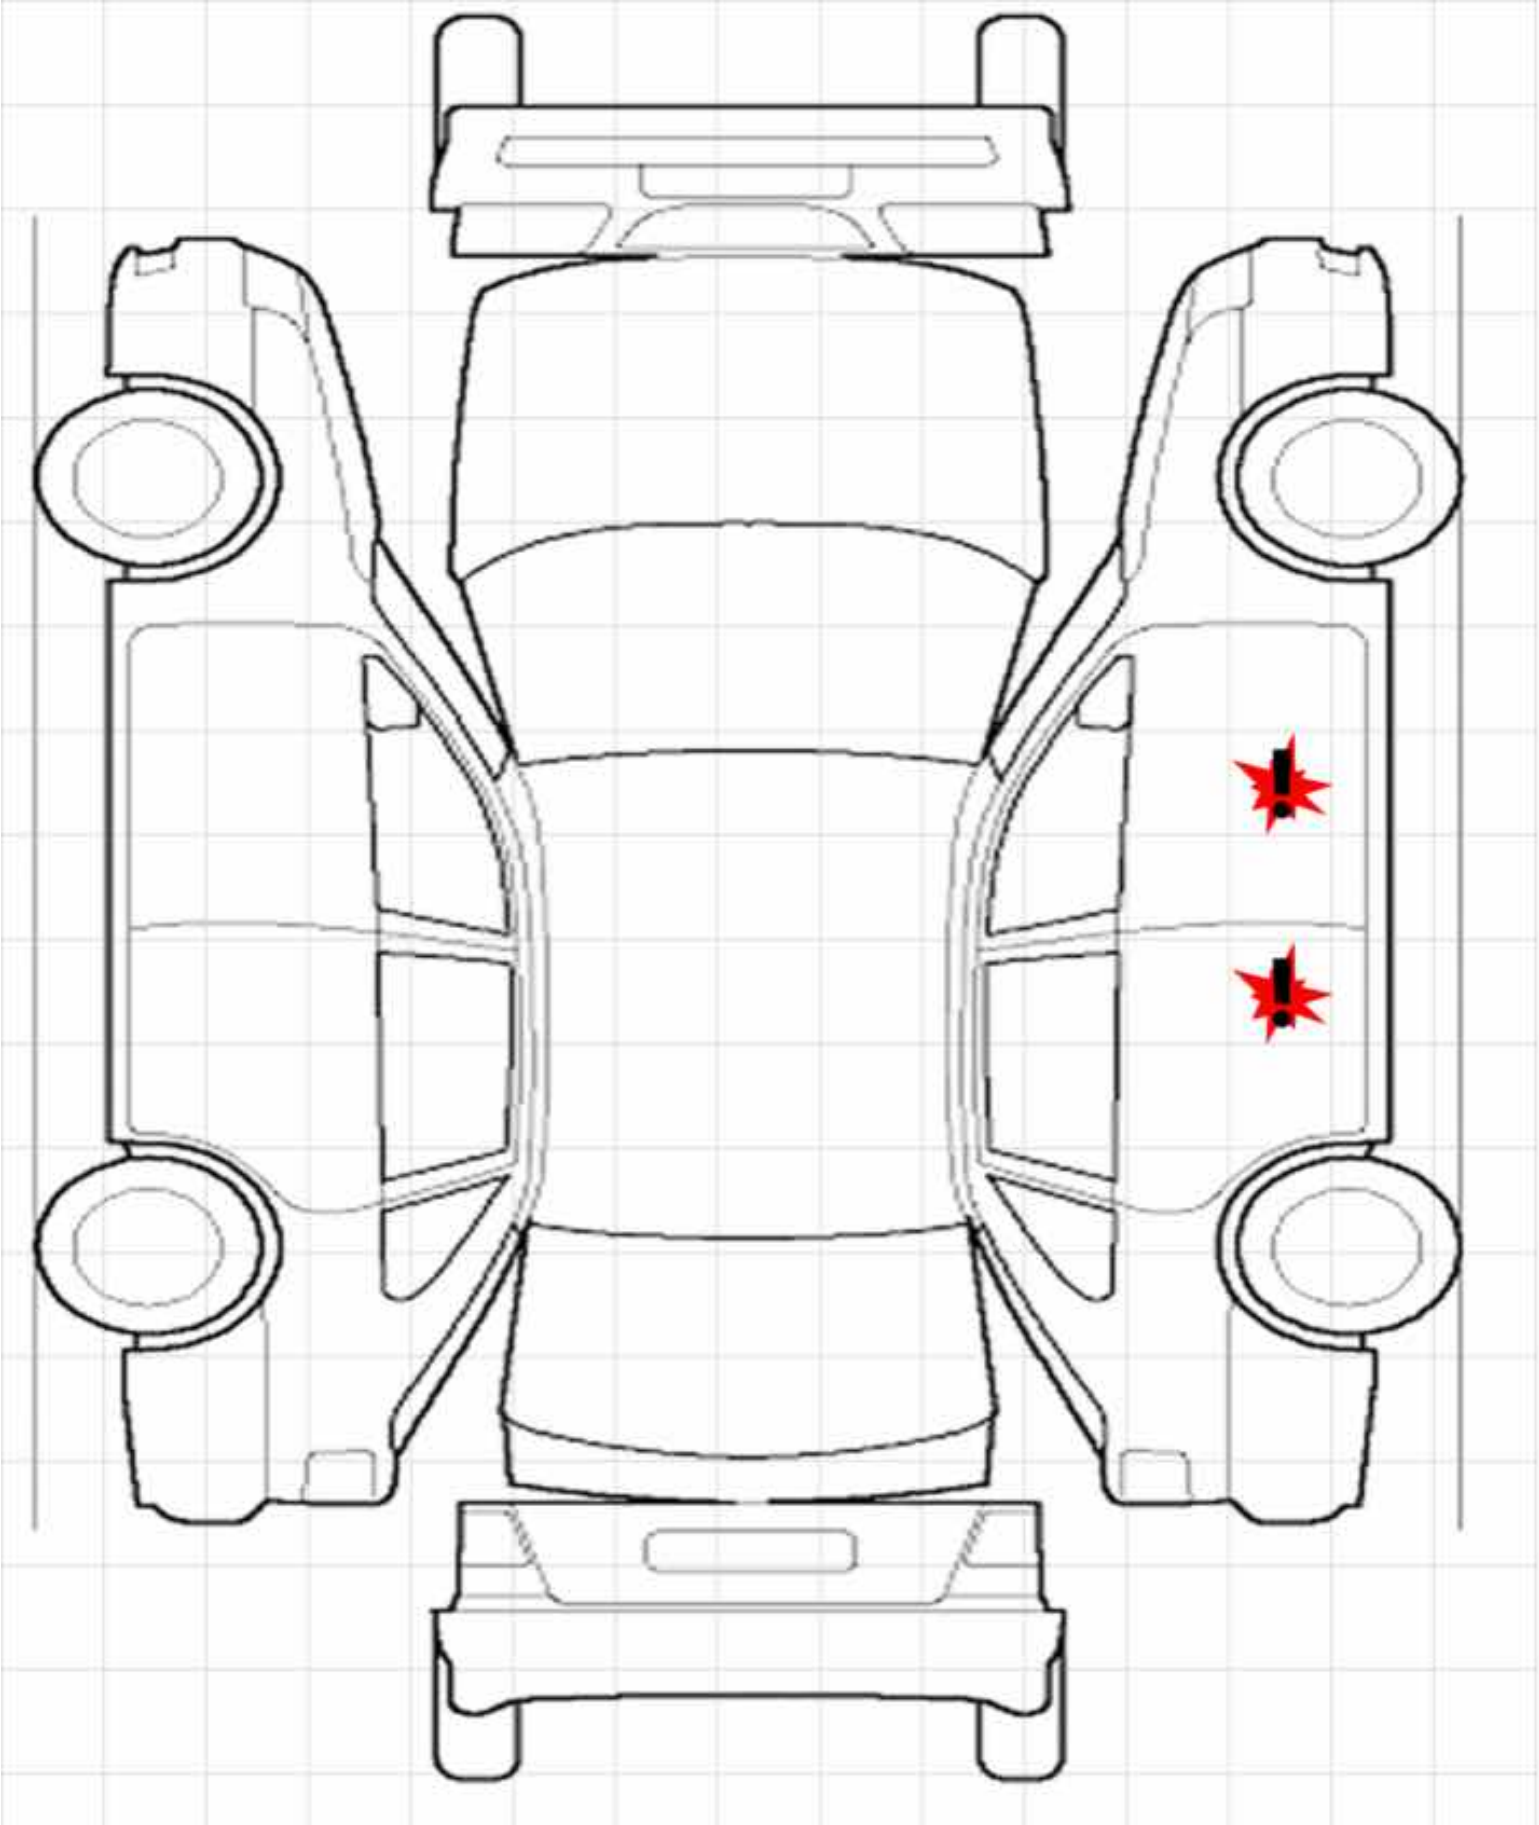
DIAGRAMS

Please refer to mud map for exterior defects located on the last page of this report (after terms and conditions).
