Inspection Report

MTA Pre Purchase Inspections ABN 72158123418

Client Name	Fabiana Bxxxx
Client Email	fx@hotmai.com
Vehicle Make and Model	Toyota Rav 4
Year of Manufacture	2006
Registration Number	AXJ59N
Booking Reference	CAMxxxxP

Inspection Date:	06 Nov 2021
Inspection Time:	12:05 pm

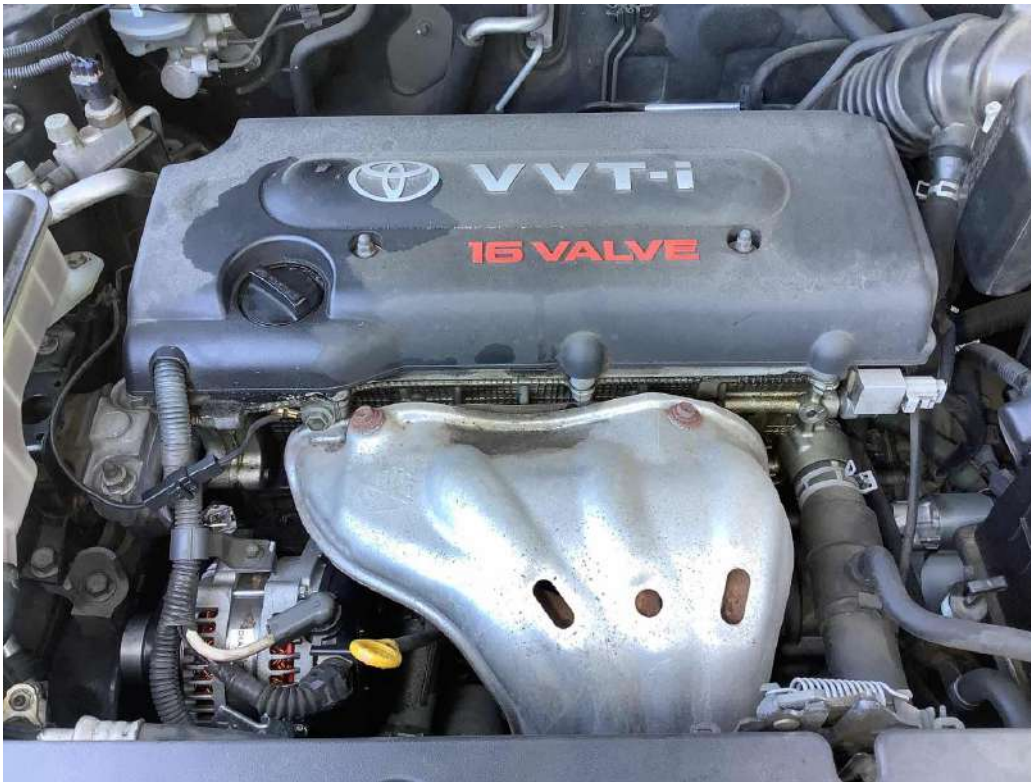
Engine bay-General

External drive belt has fatigue cracks-suggest replacement.

Bonnet hold retaining clip broken.

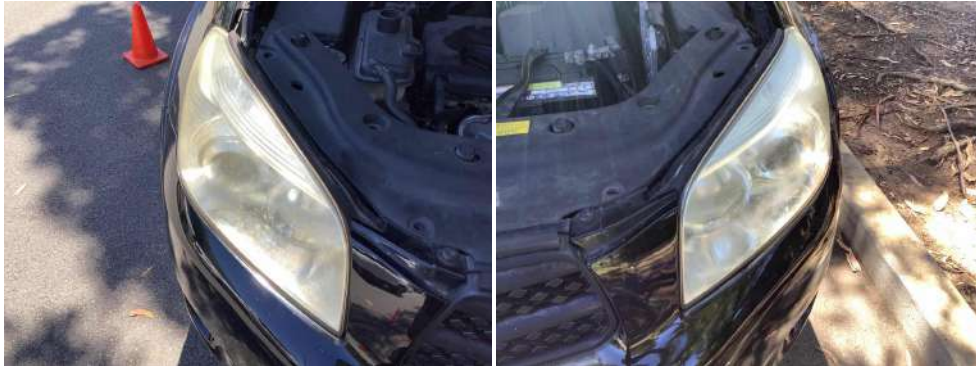
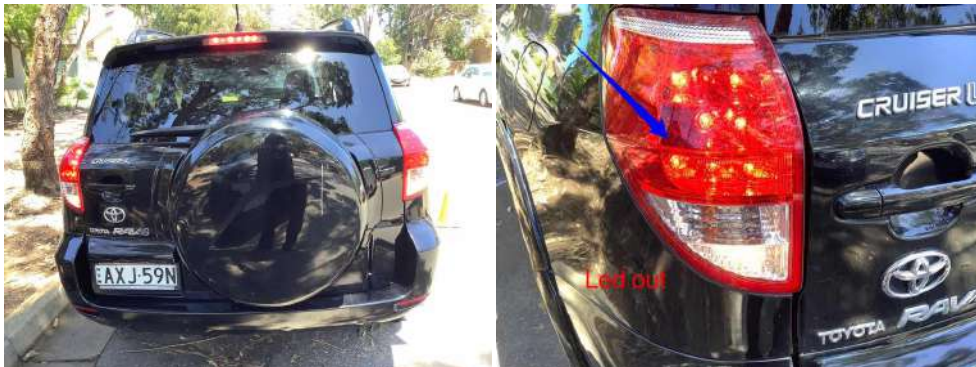
Lights and lenses

Front and rear lights have been tested-all working at time of inspection.
Headlight lenses are tarnished, polish and re-assess.

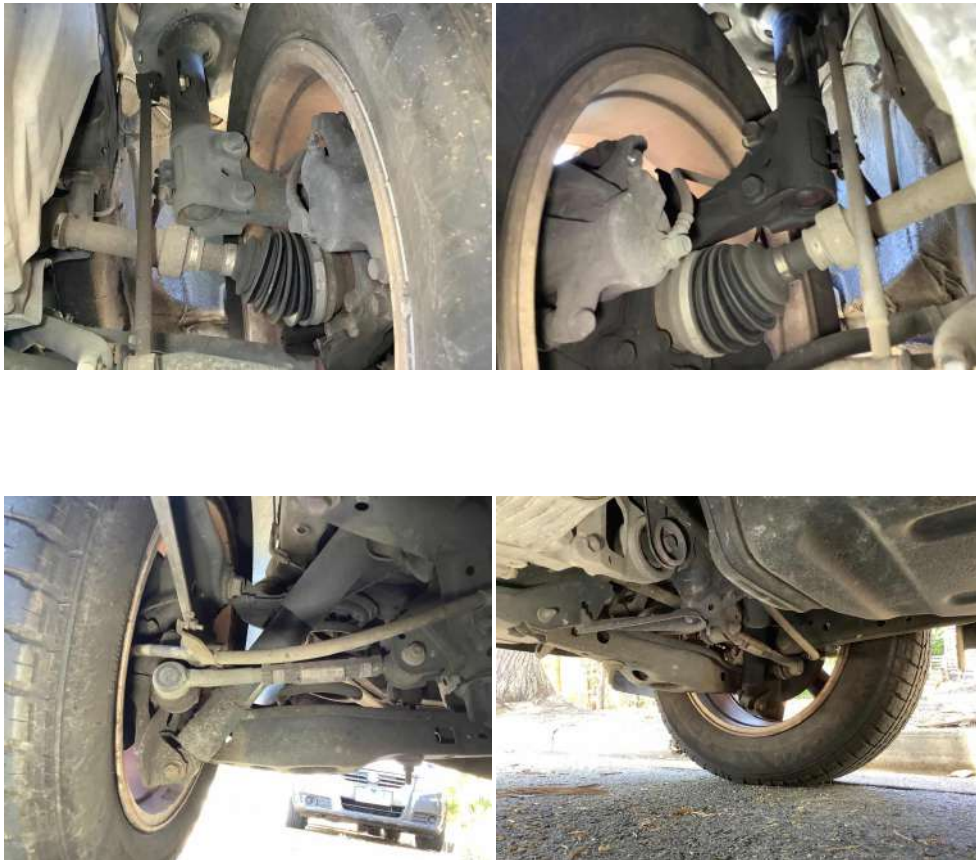
Steering and suspension recommendations

Shock absorber is leaking, replace as required-front and rear.

Shock absorber dust boot split-replace as required.

Front link pins worn-replace.

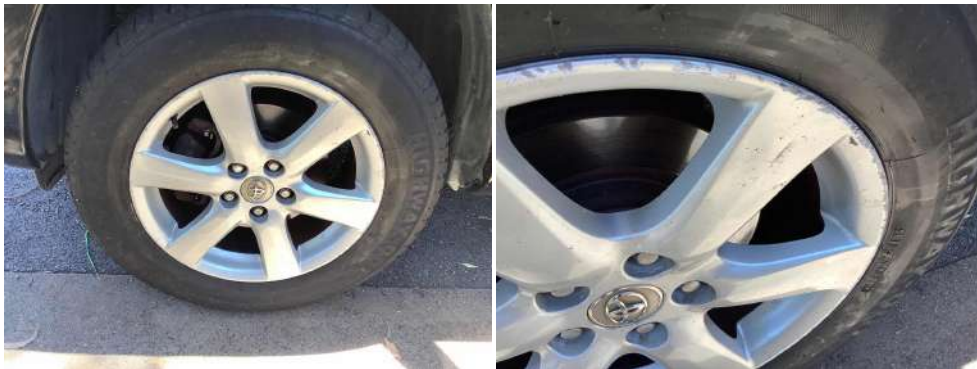
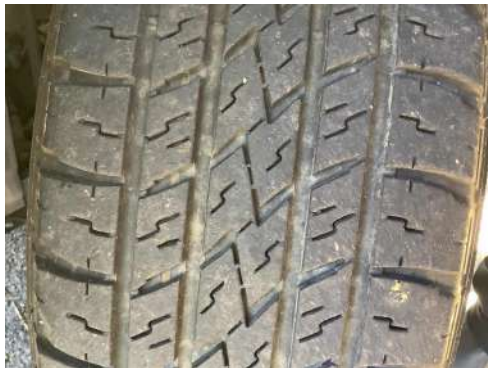
Passenger front

Approximately 90% remaining.

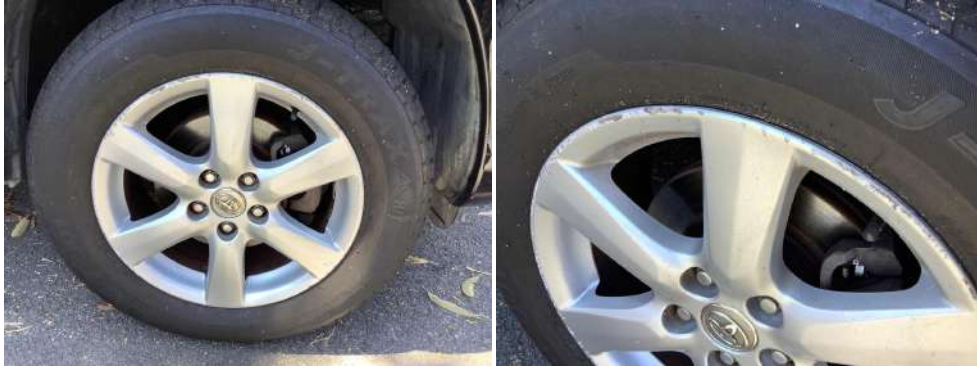
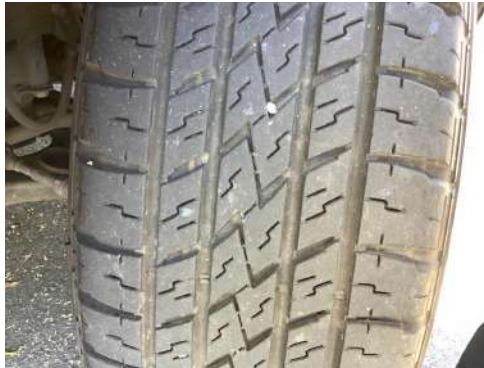
Drivers front

Approximately 90% remaining.

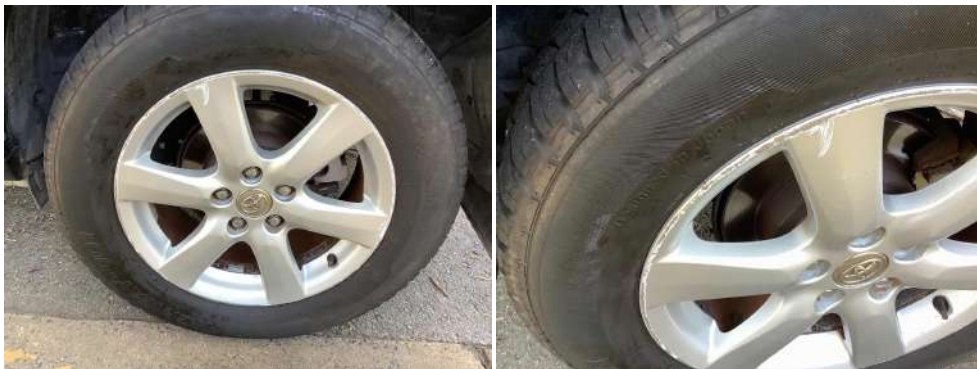
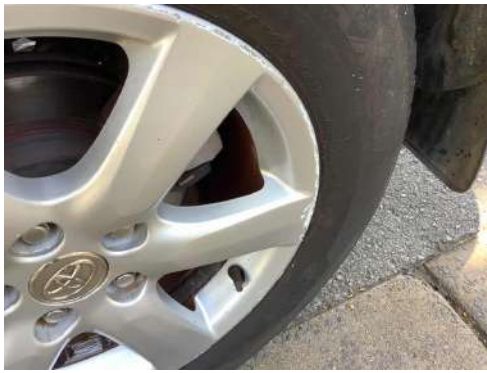
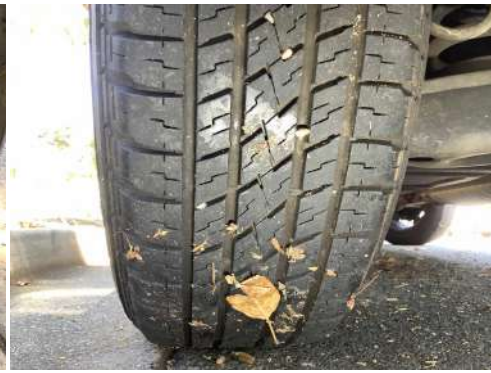
Passenger rear

Approximately 90% remaining.

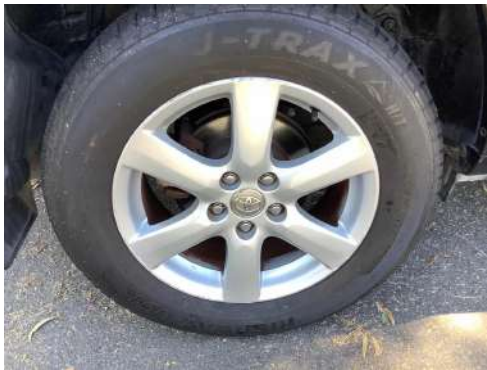
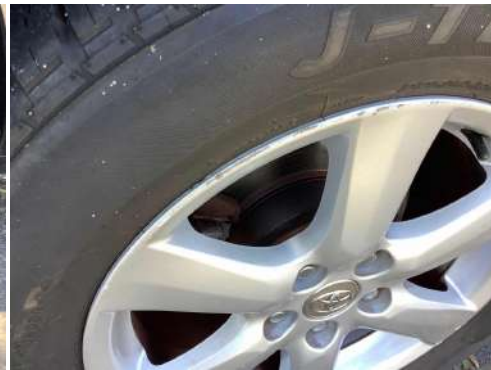
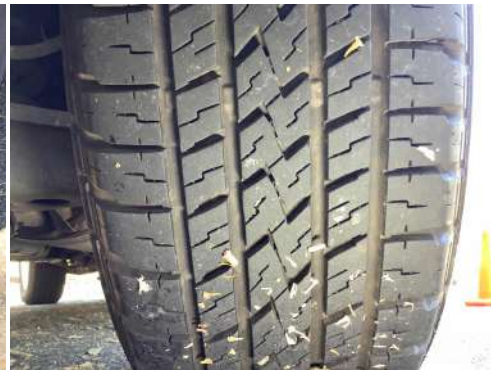
Drivers rear

Approximately 90% remaining.

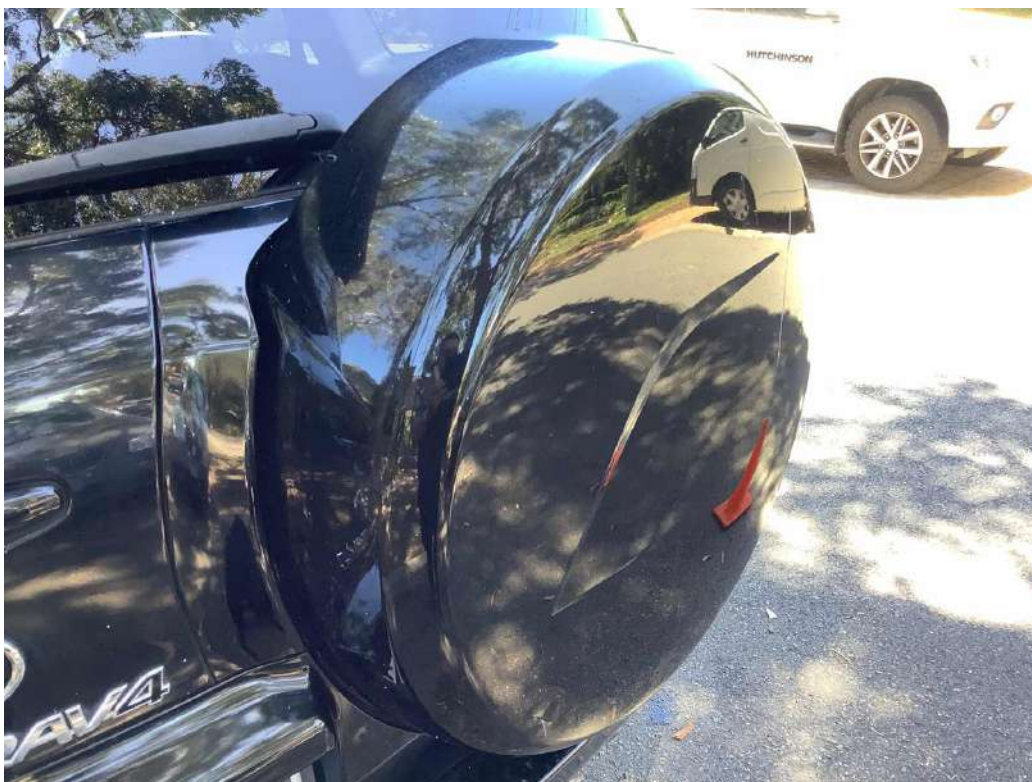
Spare tyre not visible.

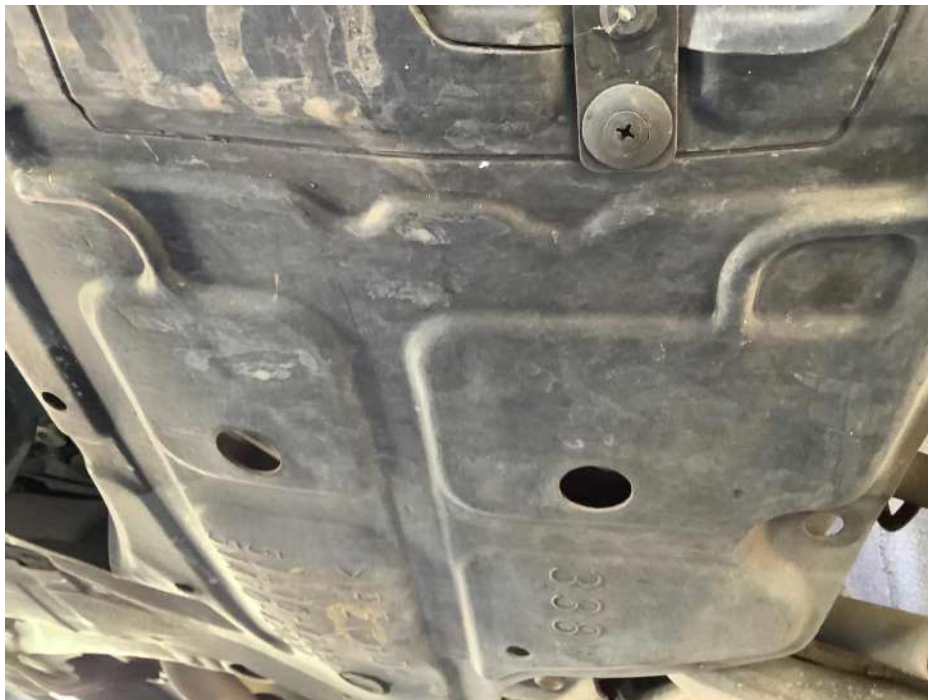
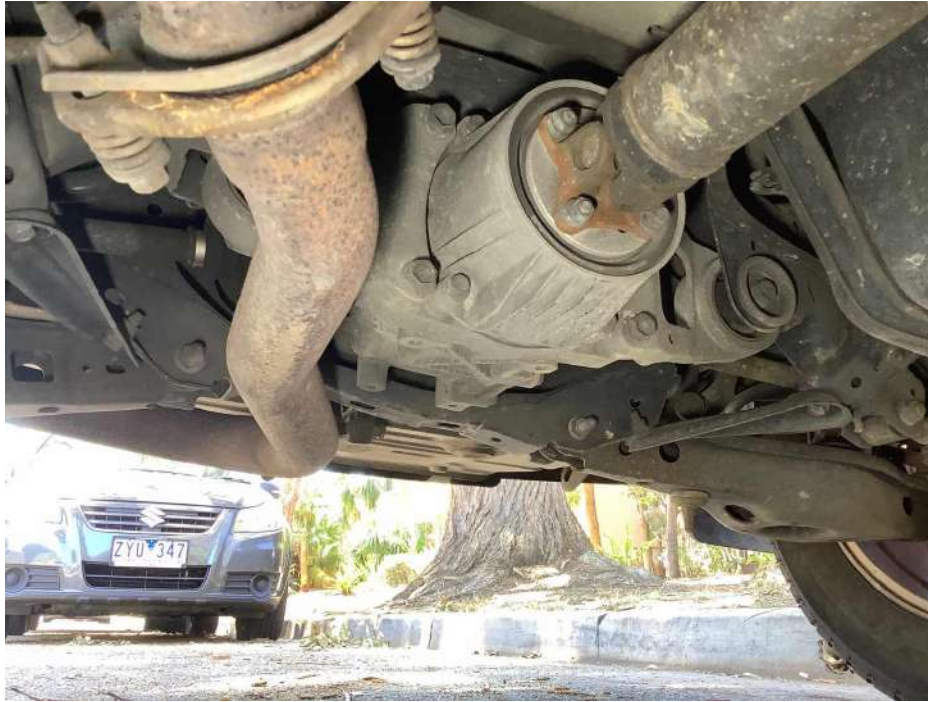
No faults or issues found with external driveline and transmission components, visually appears to be in good order at the time of inspection. This is subject to test drive outcomes. Refer to road test for transmission and driveline operation.

No oil leaks visible at underbody driveline.
Recommend Auto transmission service-oil dirty.

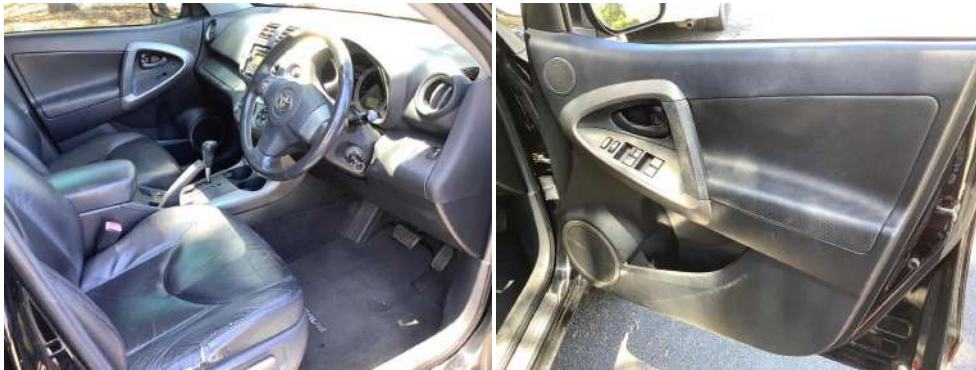
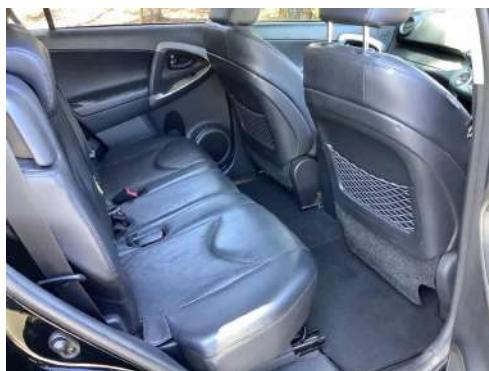
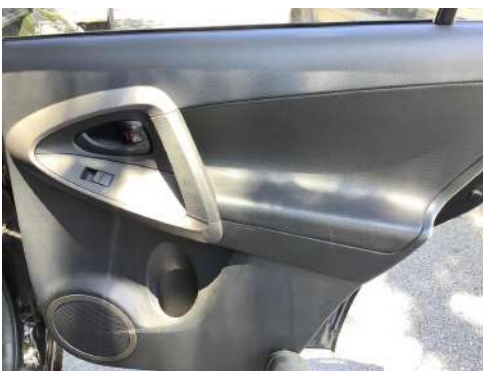
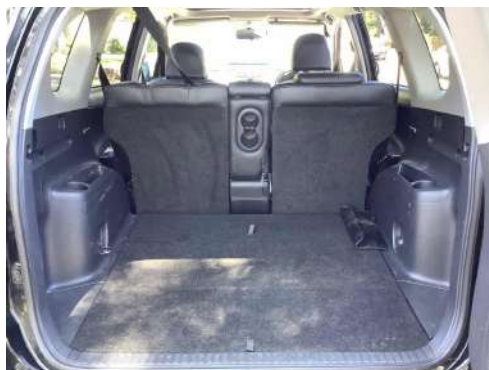
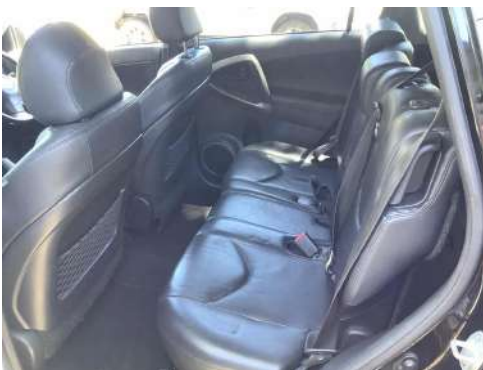
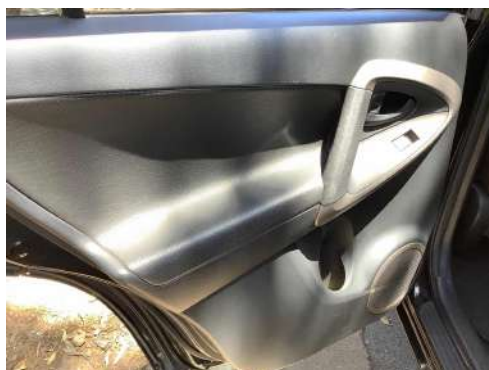
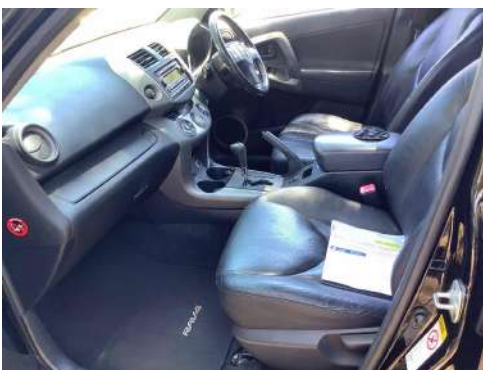
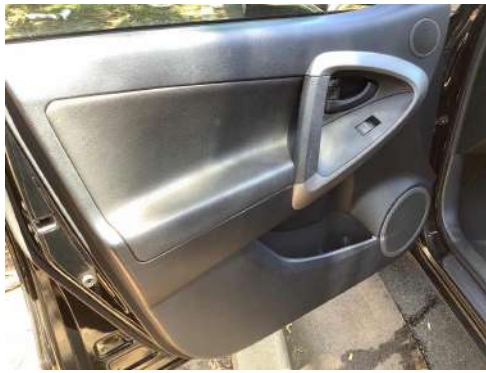
Interior trims & seats have light marks.
 Interior trim & carpet is dirty recommend full interior detailing.
 Rear cargo cover not fitted at this time.
 Baby seat previous fitted-impressions to seat trim evident.
 Head restraint missing.
 Seat belt twisted.
 Air vent slats damaged.

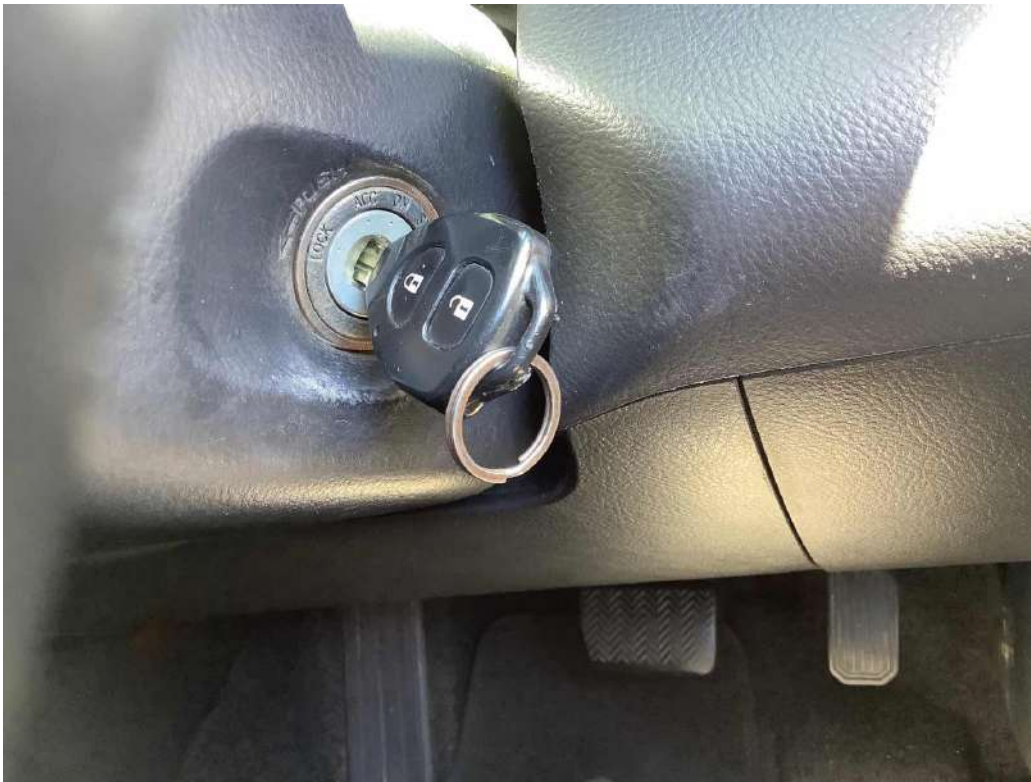
Keys and remotes

One key sighted-suggest checking with seller for additional keys.

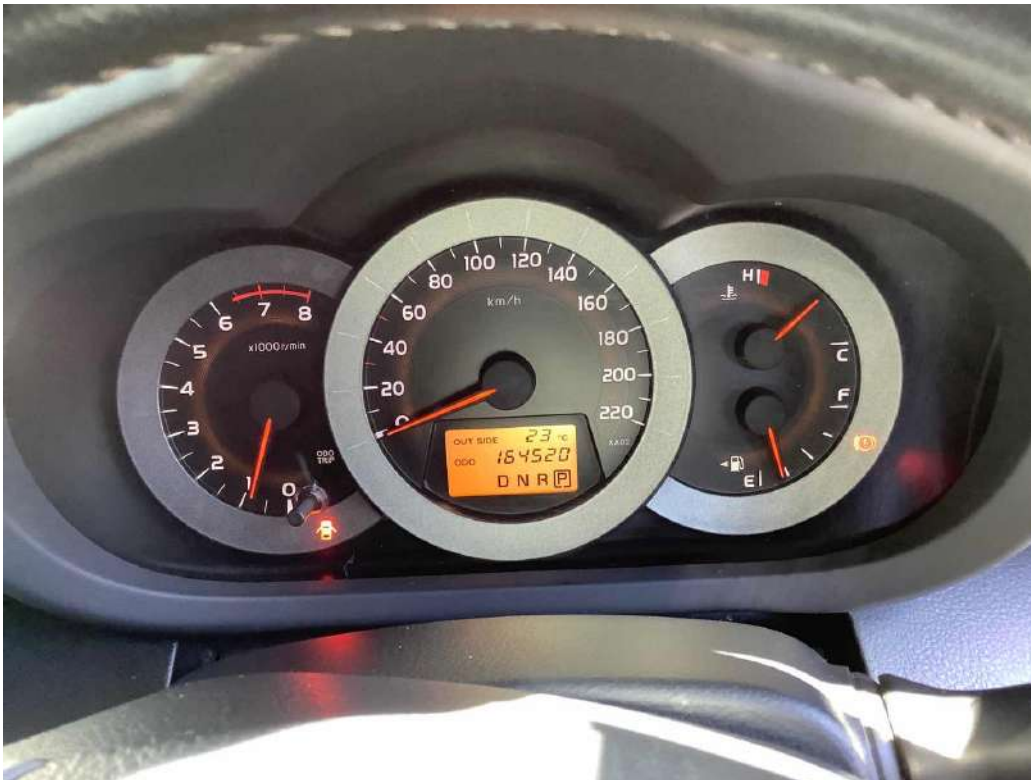
Warning lights / Cluster

No warning lights illuminated at time of inspection.

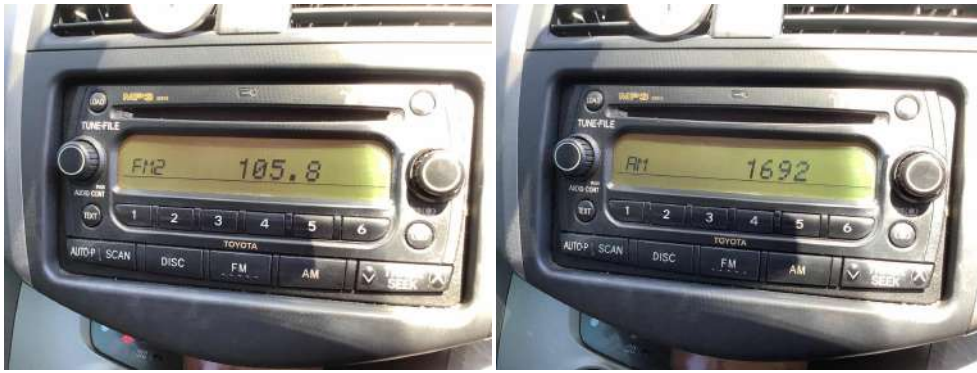
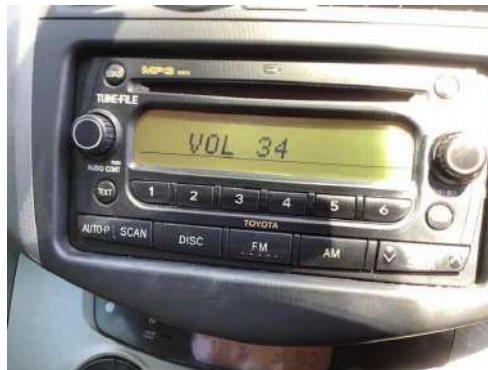
Entertainment.

Cd player not accepting cd's

Radio display operational however no sound from head unit.

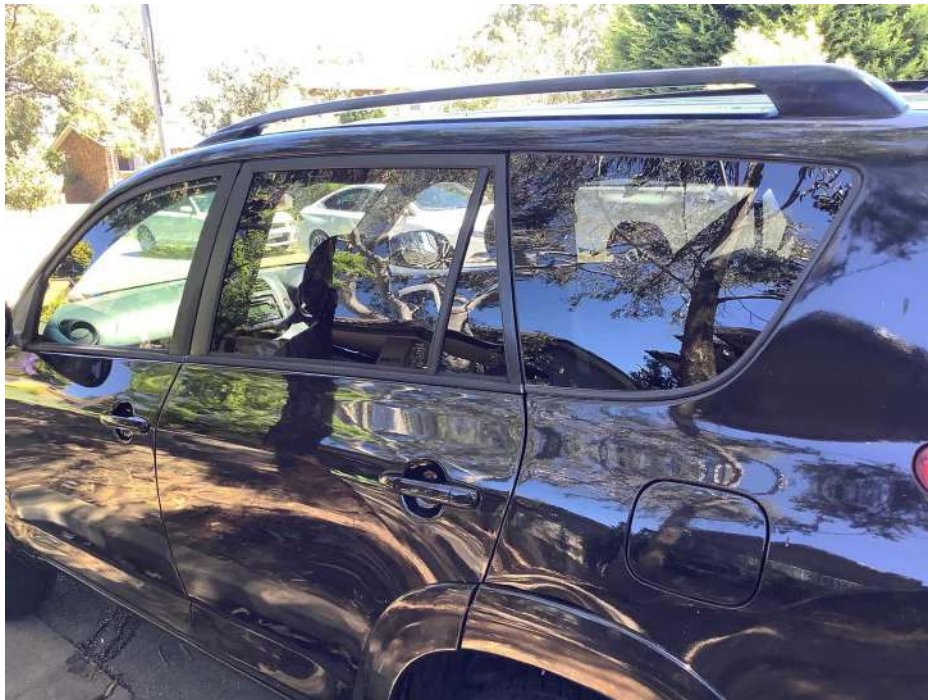
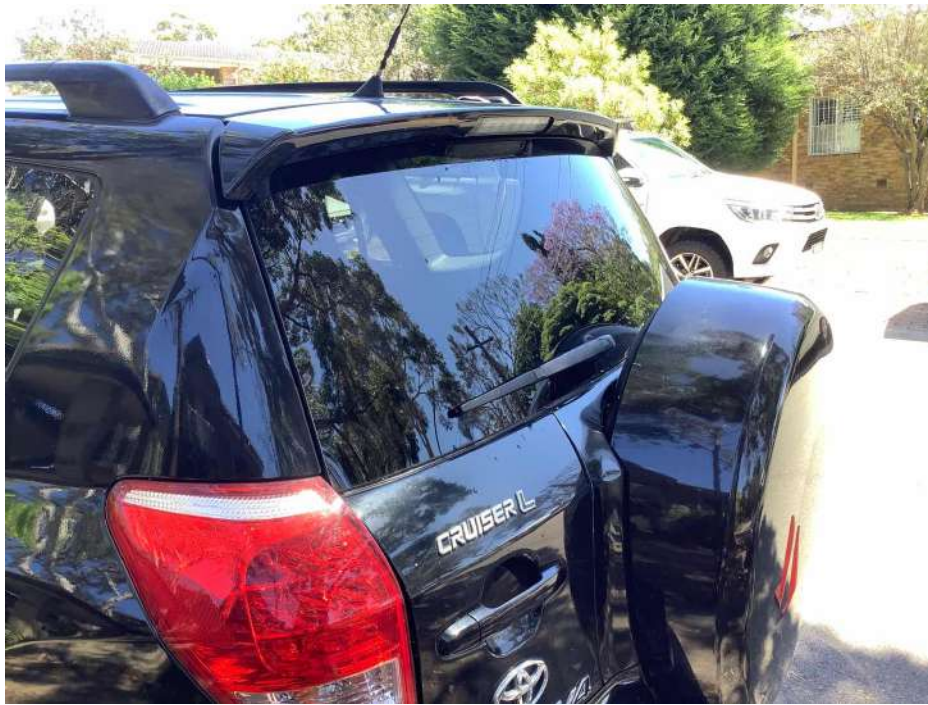
Window tint and accessories.

Windows have been tinted.

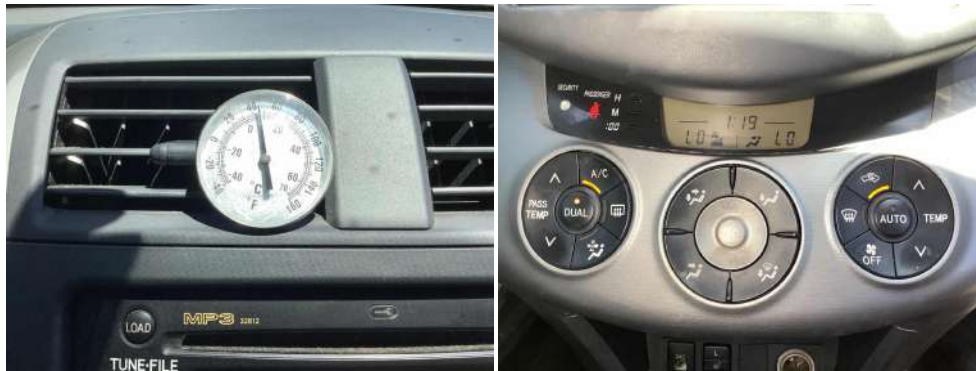
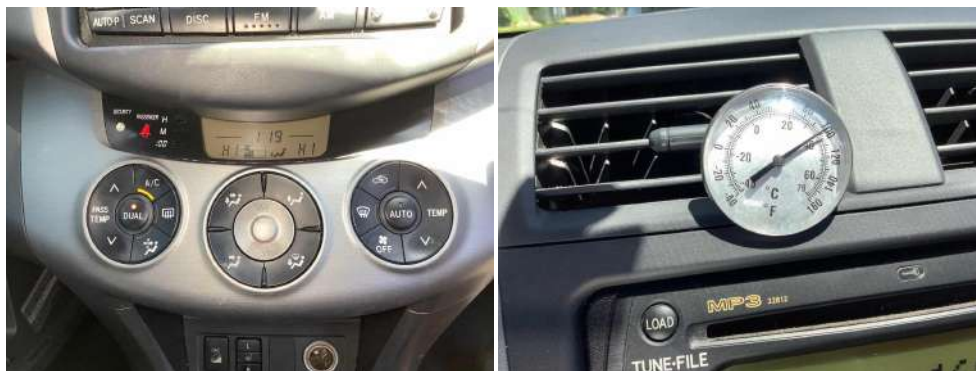
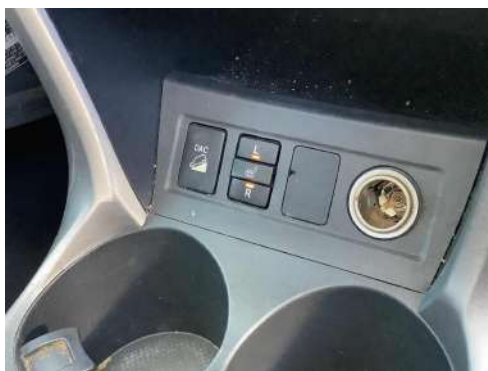
Air conditioning and heater has been tested-all operational.

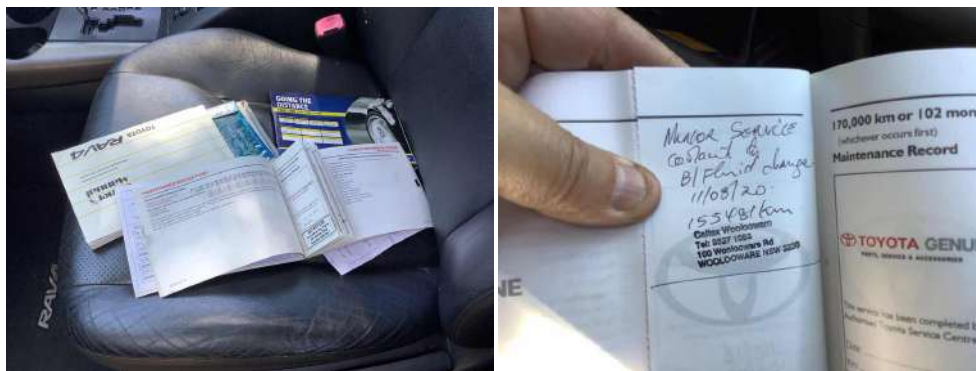
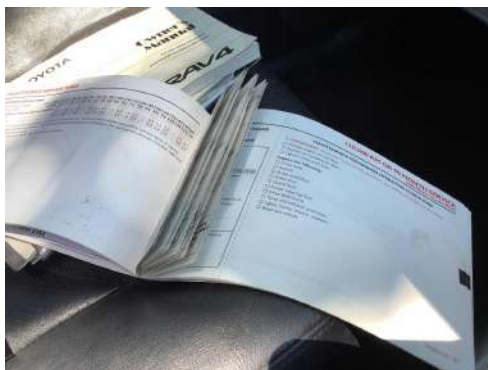
Service records up to date

SERVICE LOG BOOKS SIGHTED AND APPEAR TO BE UP TO DATE.

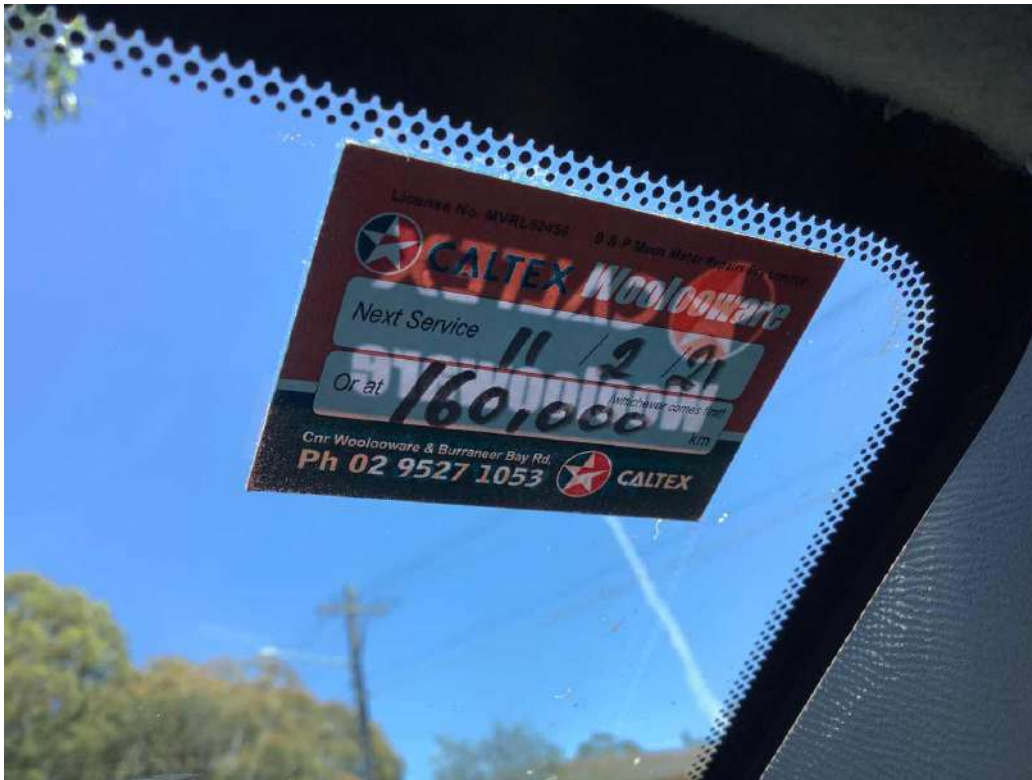
Next Service due

Service overdue-service required.

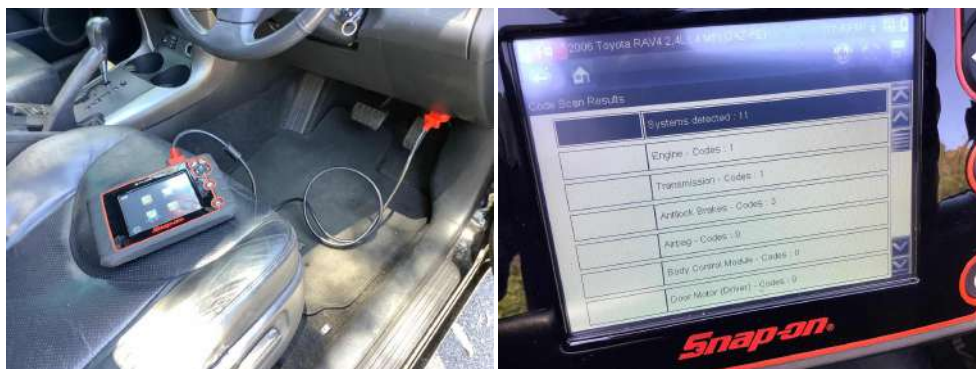
VEHICLE MANAGEMENT SCAN

VEHICLE MANAGEMENT SYSTEM HAS BEEN SCANNED-FAULT CODES RECORDED-SUGGEST FURTHER WORKSHOP TESTING AND REPAIR AS REQUIRED.
