# Inspection Report

**MTA Pre Purchase Inspections ABN 72158123418**

Client Name	Fabiana XXXXXXXX
Client Email	fxX@gmail.com
Vehicle Make and Model	Toyota Rav 4
Variant	Cruiser
Year of Manufacture	2006
Registration Number	AXJ59N
Booking Reference	CAMXXXXP
Total Fee	\$295.00

Inspection Date:	06 Nov 2021
Inspection Time:	12:05 pm

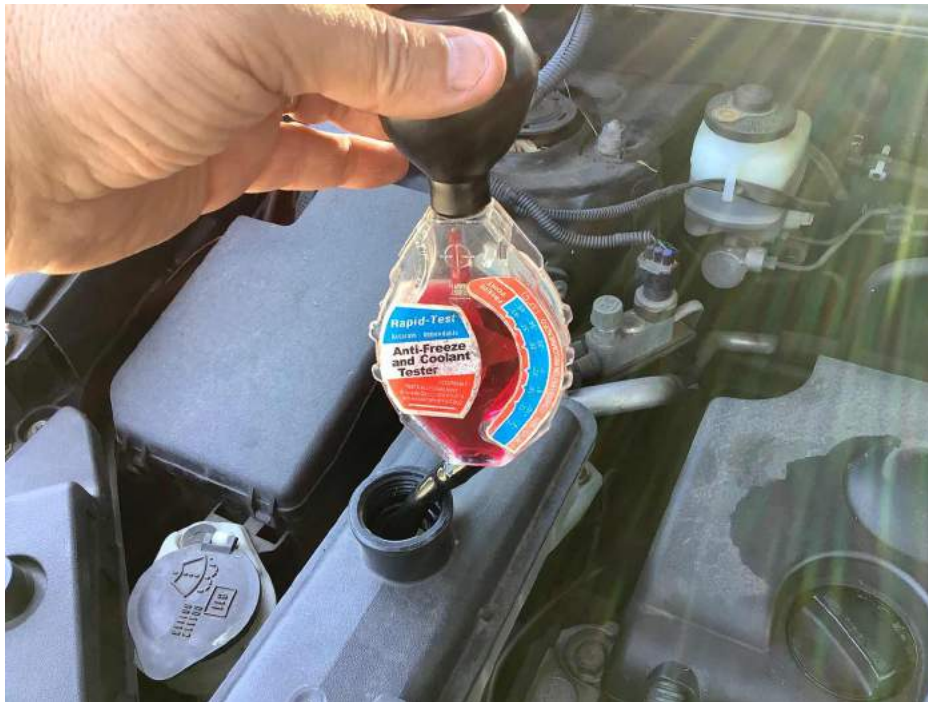
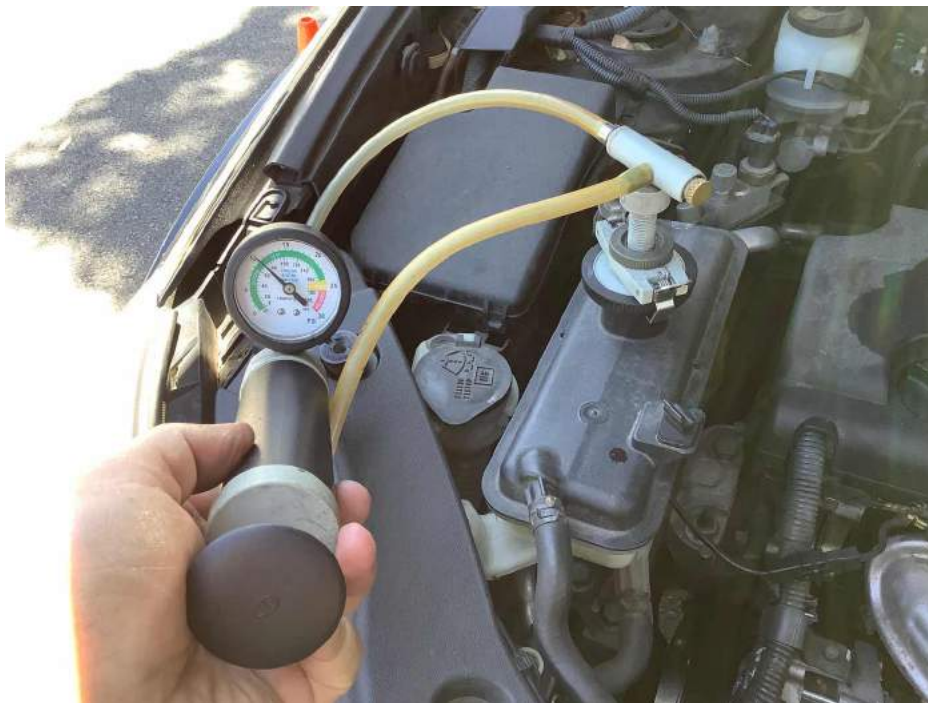
### **Cooling system summary**

The cooling system and its components visually appear in good order of service at the time of inspection. The cooling system has passed a pressure test. The engine is running at normal operating temperature. The radiator corrosion inhibitor concentrate level has been measured and is at serviceable level.

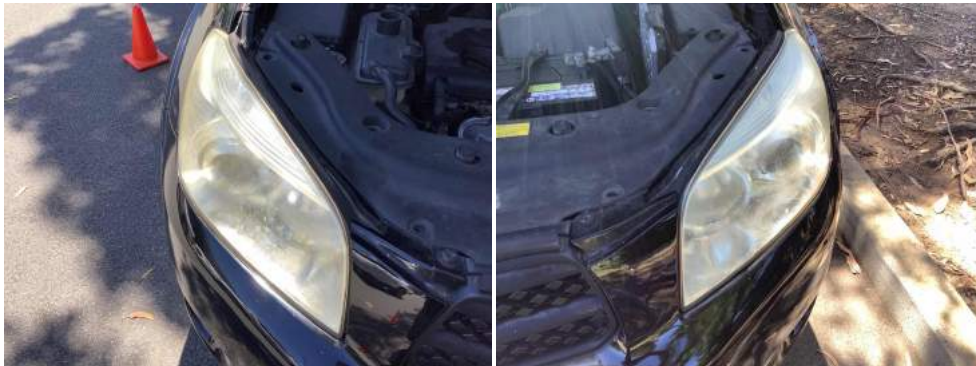
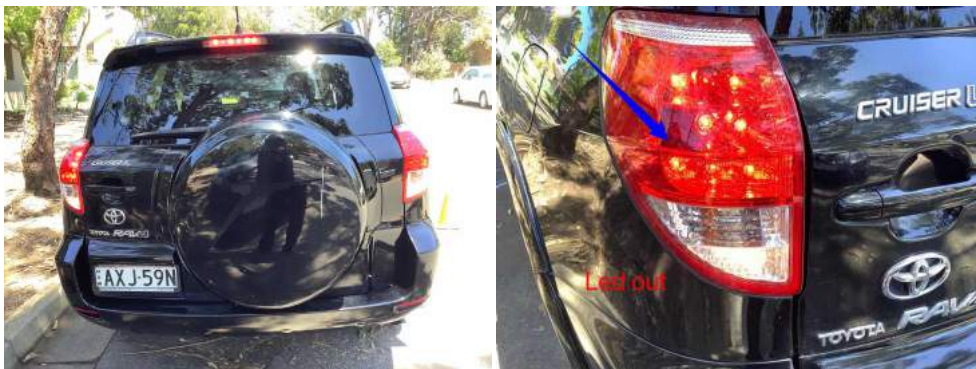
### Lights and lenses

Front and rear lights have been tested-all working at time of inspection.  
Headlight lenses are tarnished, polish and re-assess.

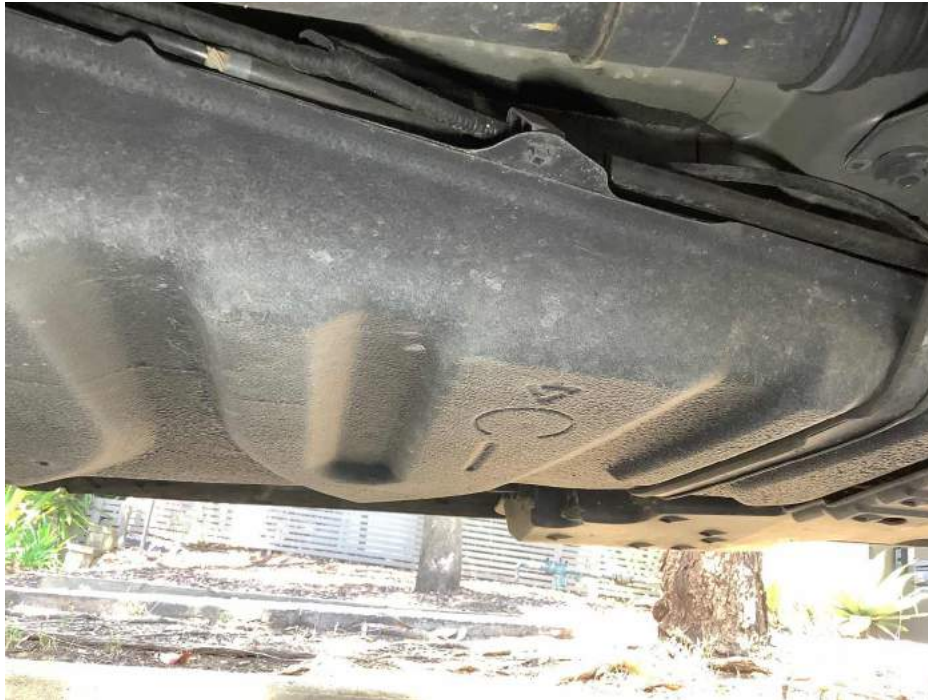
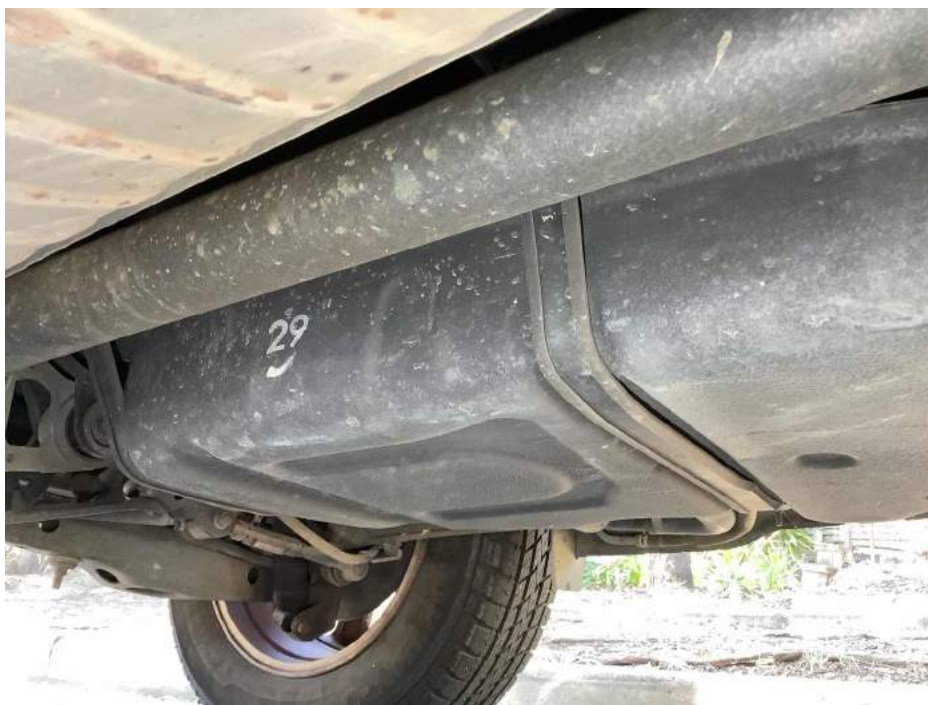
### Fuel system Summary

The fuel system visually appears to have no faults and is in good condition at time of inspection. No fuel leaks evident.

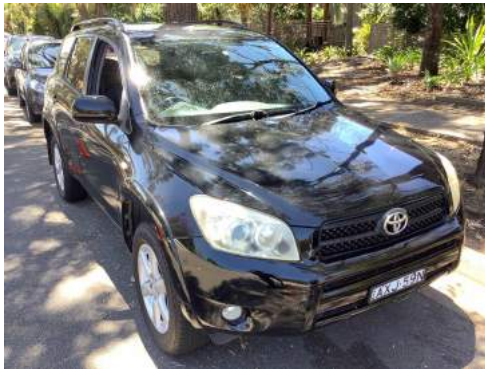
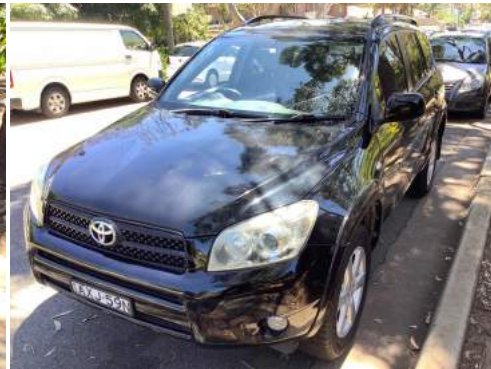
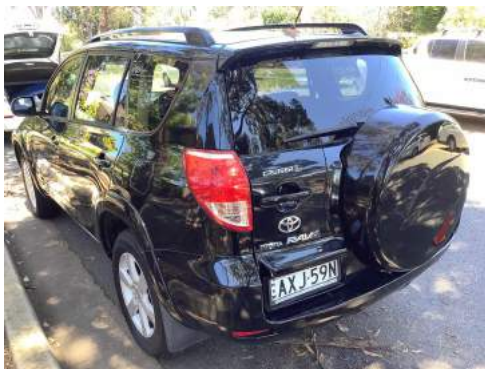
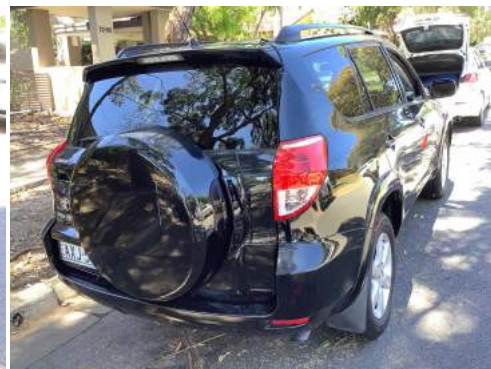
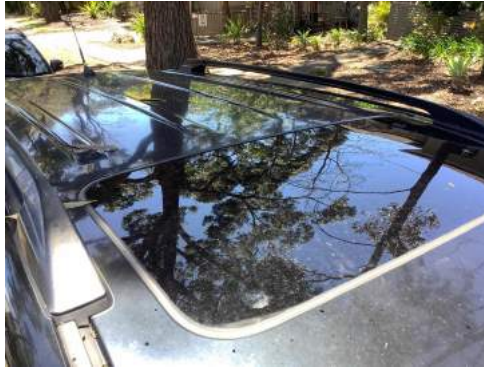
#### Body summary.

The body panels appears to be in Poor order at time of inspection.

Vehicle has had panel and paint repairs to passenger side panels- No evidence of any chassis or structural repairs found.

Overall repairs and paint finish have deteriorated over time.

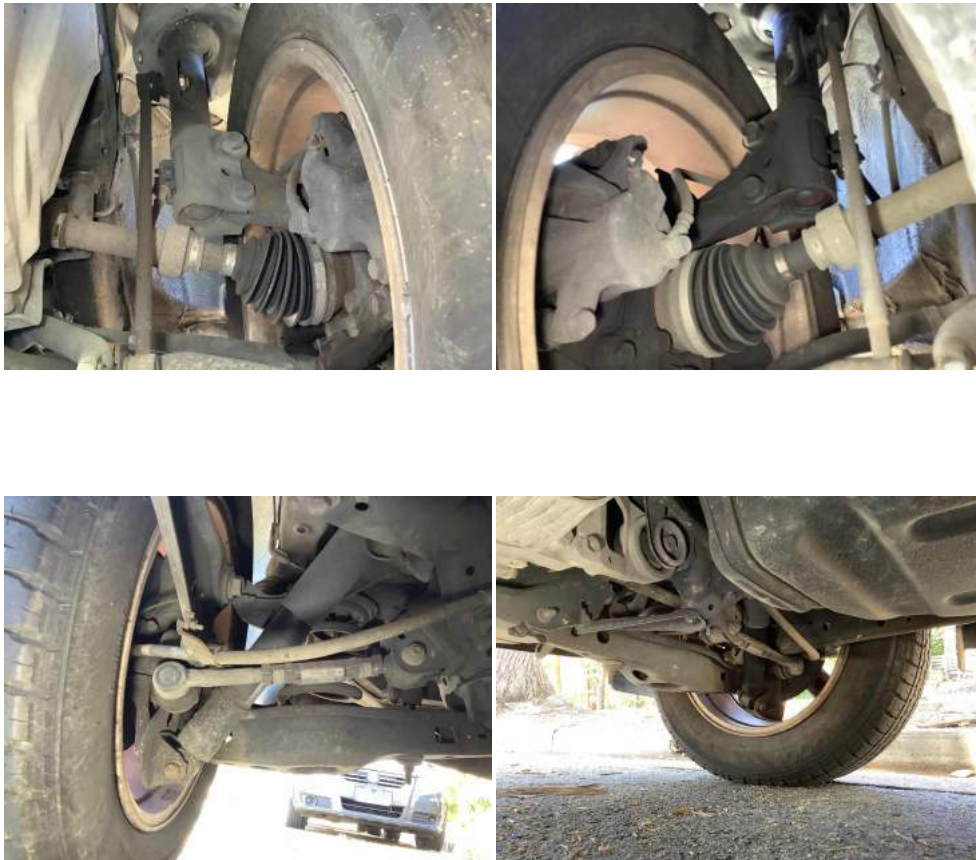
Steering and Suspension components appear in POOR overall condition the following recommendations are strongly advised.

Shock absorber is leaking, replace as required-front and rear.

Shock absorber dust boot split-replace as required.

Front link pins worn-replace.

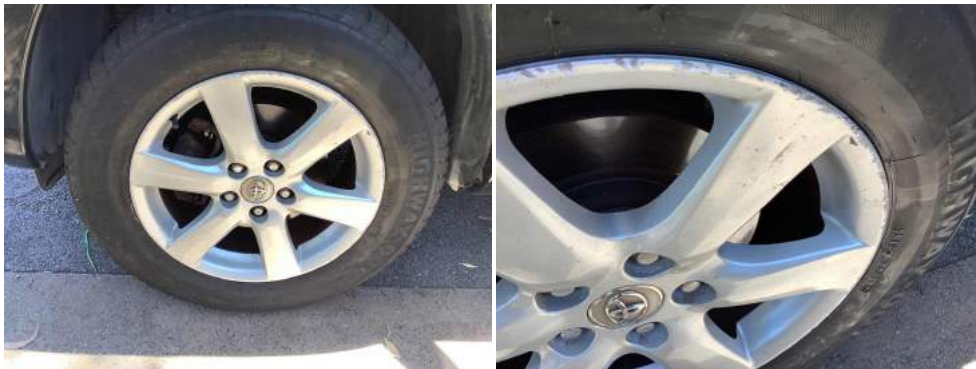
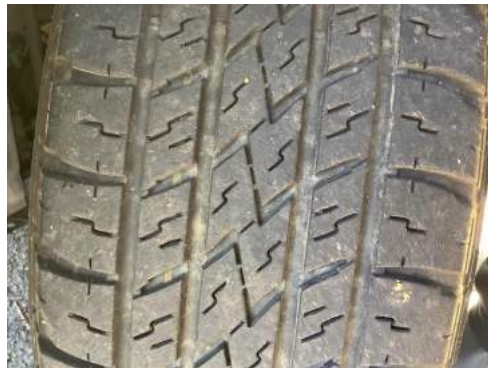
#### **Passanger front**

Approximately 90% remaining.

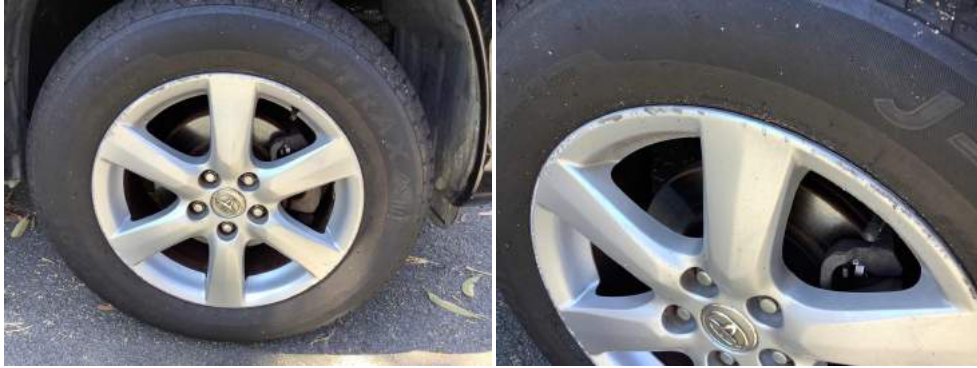
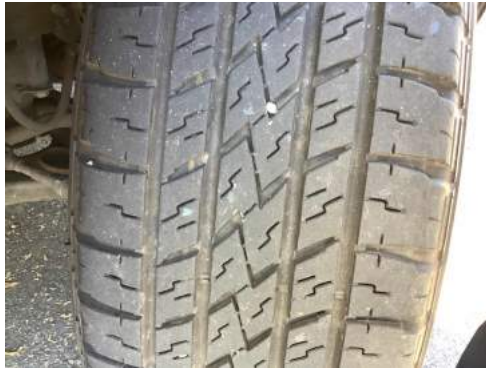
#### **Drivers front**

Approximately 90% remaining.

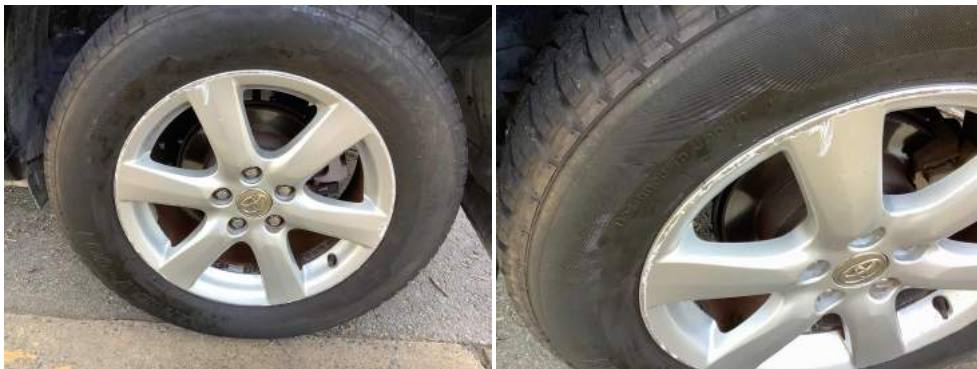
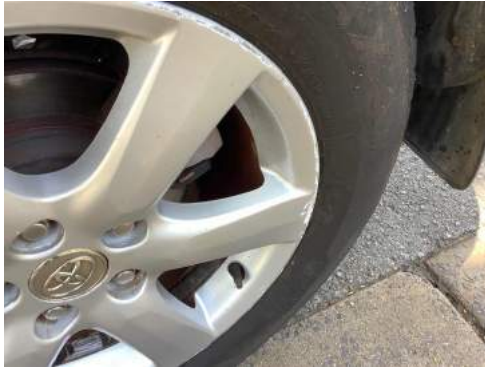
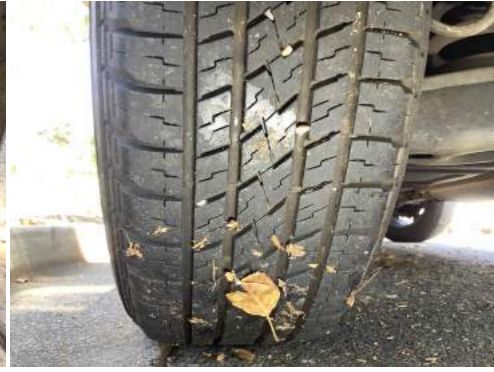
### **Passanger rear**

Approximately 90% remaining.

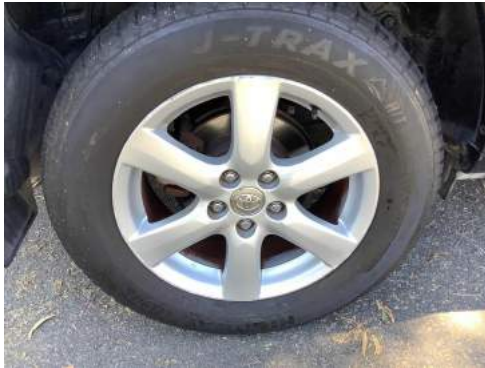
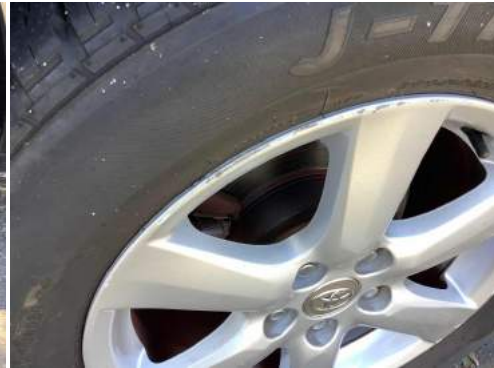
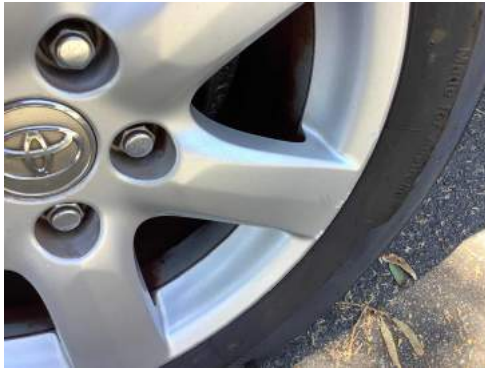
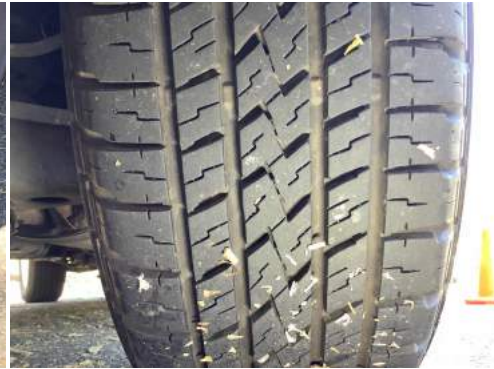
### Drivers rear

Approximately 90% remaining.

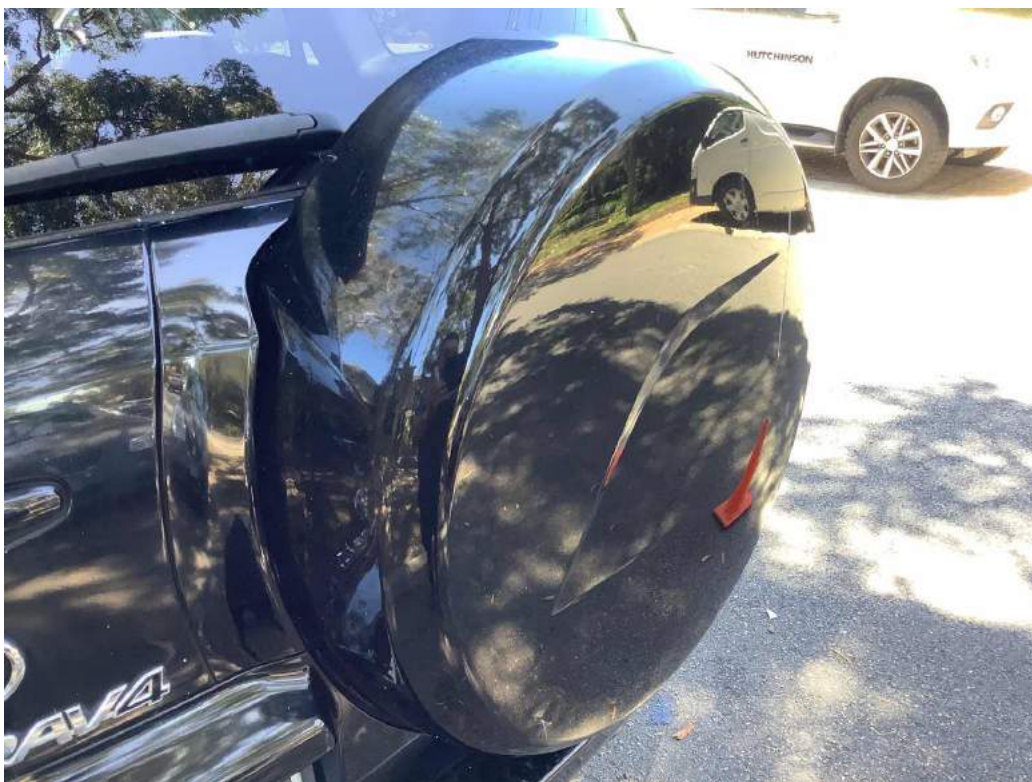
### Spare

Spare tyre not visible.

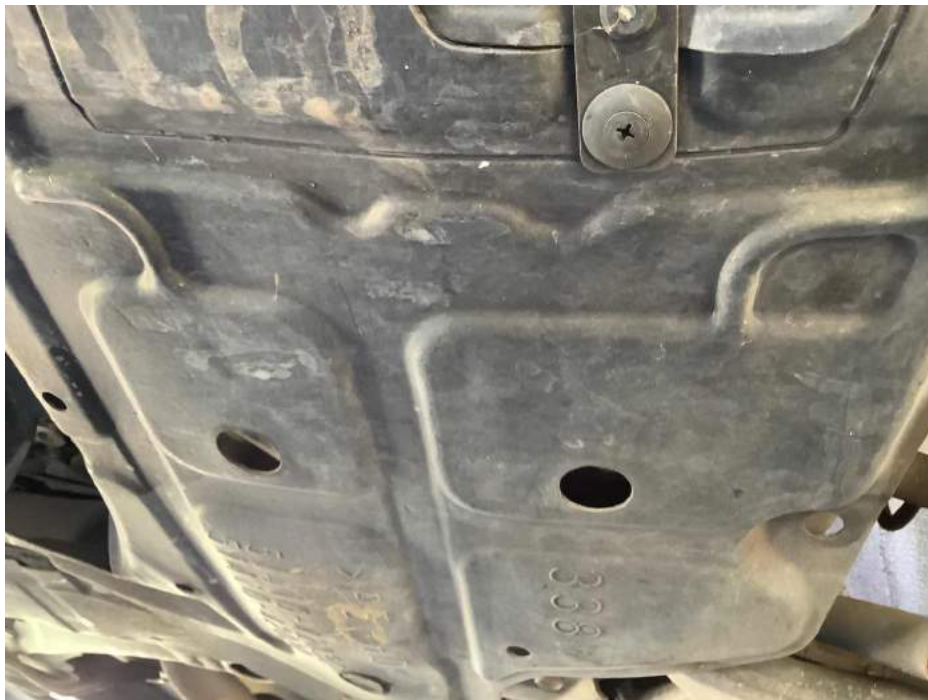
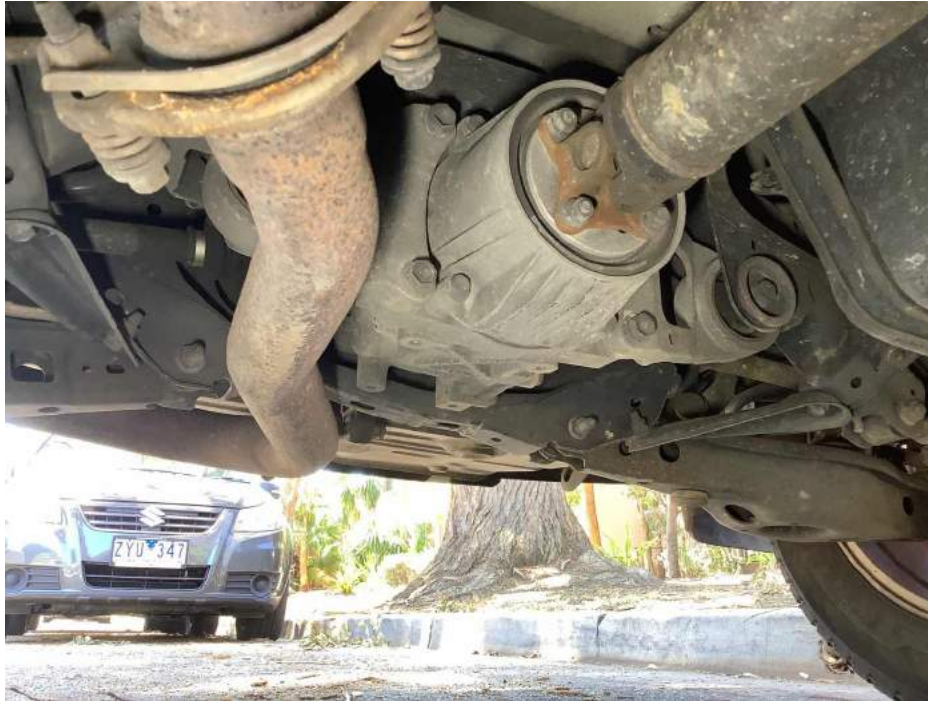
No faults or issues found with external driveline and transmission components, visually appears to be in good order at the time of inspection. This is subject to test drive outcomes. Refer to road test for transmission and driveline operation.

No oil leaks visible at underbody driveline.  
Recommend Auto transmission service-oil dirty.

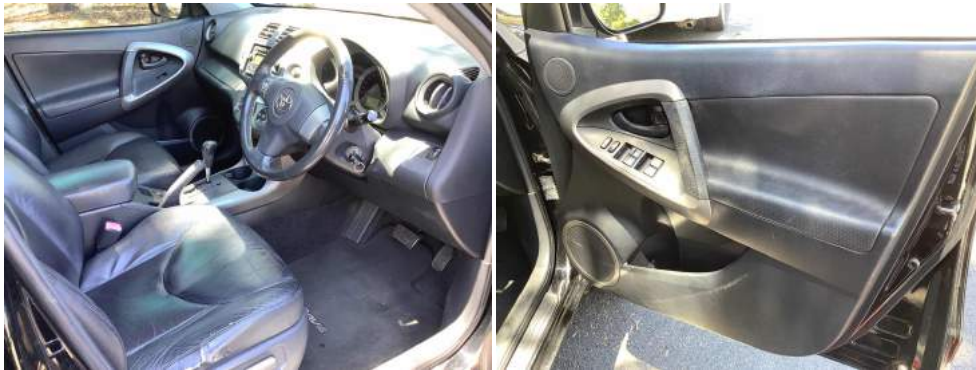
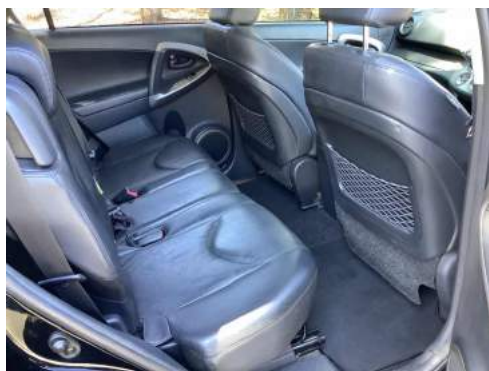
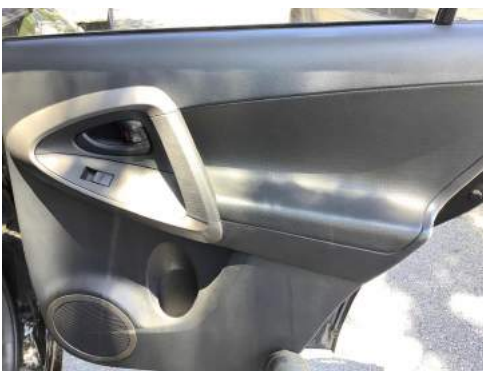
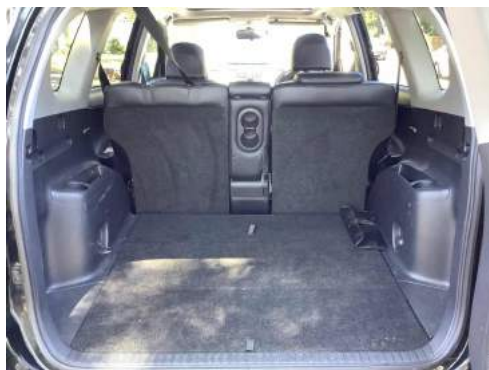
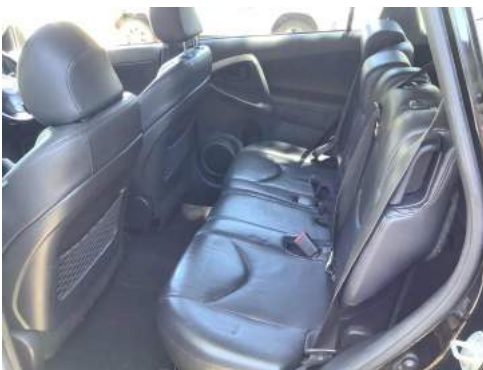
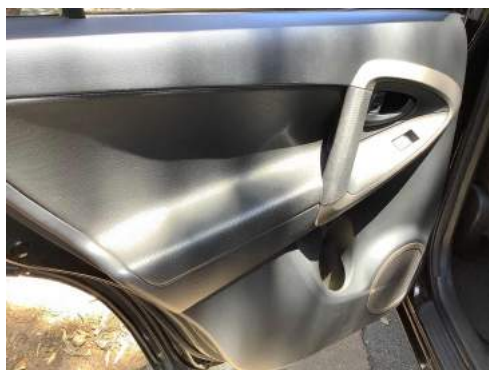
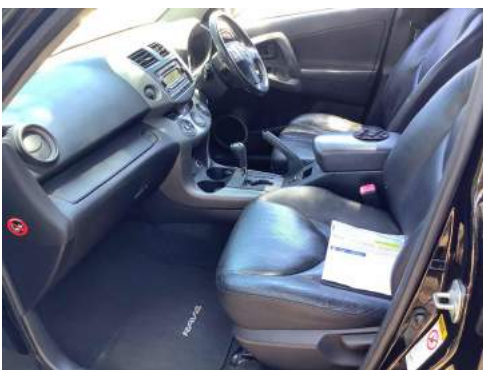
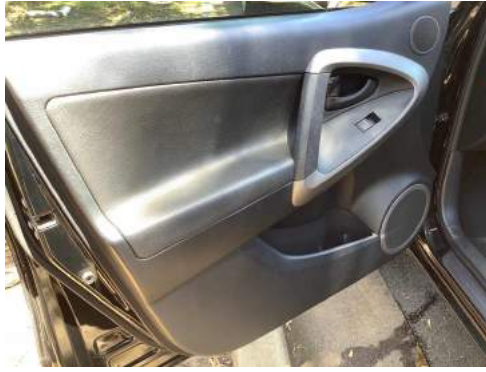
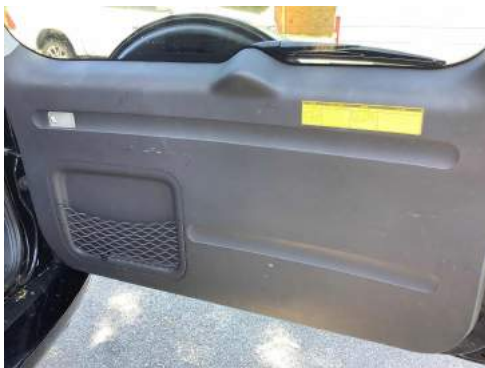
Interior trims & seats have light marks.  
 Interior trim & carpet is dirty recommend full interior detailing.  
 Rear cargo cover not fitted at this time.  
 Baby seat previous fitted-impressions to seat trim evident.  
 Head restraint missing.  
 Seat belt twisted.  
 Air vent slats damaged.

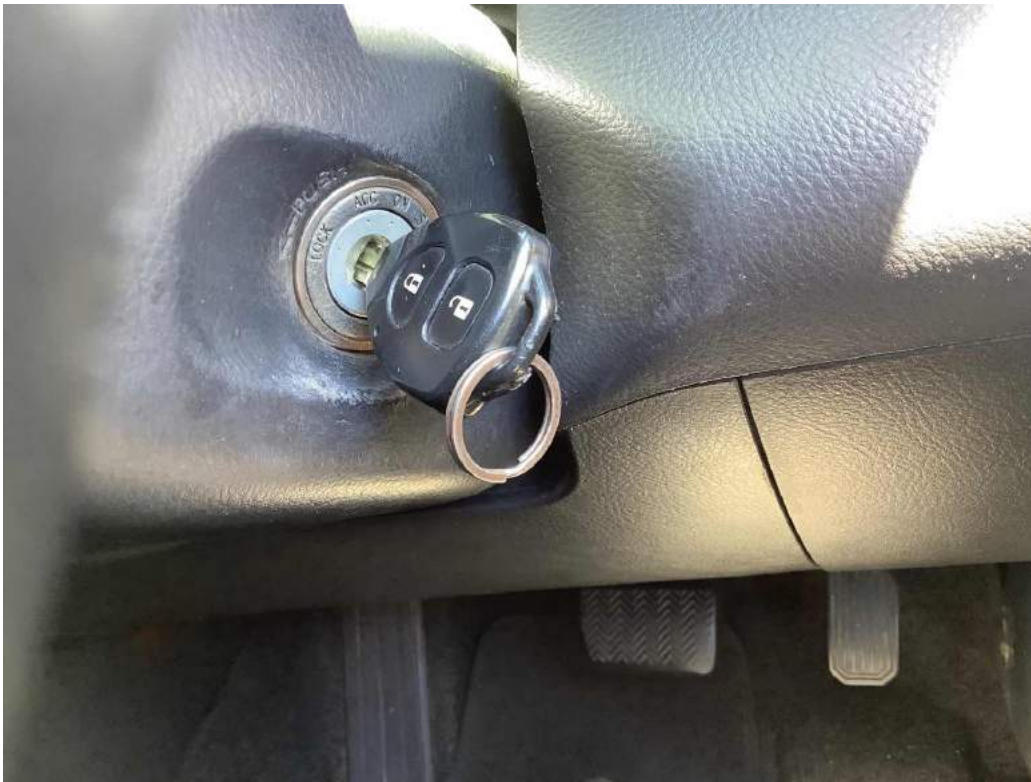
### Keys and remotes

One key sighted-suggest checking with seller for additional keys.  
Remote control inoperative-check battery/recharge x 1.

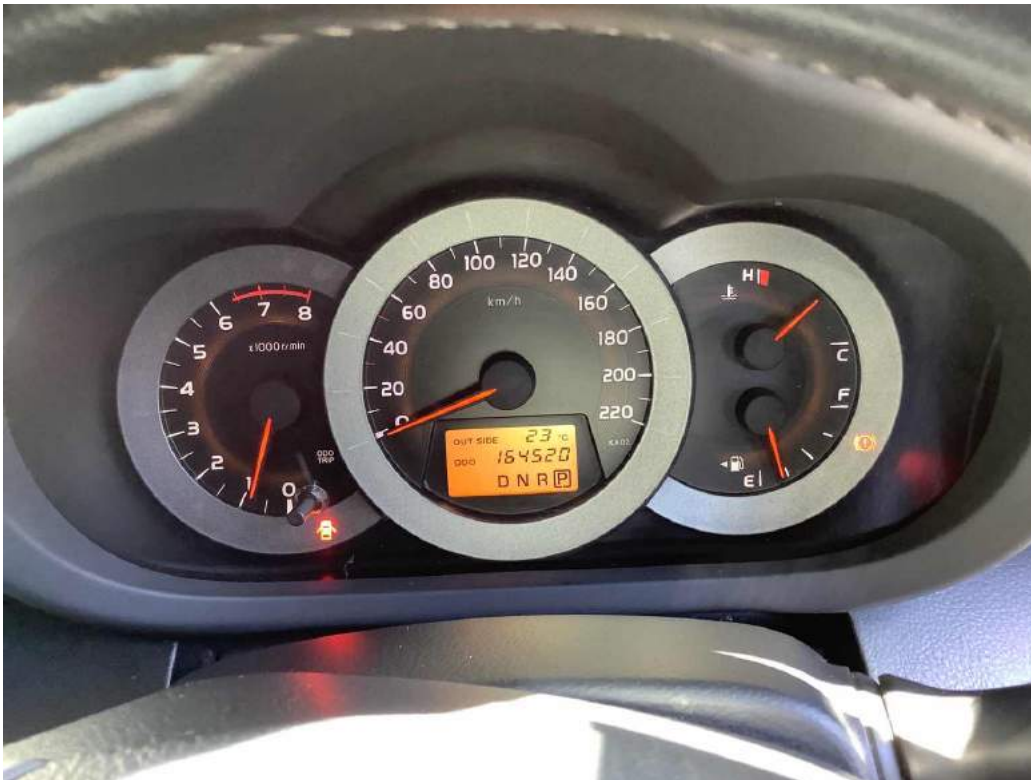
### Warning lights / Cluster

No warning lights illuminated at time of inspection.

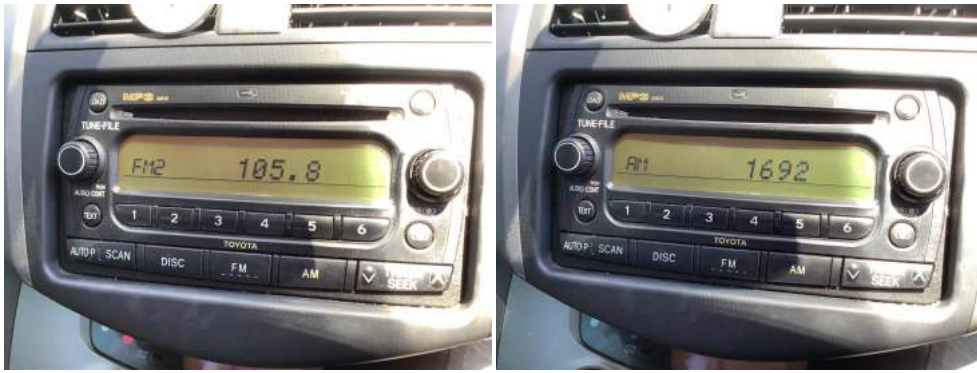
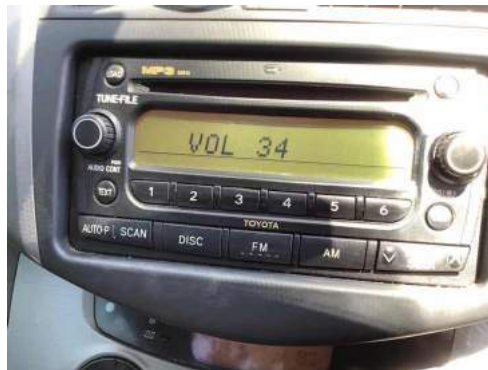
### Entertainment.

Cd player not accepting cd's

Radio display operational however no sound from head unit.

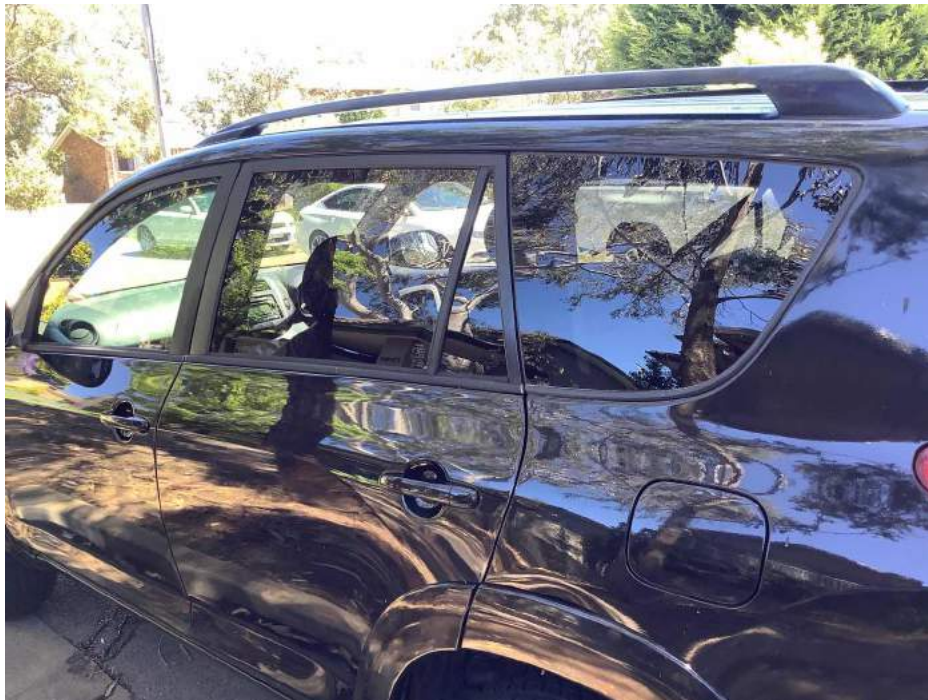
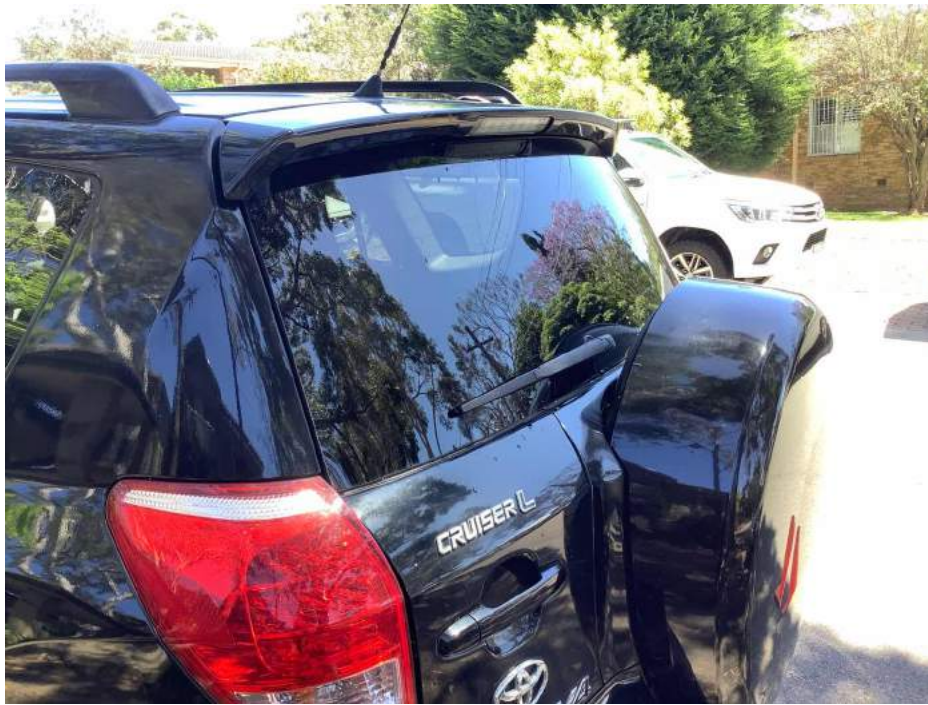
### Window tint and accessories.

Windows have been tinted.

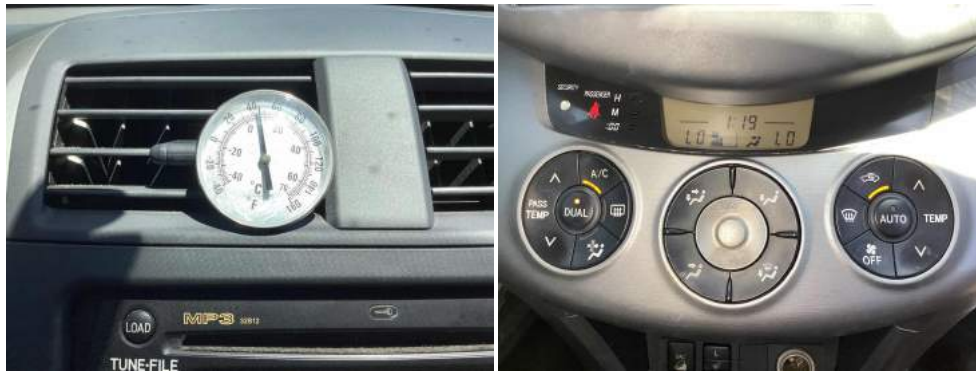
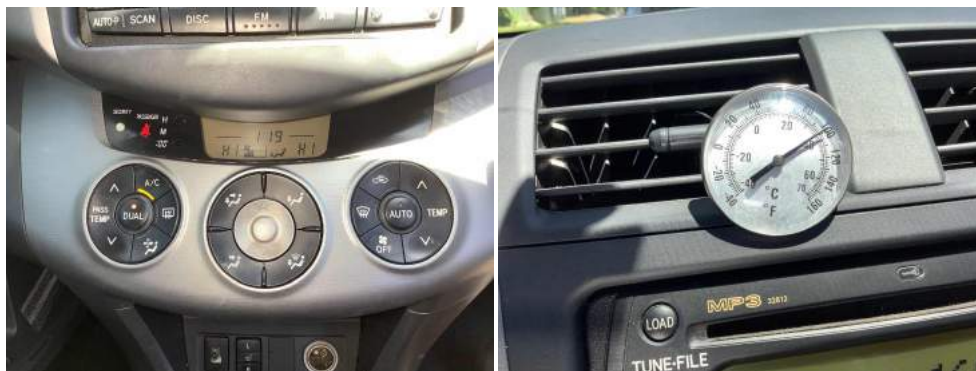
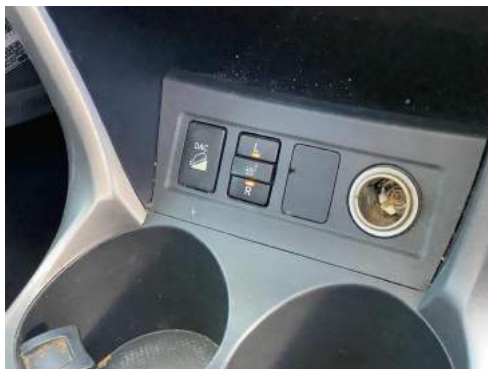
### Air conditioning

Air conditioning and heater has been tested-all operational.

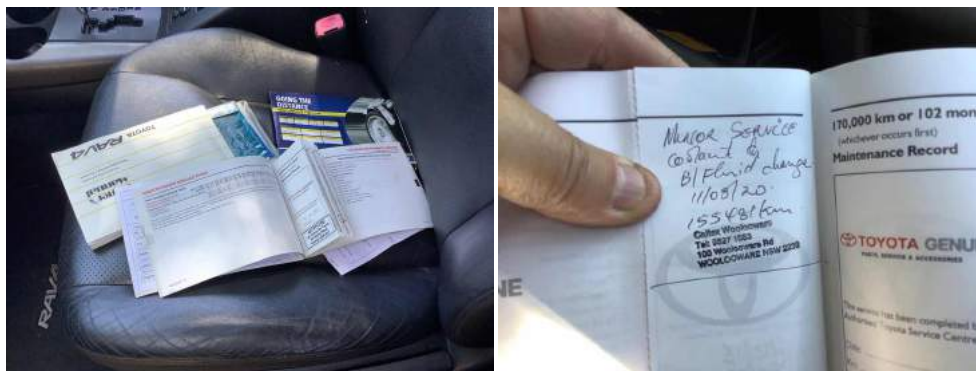
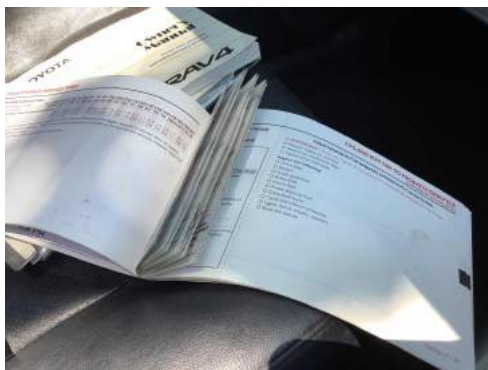
### Service records up to date

SERVICE LOG BOOKS SIGHTED AND APPEAR TO BE UP TO DATE.

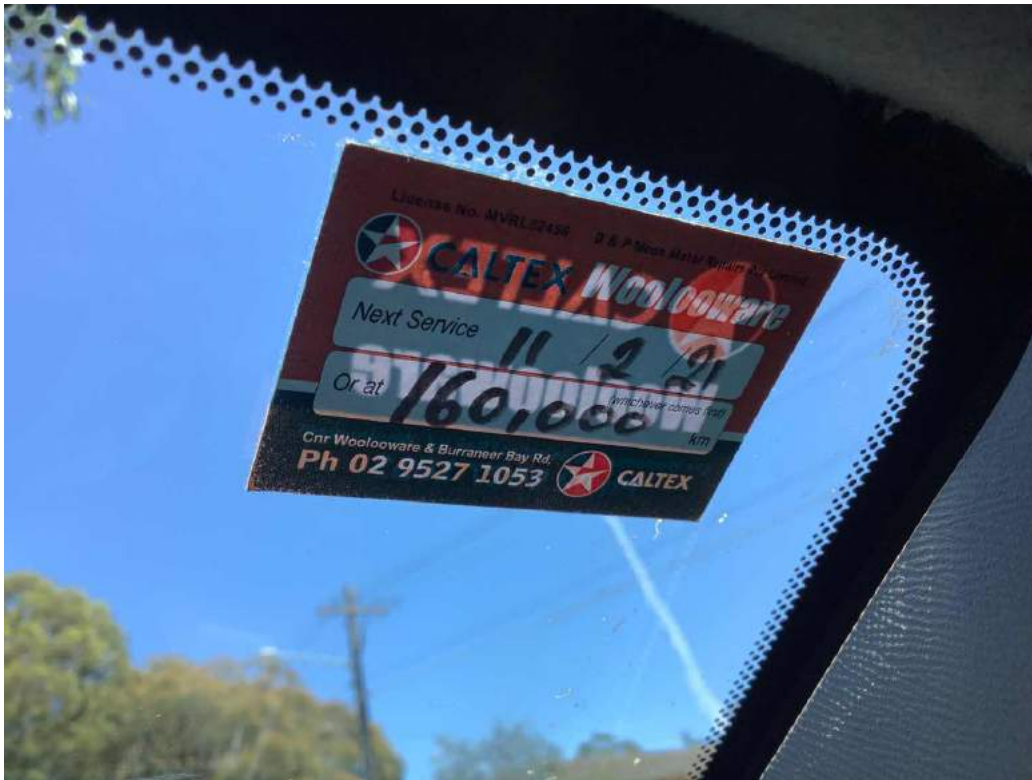
### Next Service due

Service overdue-service required.

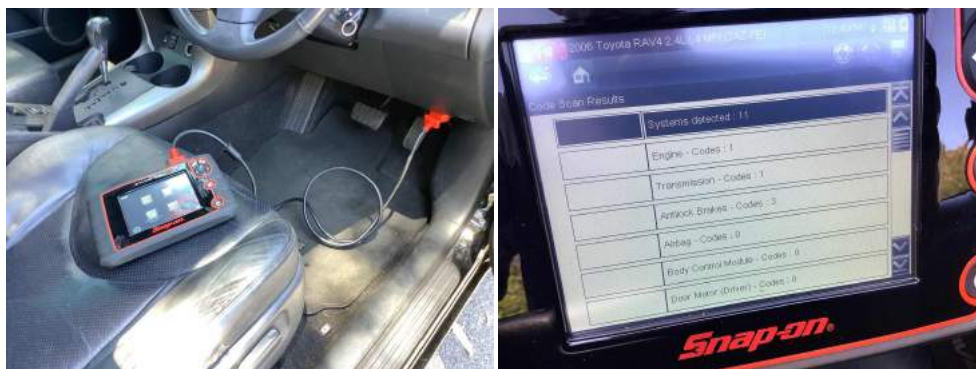
### VEHICLE MANAGEMENT SCAN

VEHICLE MANAGEMENT SYSTEM HAS BEEN SCANNED-FAULT CODES RECORDED-SUGGEST FURTHER WORKSHOP TESTING AND REPAIR AS REQUIRED.
