# Inspection Report

**MTA Pre Purchase Inspections ABN 72158123418**

Client Name	Fabiana XXXXXXXX
Client Email	fxX@gmail.com
Vehicle Make and Model	Toyota Rav 4
Variant	Cruiser
Year of Manufacture	2006
Registration Number	AXJ59N
Booking Reference	CAMXXXXP

Inspection Date:	06 Nov 2021
Inspection Time:	12:05 pm

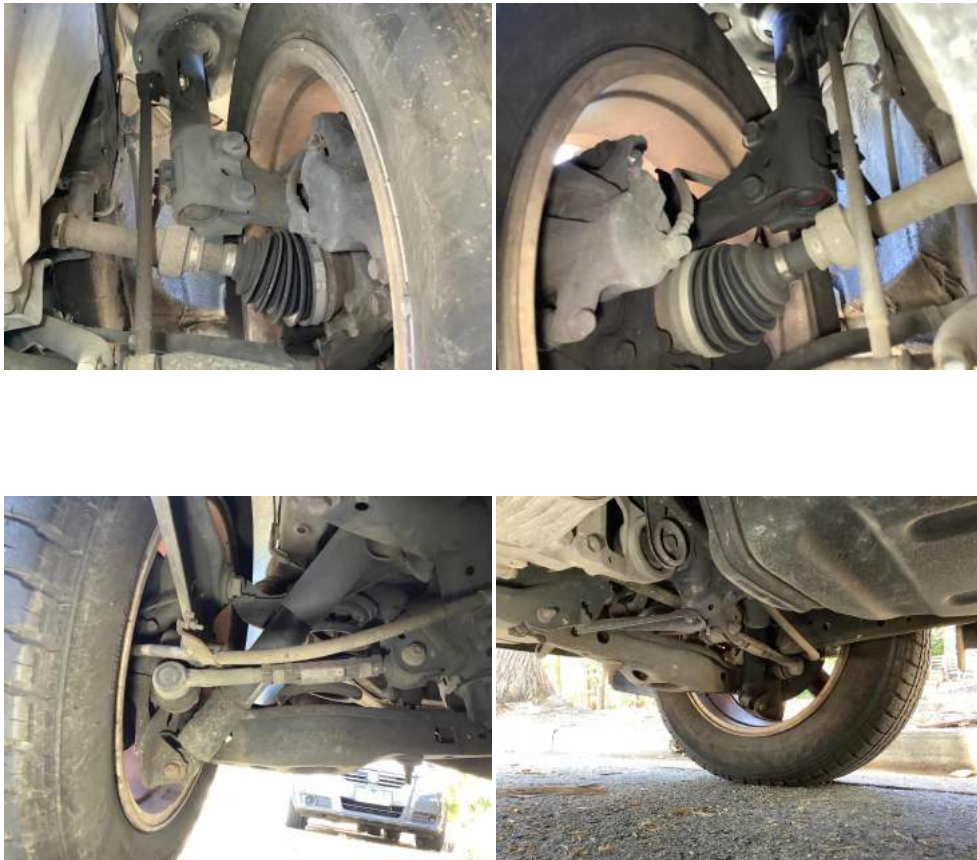
### Steering and suspension summary

Steering and Suspension components appear in POOR overall condition the following recommendations are strongly advised.

Shock absorber is leaking, replace as required-front and rear.

Shock absorber dust boot split-replace as required.

Front link pins worn-replace.

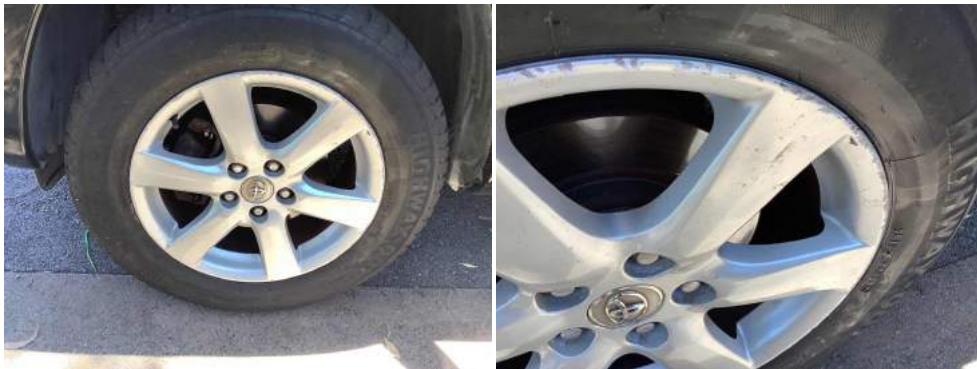
#### **Passanger front**

Approximately 90% remaining.

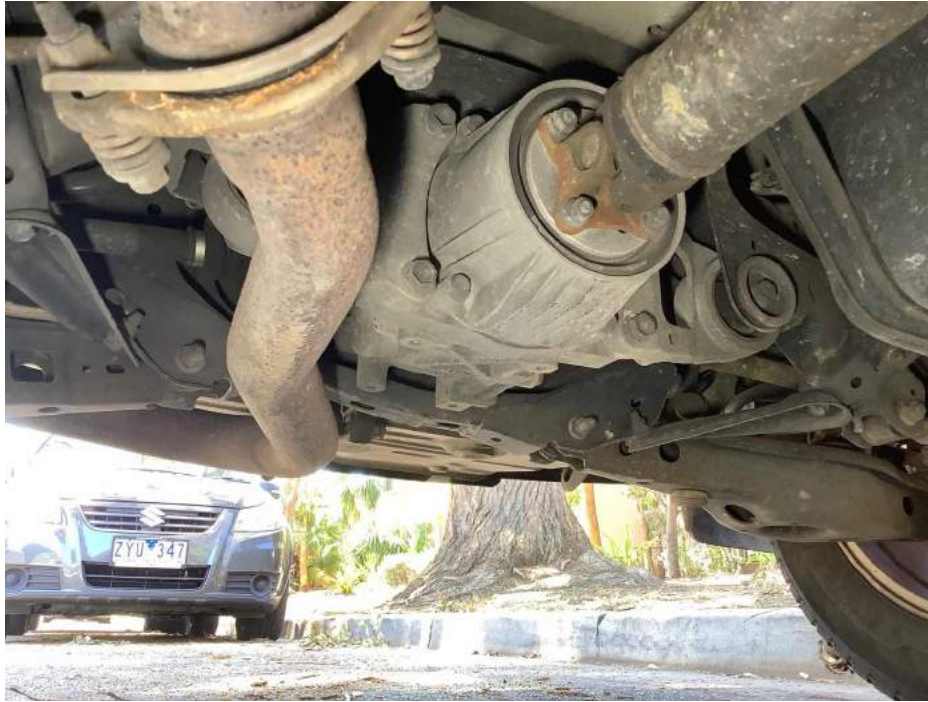
No faults or issues found with external driveline and transmission components, visually appears to be in good order at the time of inspection. This is subject to test drive outcomes. Refer to road test for transmission and driveline operation.

No oil leaks visible at underbody driveline.  
Recommend Auto transmission service-oil dirty.

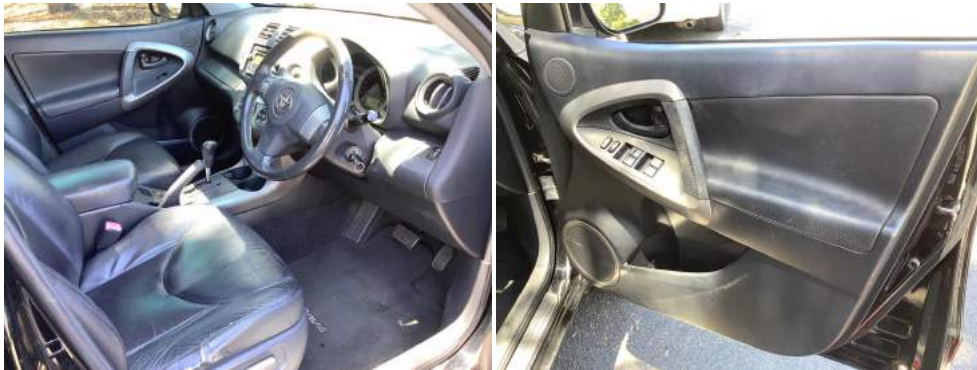
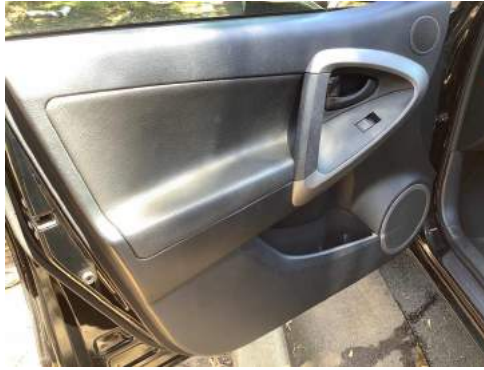
Interior trims & seats have light marks.  
 Interior trim & carpet is dirty recommend full interior detailing.  
 Rear cargo cover not fitted at this time.  
 Baby seat previous fitted-impressions to seat trim evident.  
 Head restraint missing.  
 Seat belt twisted.  
 Air vent slats damaged.

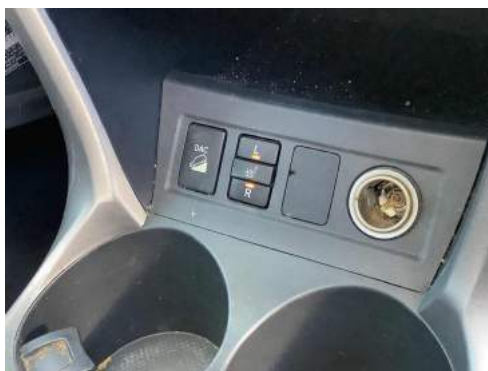
### Air conditioning

Air conditioning and heater has been tested-all operational.

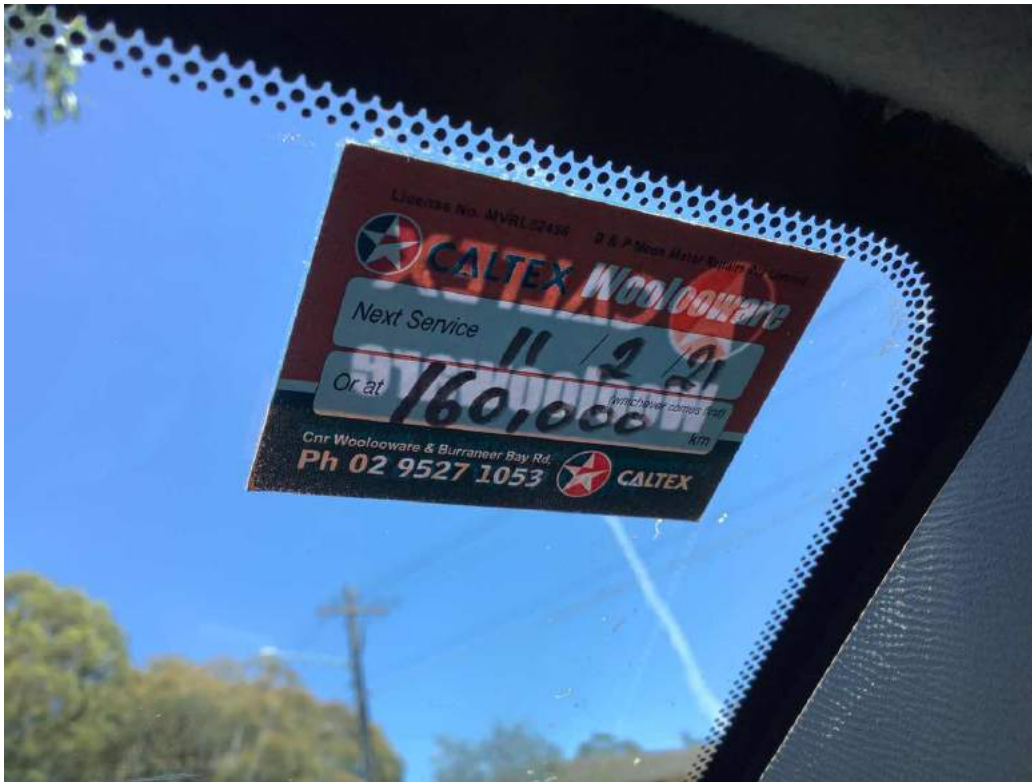
### Next Service due

Service overdue-service required.

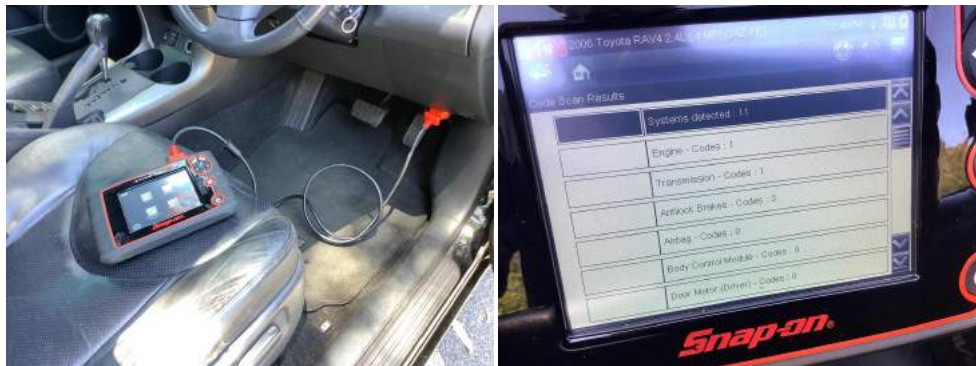
### VEHICLE MANAGEMENT SCAN

VEHICLE MANAGEMENT SYSTEM HAS BEEN SCANNED-FAULT CODES RECORDED-SUGGEST FURTHER WORKSHOP TESTING AND REPAIR AS REQUIRED.
