Inspection Report

MTA Pre Purchase Inspections ABN 72158123418

Client Name	Stewart XXXXXXX
Inspection Ordered By	Phil
Client Email	piacxxx@xxxxxxxxxxcom.au
Vehicle Make and Model	Volkswagen
Variant	Tiguan Type R
Year of Manufacture	2017
Registration Number	NBT31T
Booking Reference	CAM8xxxxD
Total Fee	\$295.00

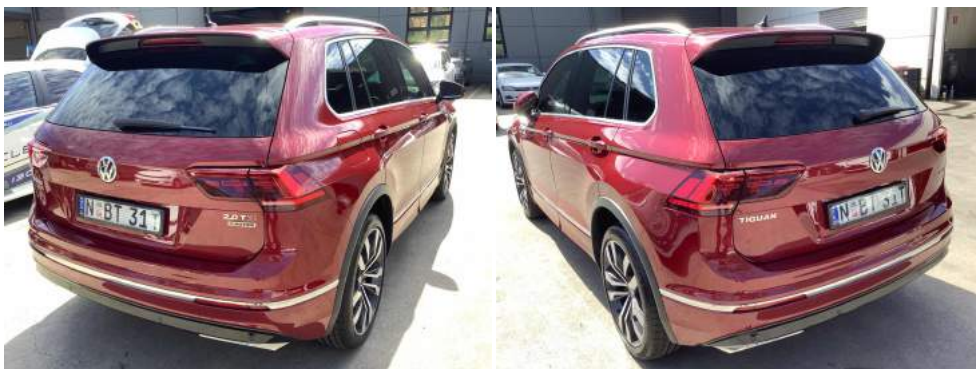
External appearance

The body panels appears to be in good order at time of inspection.

Carpark type dents, chips, scratches and marks to various panels and bumpers however external presentation is good.

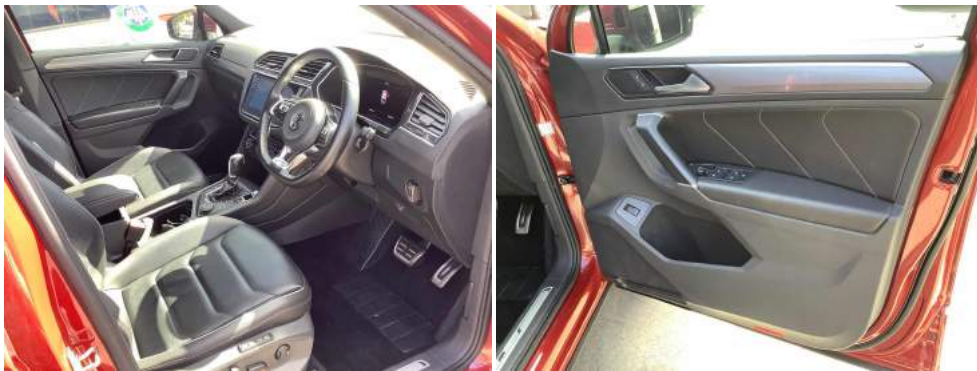
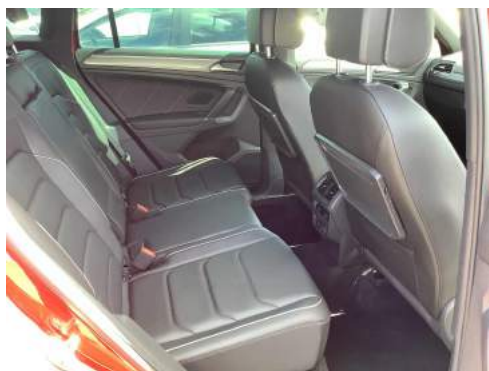
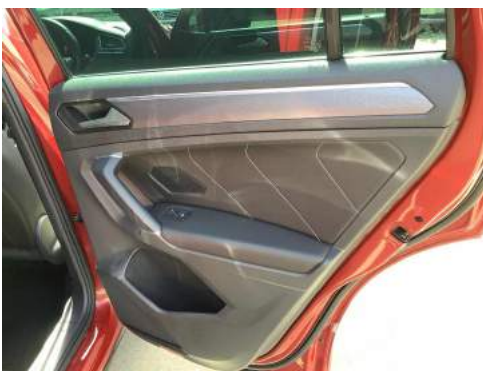
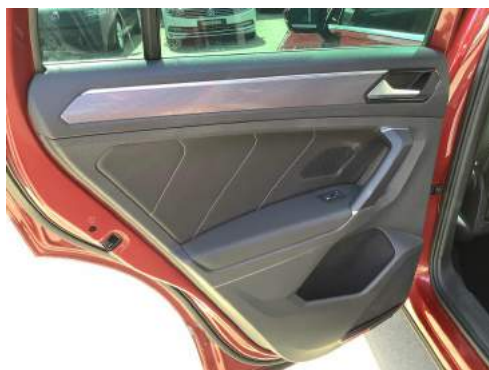
Interior summary

The interior trim and components appear to be in good order at the time of inspection.
General wear and tear to upholstery and trims mainly to contact areas.

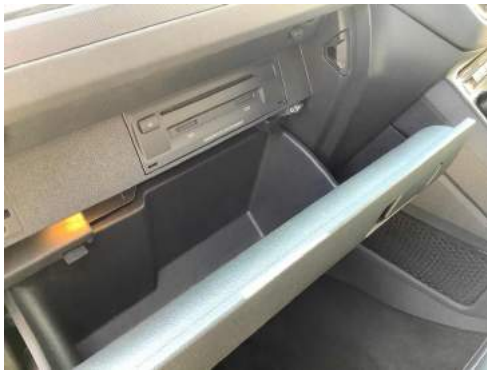
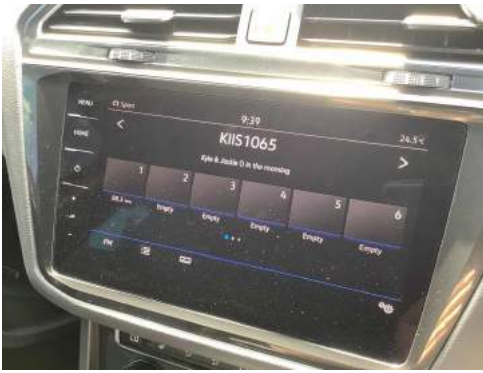
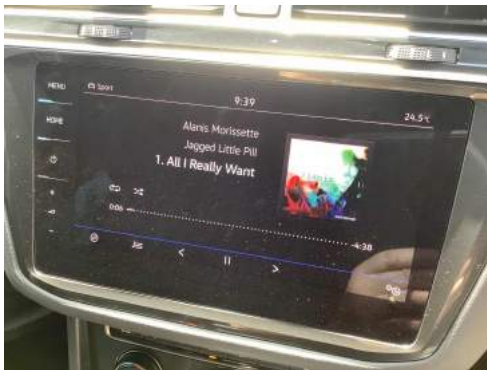
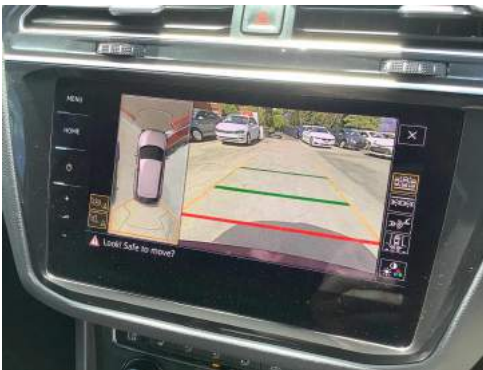
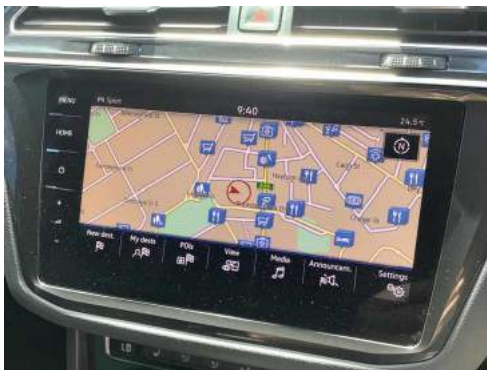
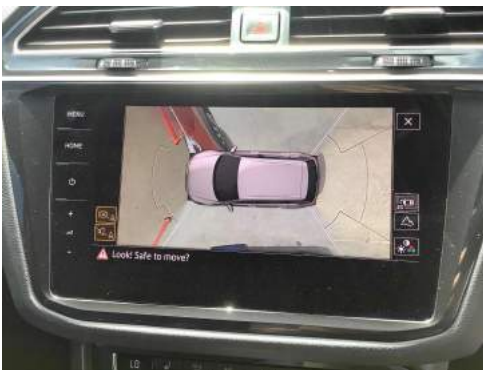
Entertainment system operational (radio and Cd player)

Bluetooth and Ipod connectivity not checked as part of this inspection.

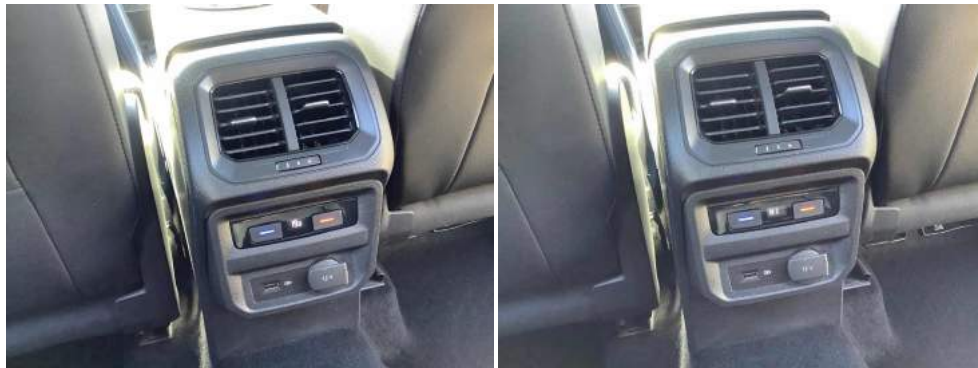
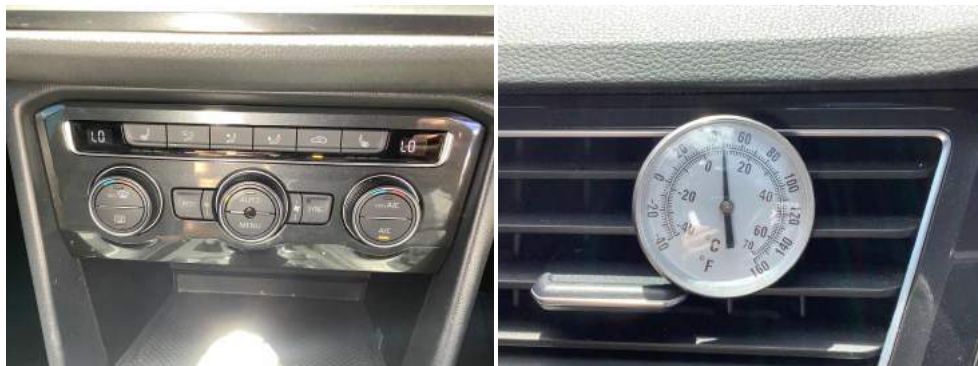
Air conditioning and heater has been tested-all operational.

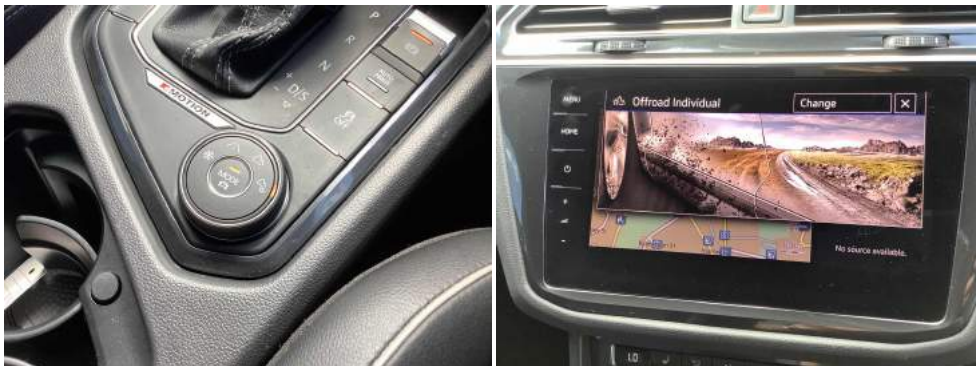
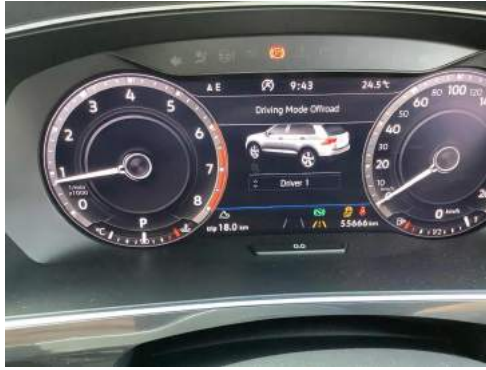
Stop start function has been tested and operates correctly.

Auto brake hold has been tested and operates correctly.
