Inspection Report

MTA Pre Purchase Inspections ABN 72158123418

Client Name	Stewart XXXXXXX
Inspection Ordered By	Phil
Client Email	piacxxx@xxxxxxxxxxcom.au
Vehicle Make and Model	Volkswagen
Variant	Tiguan Type R
Year of Manufacture	2017
Registration Number	NBT31T
Booking Reference	CAM8xxxxD

Inspection Date:	06 Nov 2021
Inspection Time:	09:30 am

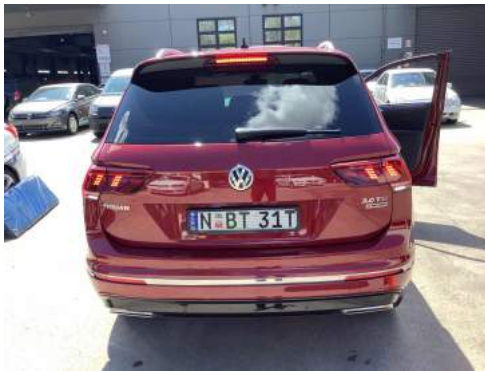
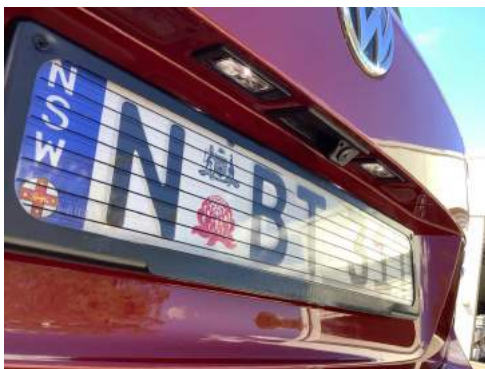
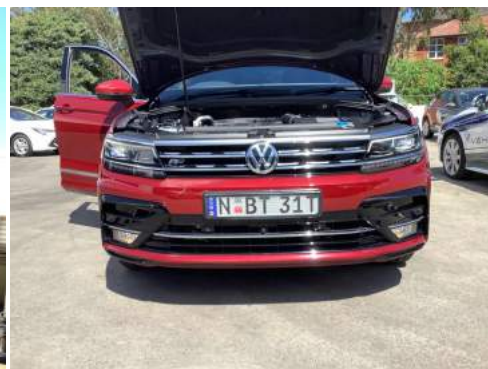
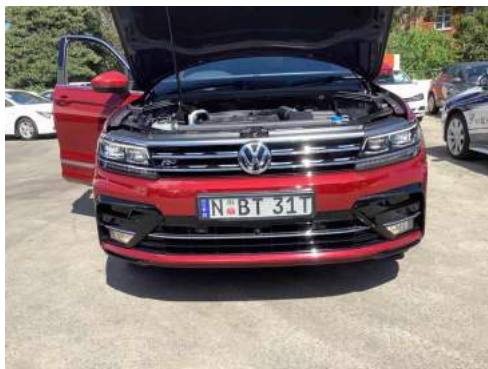
Lights and lenses

Front and rear lights have been tested-all working at time of inspection.

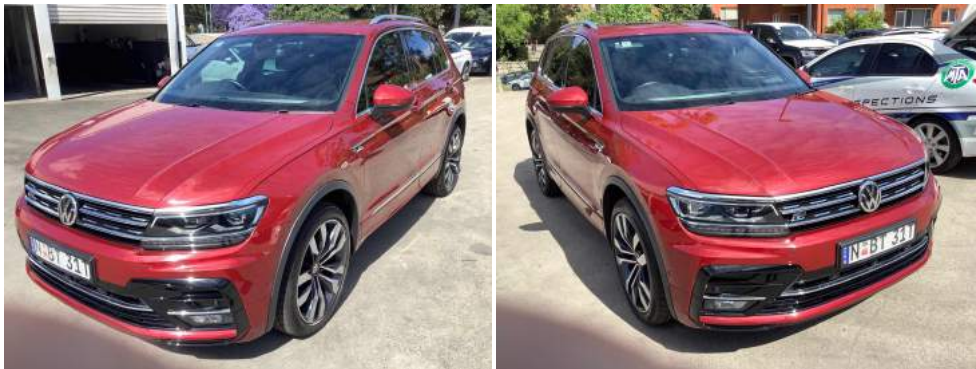
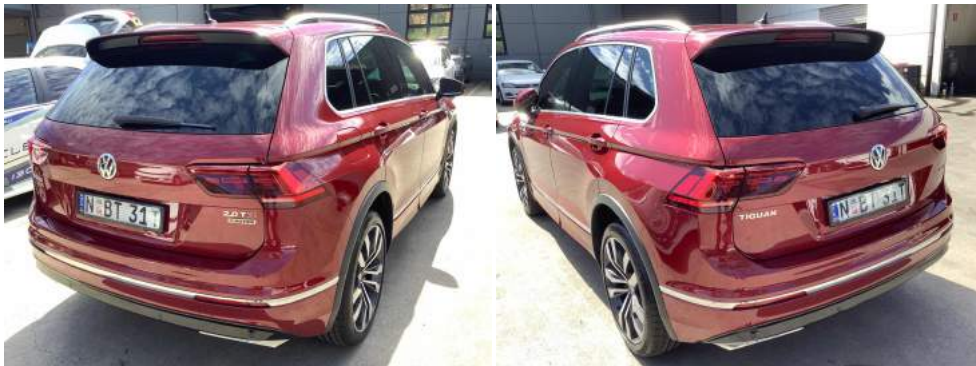
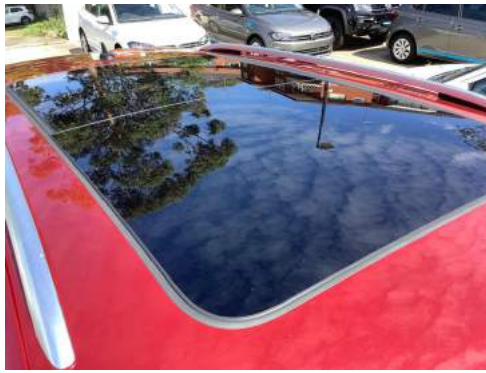
External appearance

Carpark type dents, chips, scratches and marks to various panels and bumpers however external presentation is good.

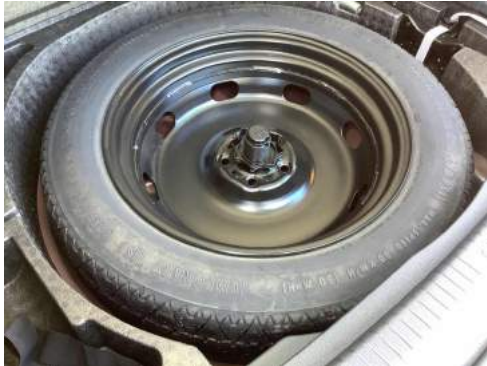
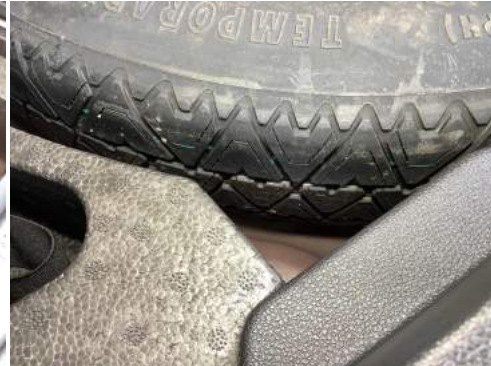
Spare

Approximately 100% remaining.
Temporary spare as standard

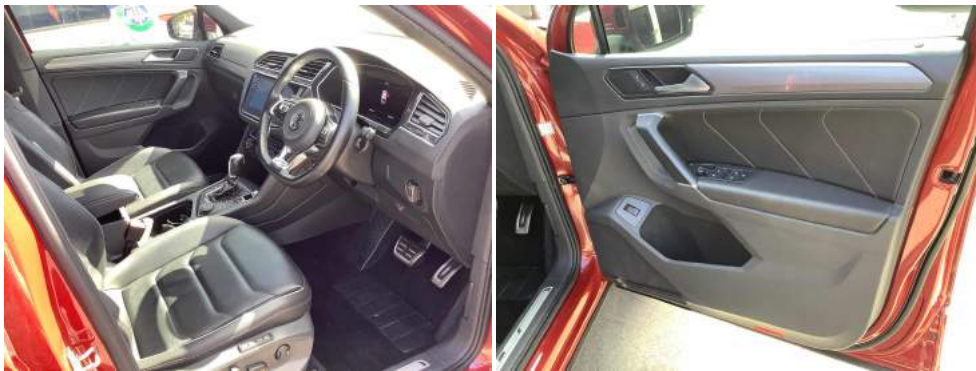
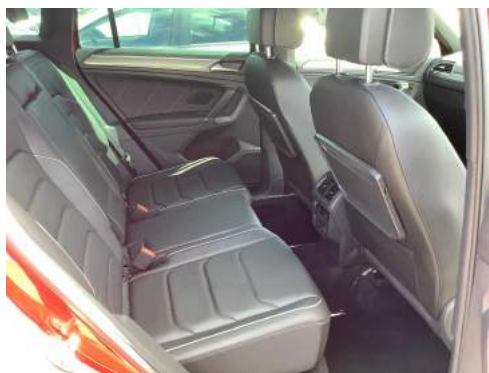
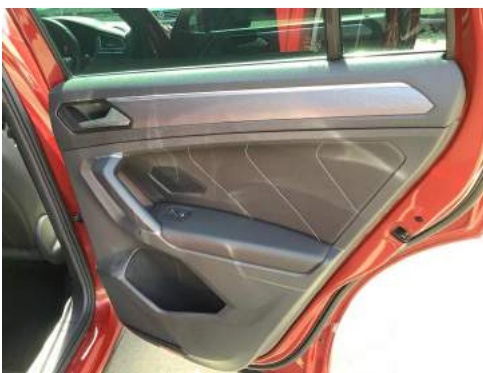
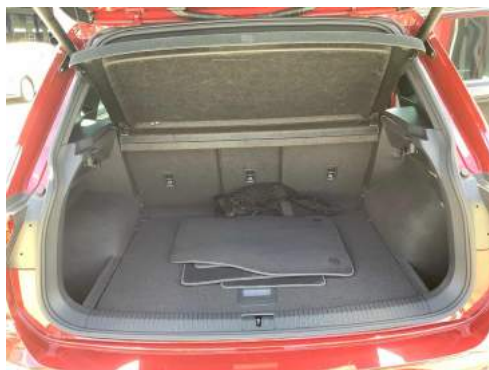
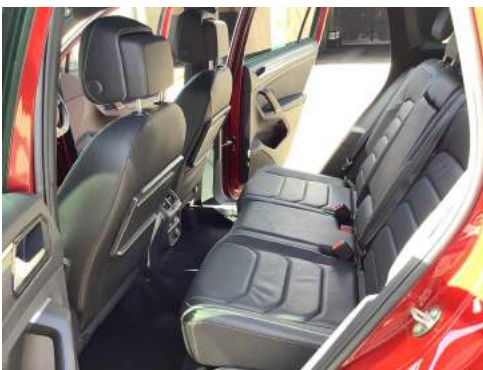
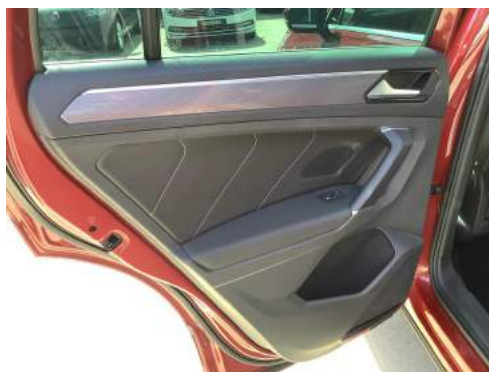
Interior summary

The interior trim and components appear to be in good order at the time of inspection.
General wear and tear to upholstery and trims mainly to contact areas.

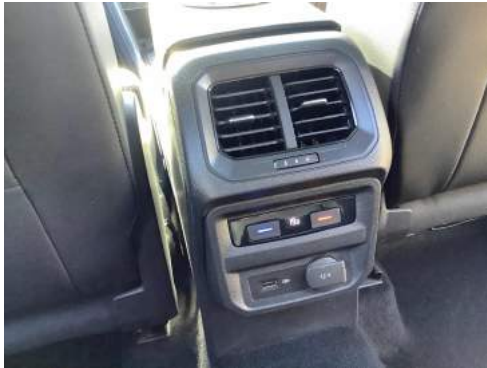
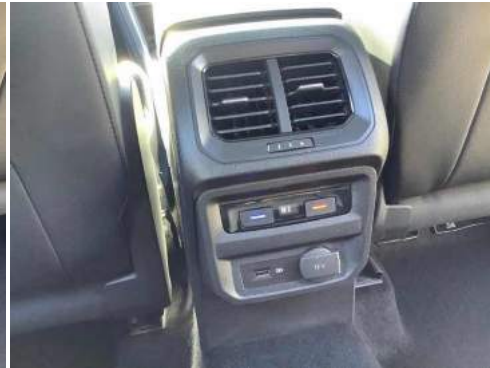
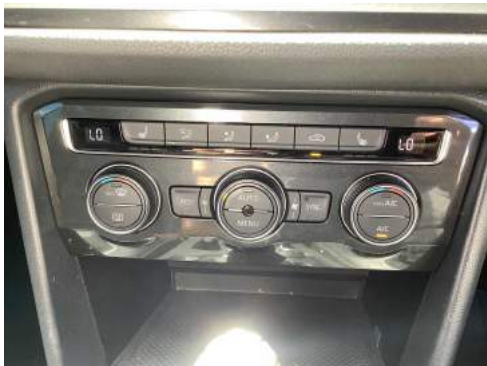
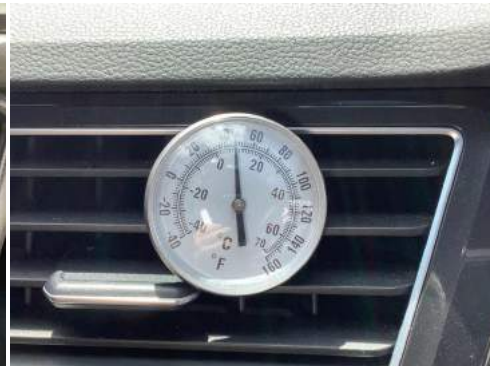
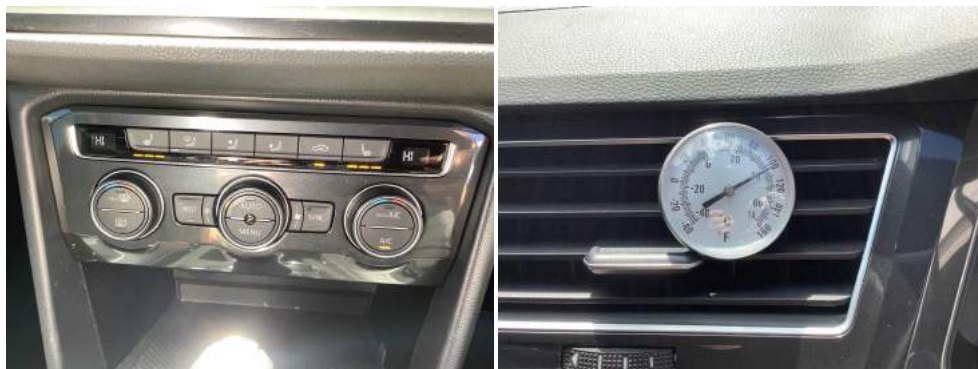
Air conditioning and heater has been tested-all operational.

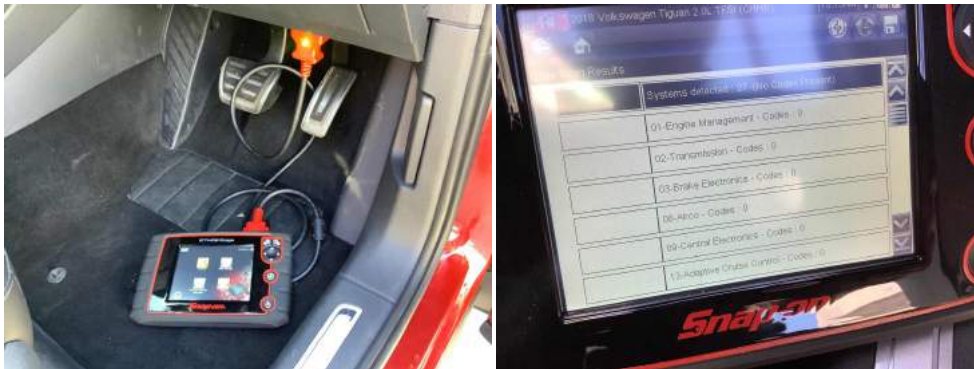
VEHICLE MANAGEMENT SCAN

VEHICLE MANAGEMENT SYSTEM HAS BEEN SCANNED-NO FAULT CODES RECORDED-ALL OK.
