Inspection Report

MTA Pre Purchase Inspections ABN 72158123418

Client Name	Stewart XXXXXXXX
Inspection Ordered By	Phil
Client Email	piacxxx@xxxxxx.com.au
Vehicle Make and Model	Volkswagen Tiguan Type R
Year of Manufacture	2017
Registration Number	NBT31T
Booking Reference	CAM8xxxxD

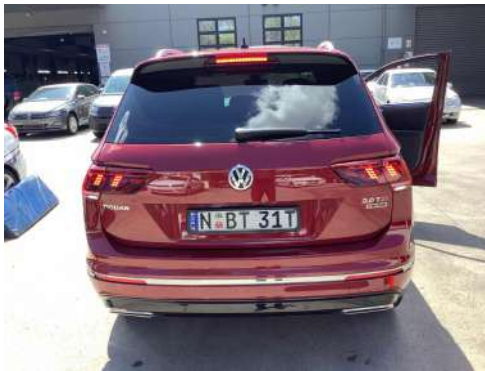
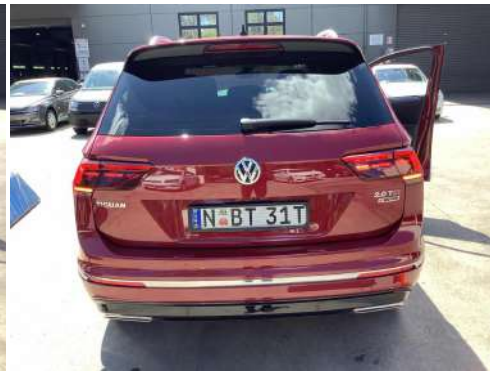
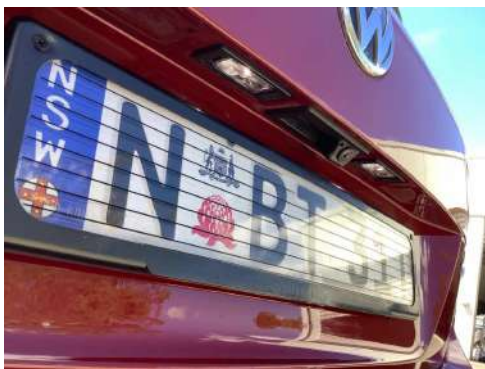
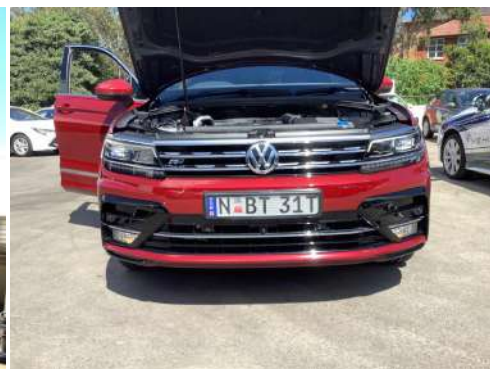
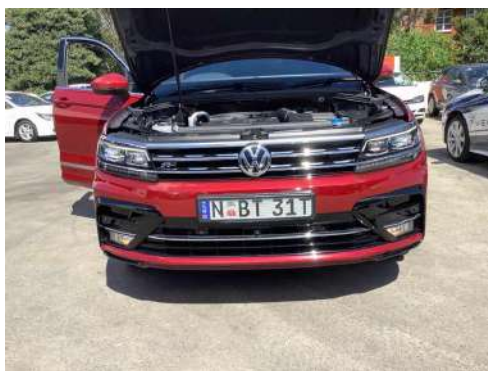
Lights and lenses

Front and rear lights have been tested-all working at time of inspection.

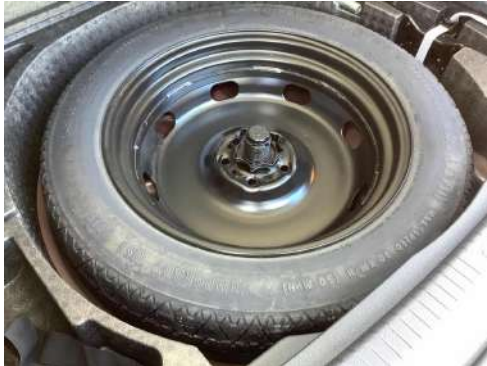
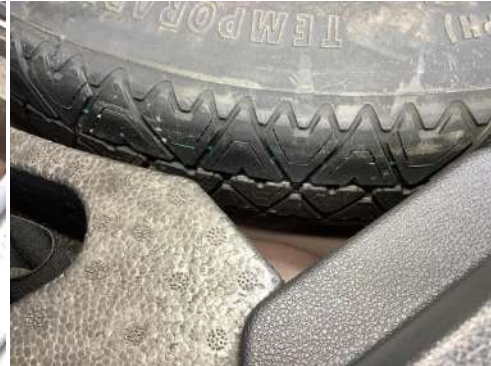
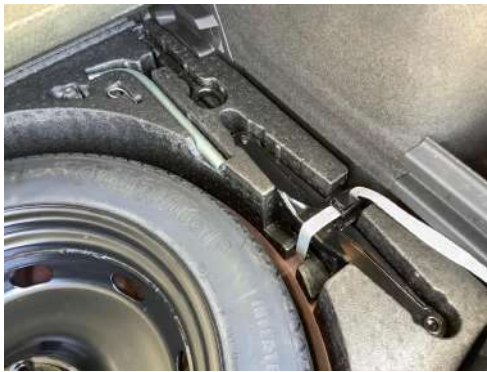
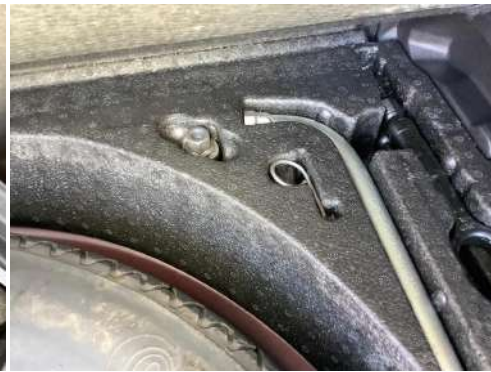
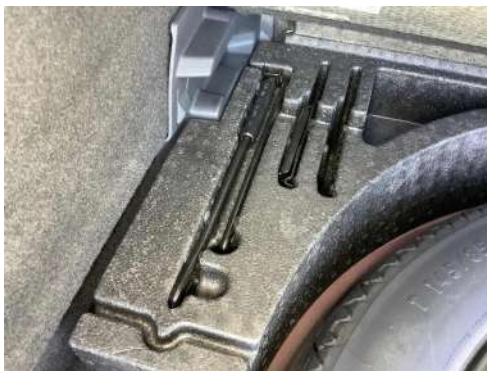
Spare

Approximately 100% remaining.
Temporary spare as standard

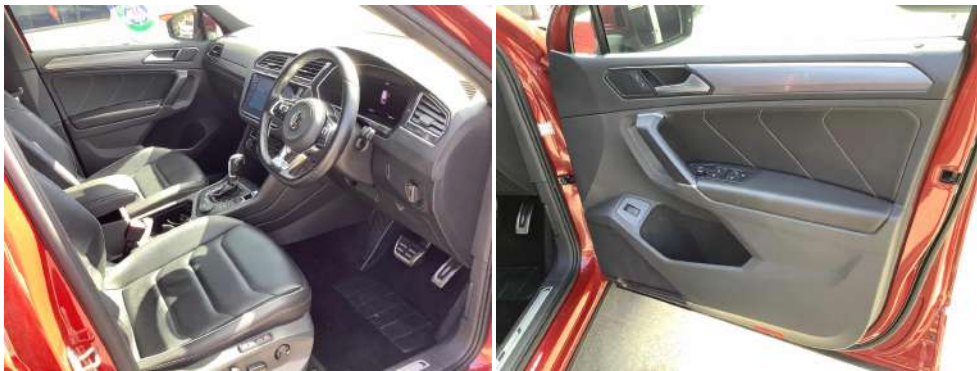
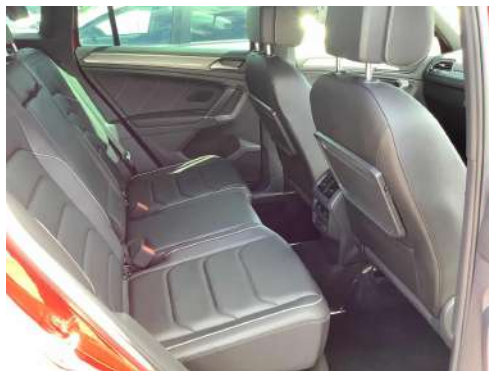
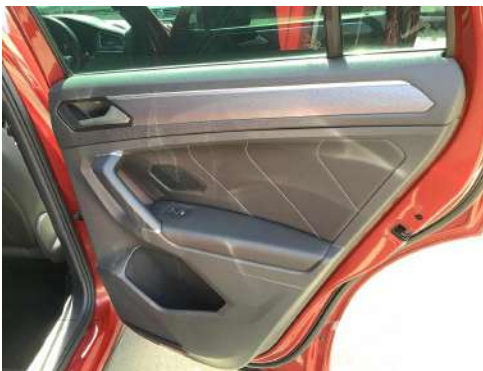
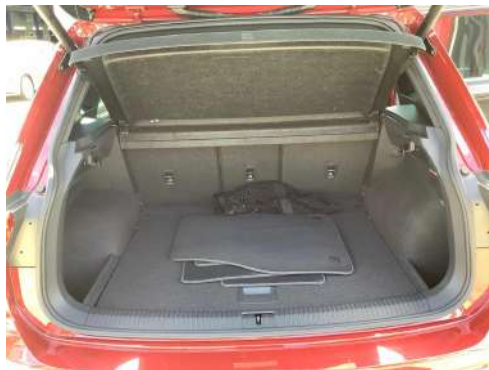
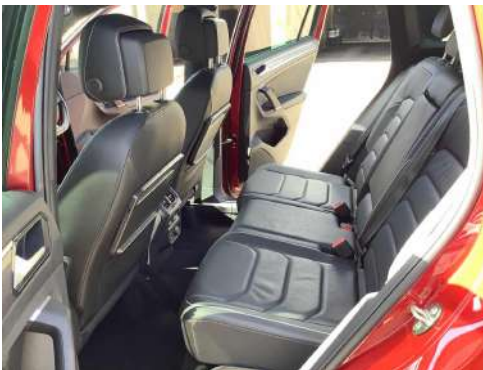
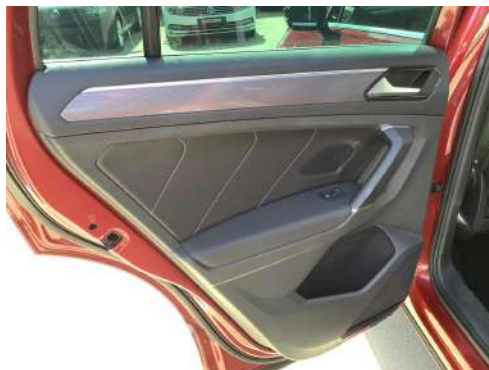
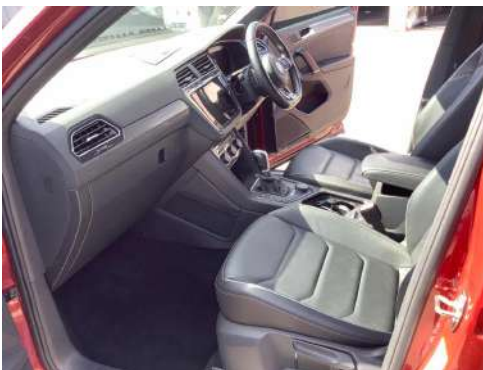
Interior summary

The interior trim and components appear to be in good order at the time of inspection.
General wear and tear to upholstery and trims mainly to contact areas.

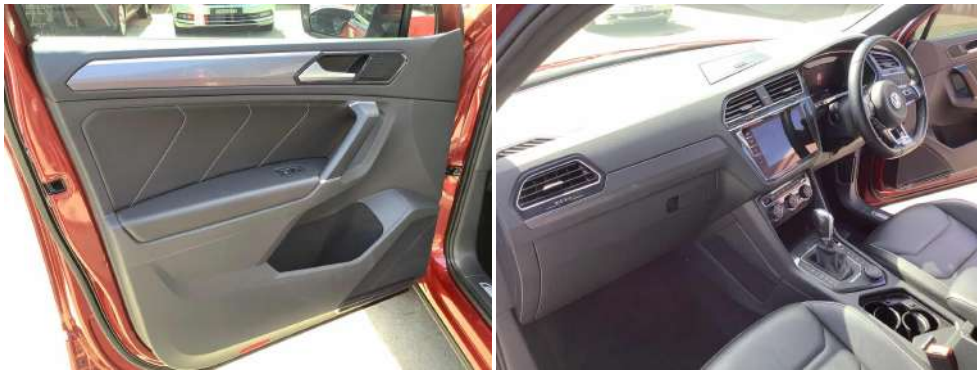
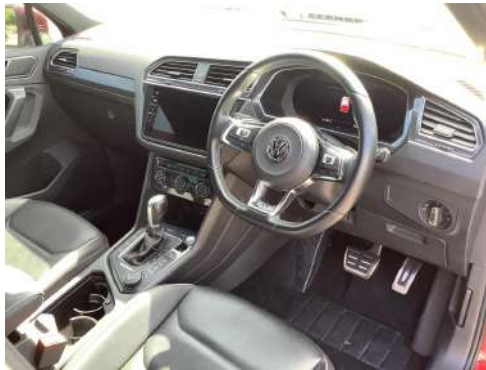
Interior comments (General)

All power options tested and operating correctly.

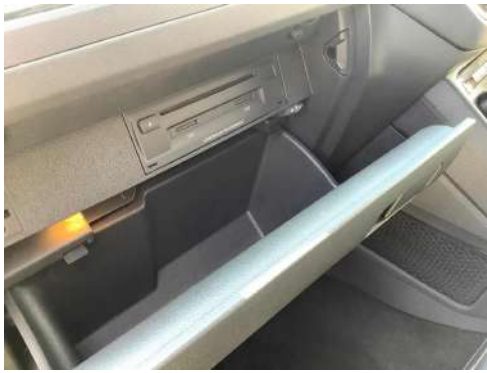
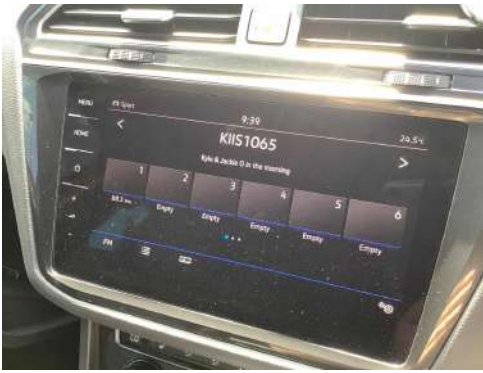
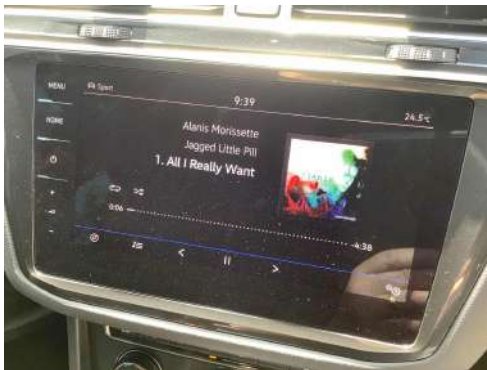
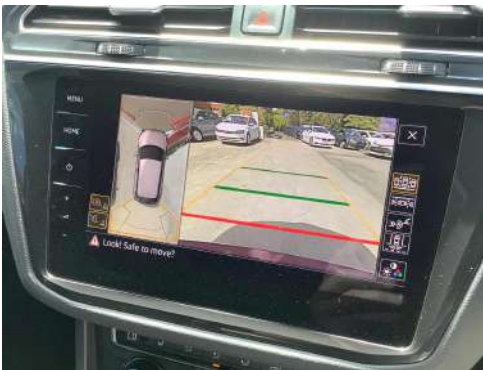
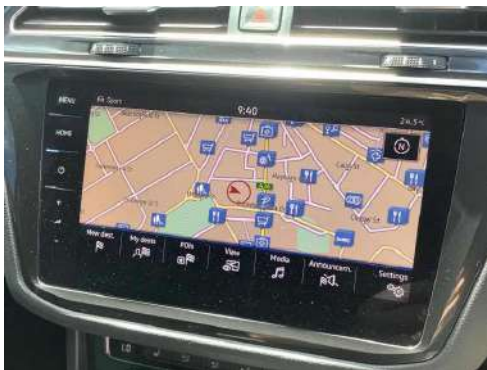
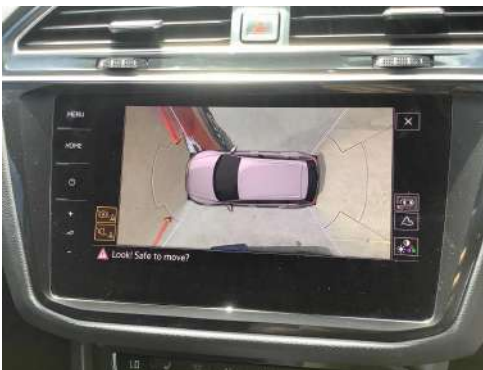
Entertainment system operational (radio and Cd player)

Bluetooth and Ipod connectivity not checked as part of this inspection.

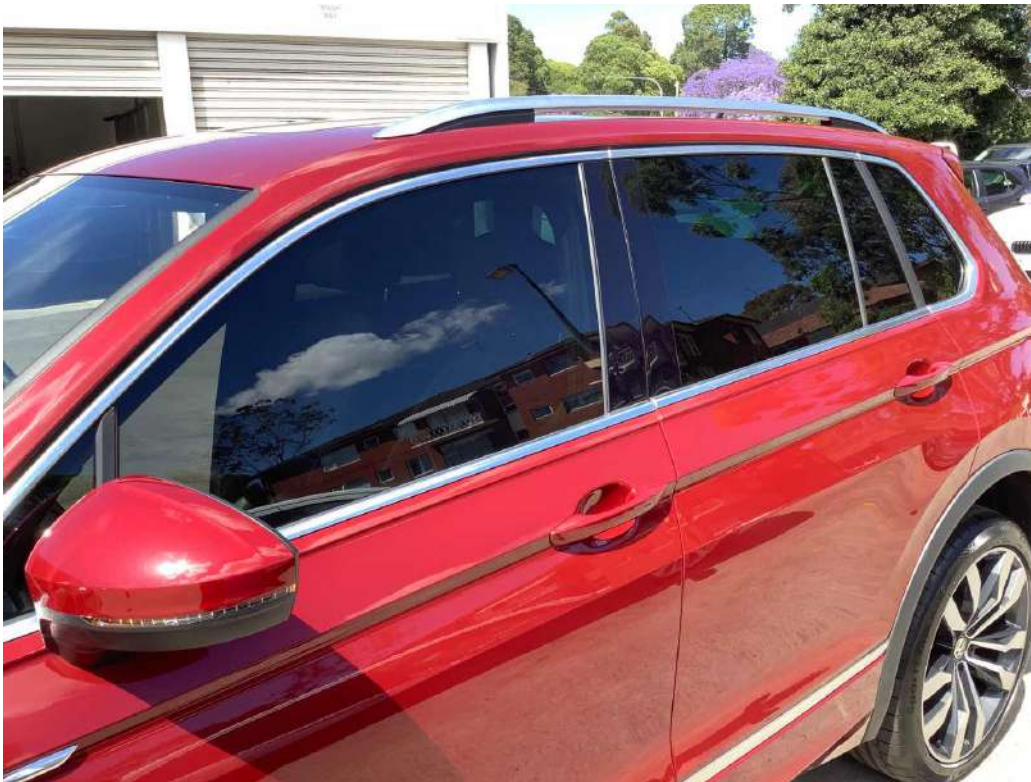
Window tint and accessories.

Windows have been tinted.

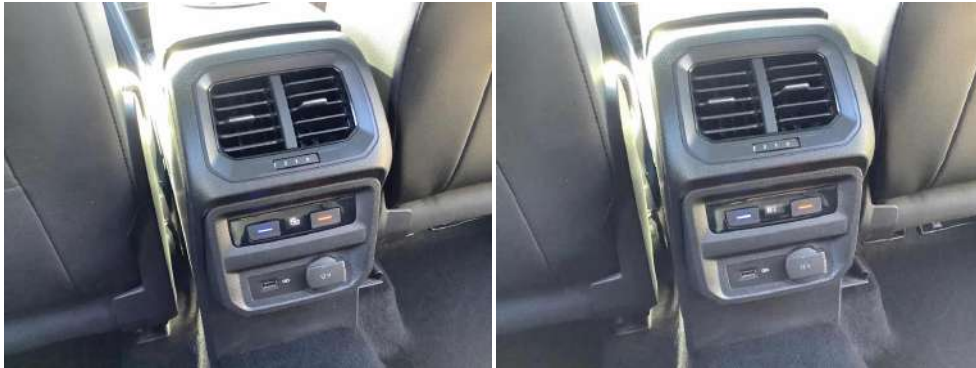
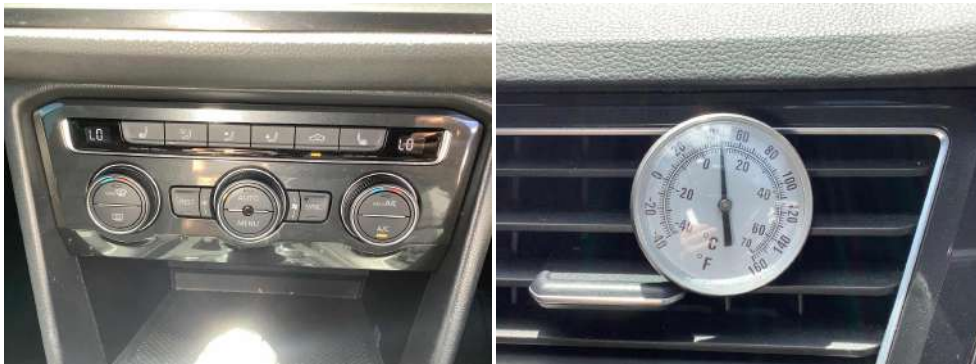
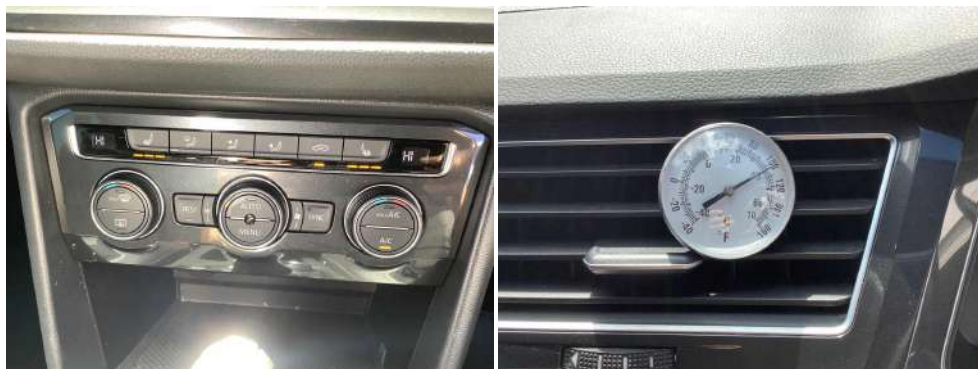
Air conditioning and heater has been tested-all operational.

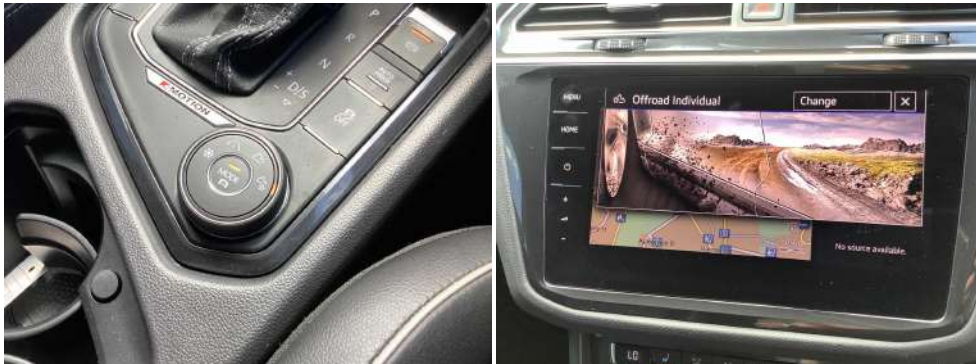
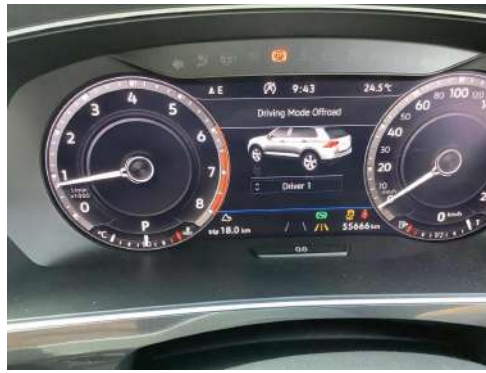
Stop start function has been tested and operates correctly.

Auto brake hold has been tested and operates correctly.

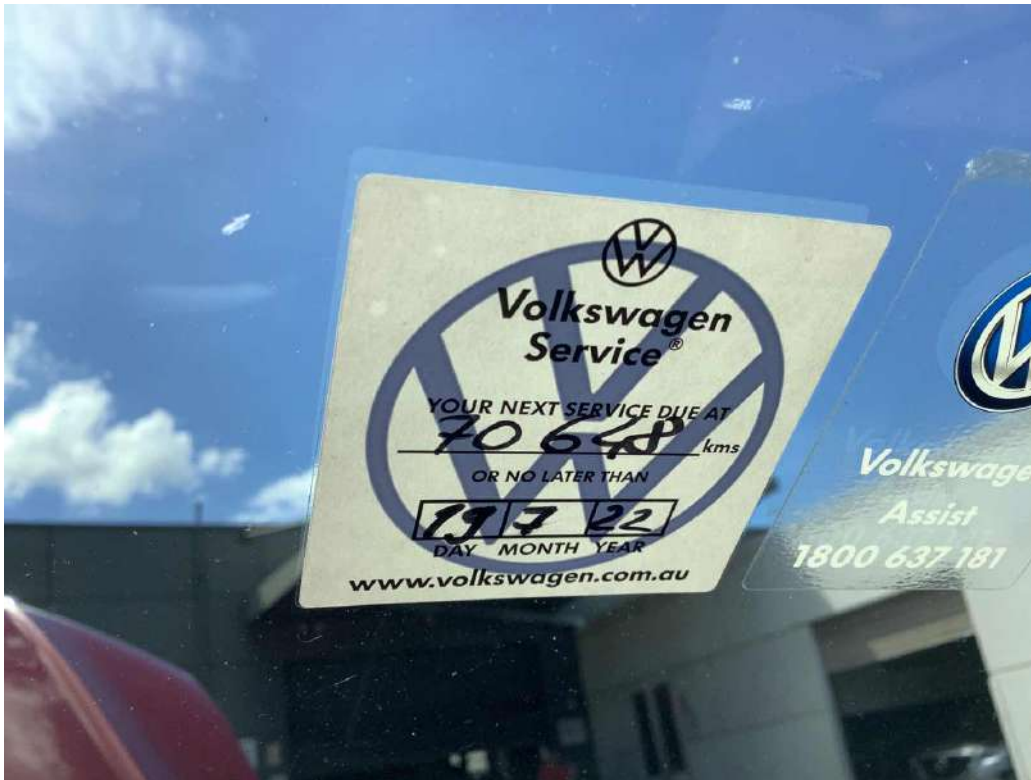
Next Service due

Suggest service as per service sticker.

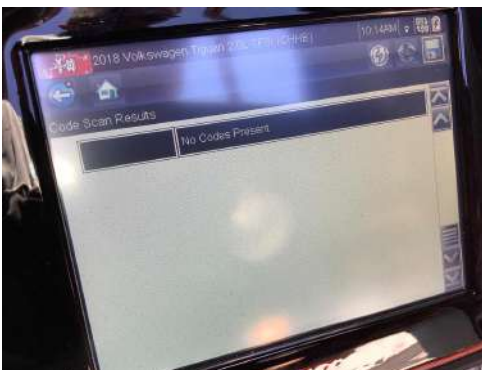
VEHICLE MANAGEMENT SCAN

VEHICLE MANAGEMENT SYSTEM HAS BEEN SCANNED-NO FAULT CODES RECORDED-ALL OK.
