Inspection Report

MTA Vehicle Inspections (ABN 72158123418)

Client Name	
Client Email	
Vehicle Make and Model	Volkswagen Tiguan
Variant	R-Line
Year of Manufacture	2020
Registration Number	
Booking Reference	CAM6XXXD

Inspection Date:	31 Oct 2024
Inspection Time:	08:10 am

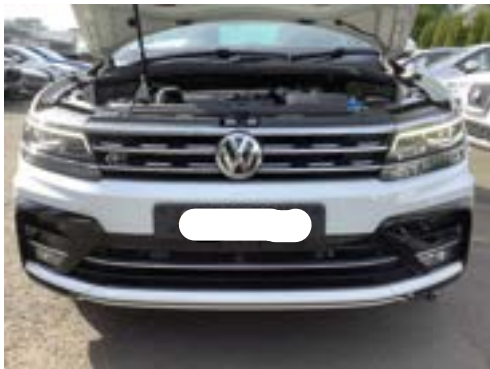
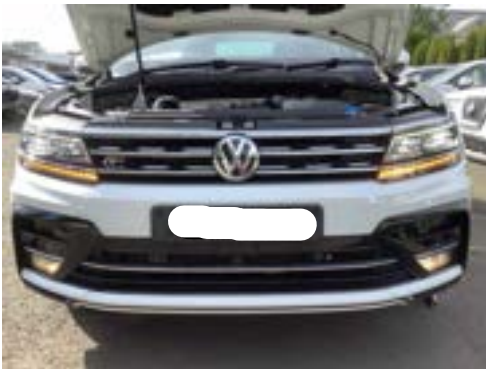
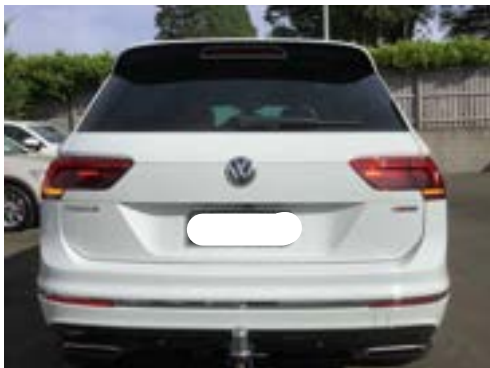
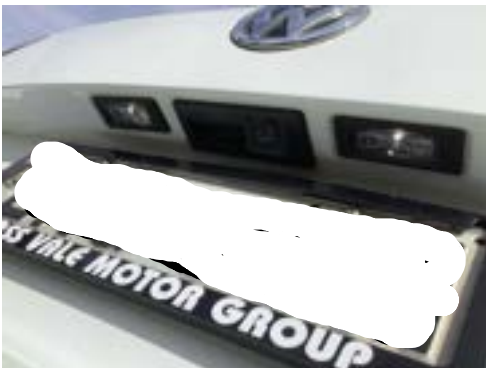
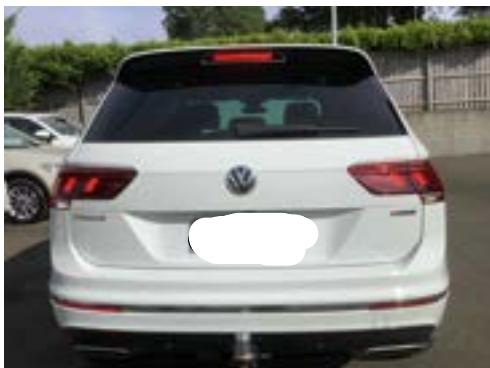
Lights and lenses

Front and rear lights have been tested-all working at time of inspection.

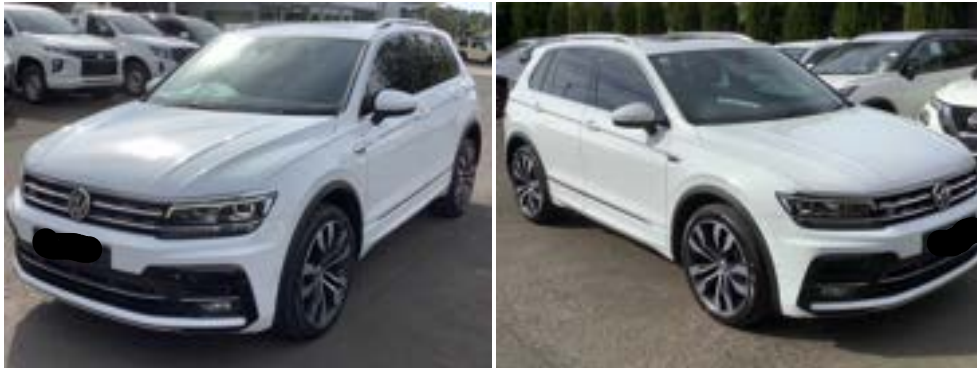
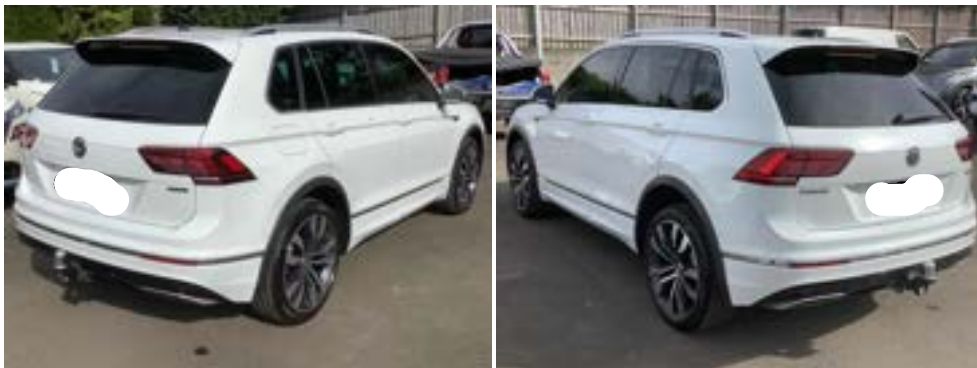
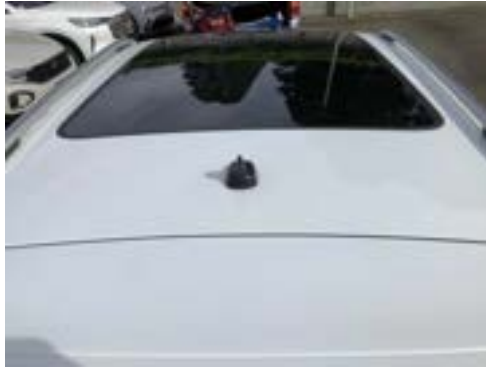
Body summary.

Paint thickness has been measured using paint thickness gauge. Overall paint thickness is consistent with factory original thickness.

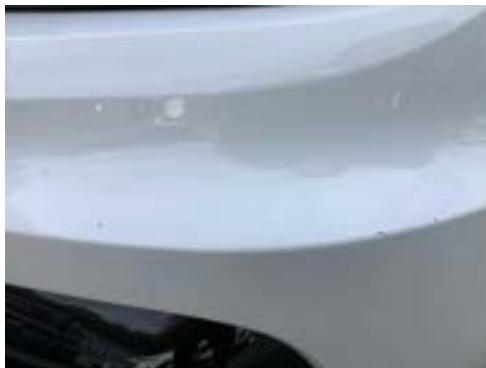
External appearance

Carpark type dents, chips, scratches and marks to various panels and bumpers however external presentation is good.

Stone chips to paint work on frontal panels/Bumper.

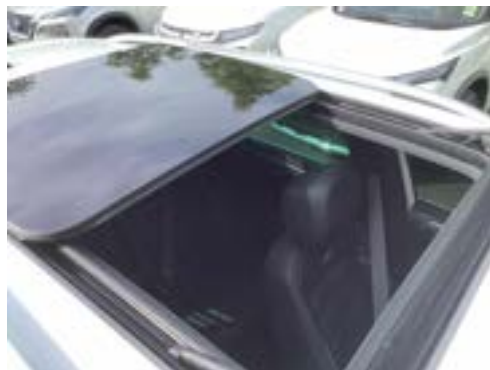
Sunroof and convertible roof

Sunroof operates correctly.

Internal sunshade operates correctly.

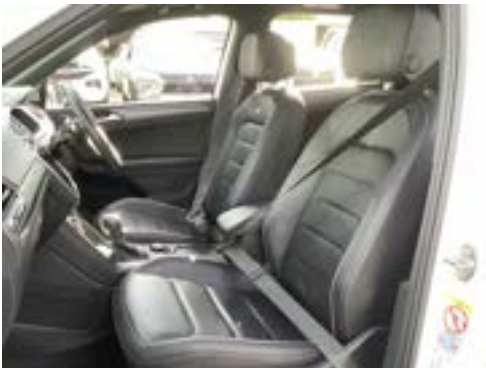
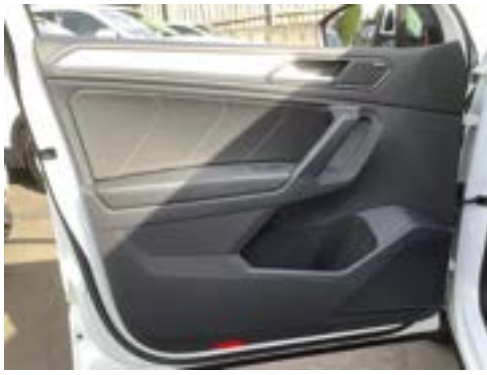
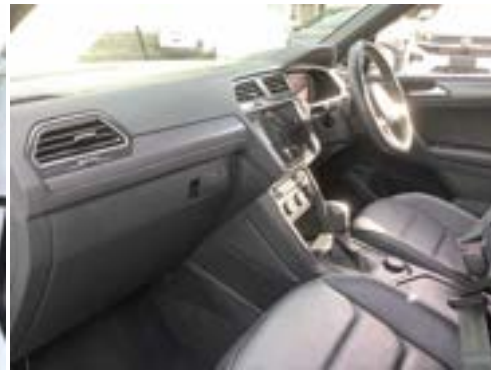
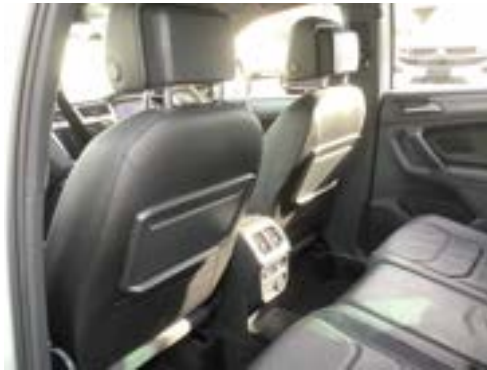
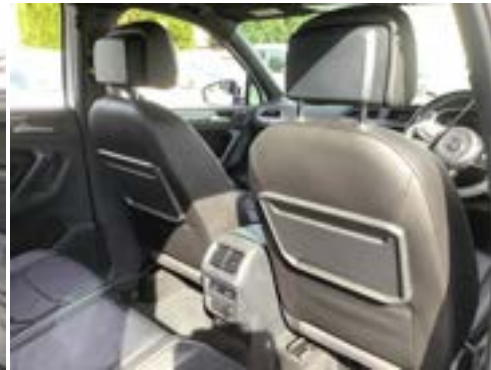
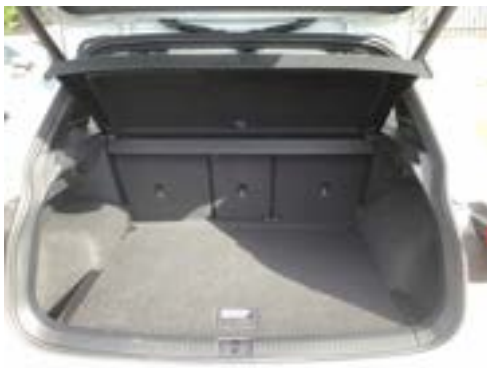
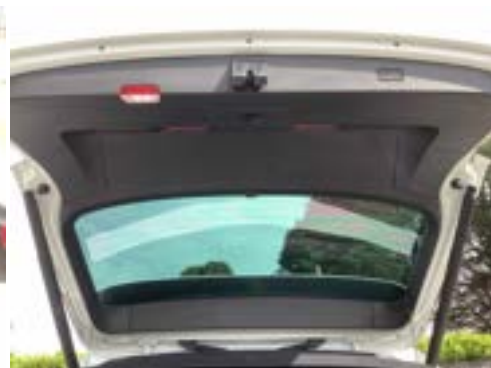
Interior comments

The interior trim and components appear to be in good order at the time of inspection.
General wear and tear to upholstery and trims mainly to contact areas.

All power options tested and operating correctly.

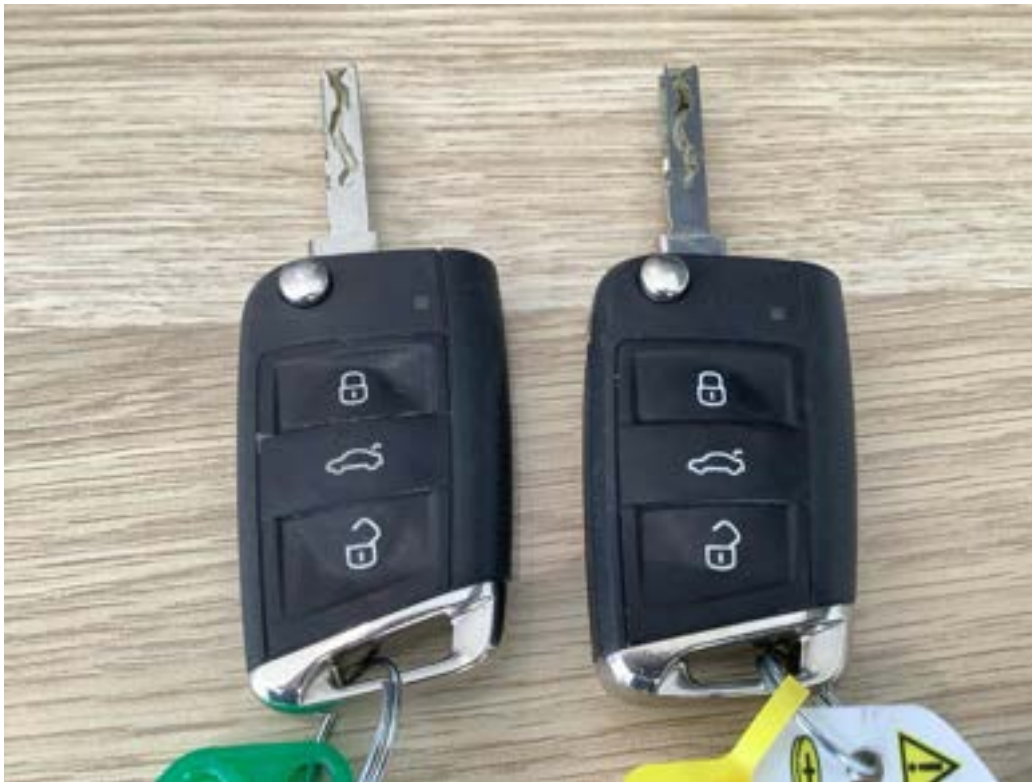
Keys and remotes

Two keys sighted.

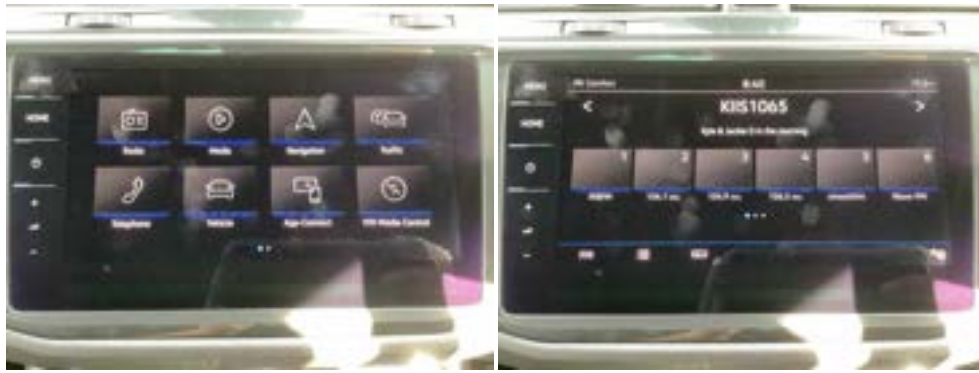
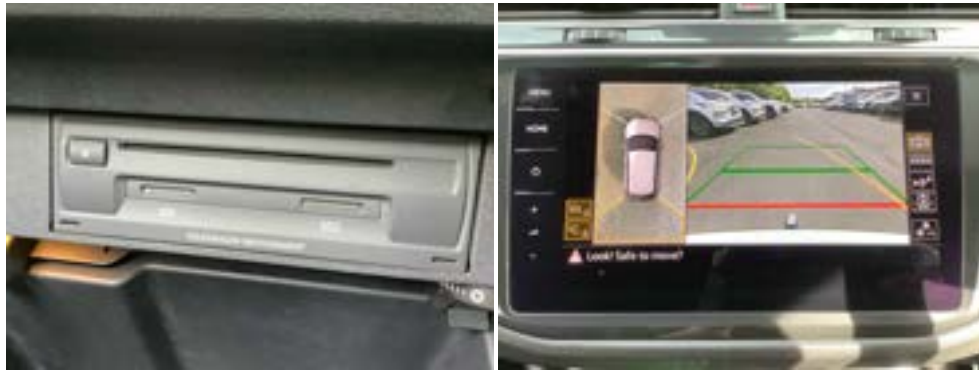
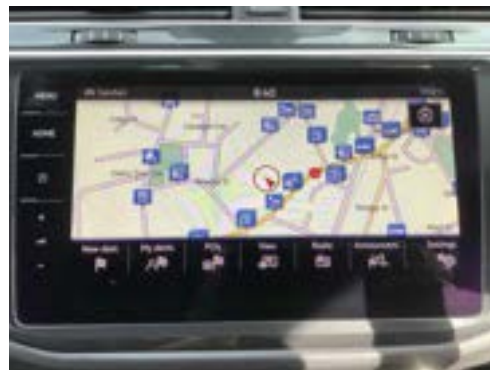
Entertainment system operational (radio and Cd player)

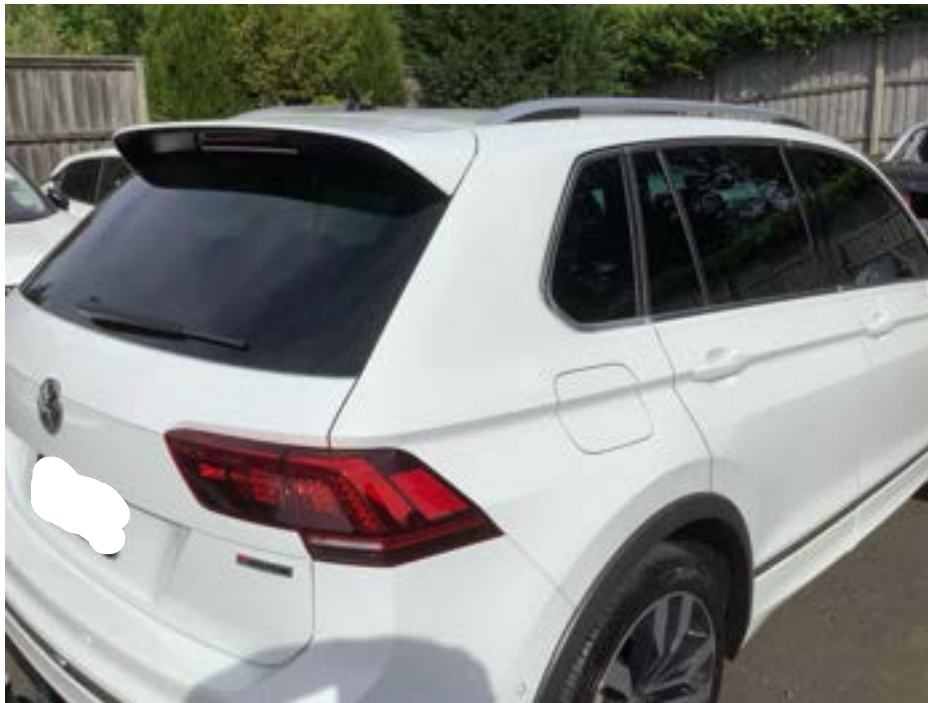
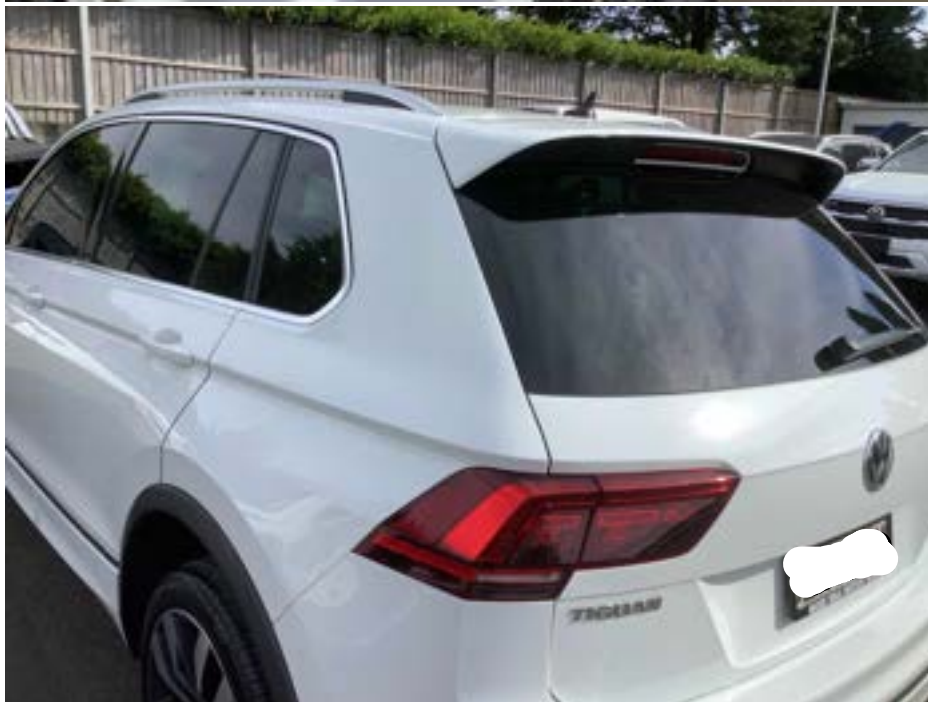
Window tint and accessories.

Windows have been tinted.

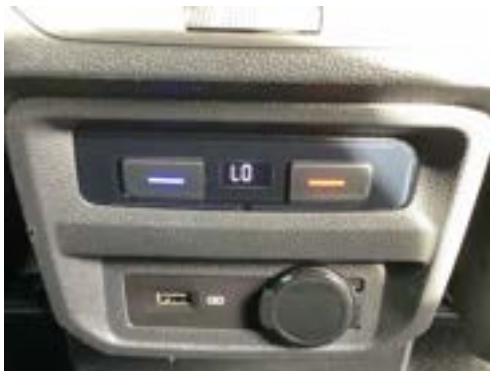
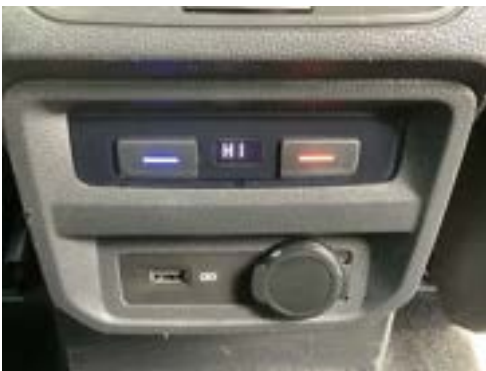
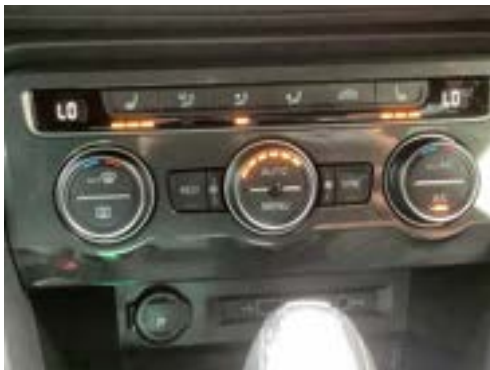
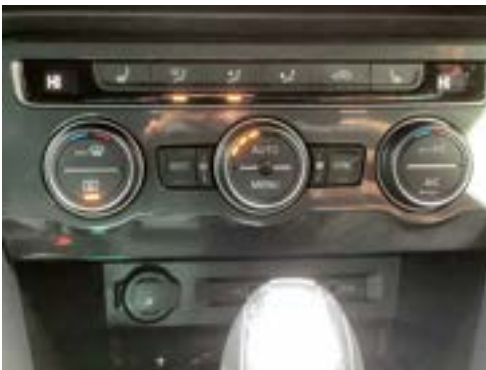
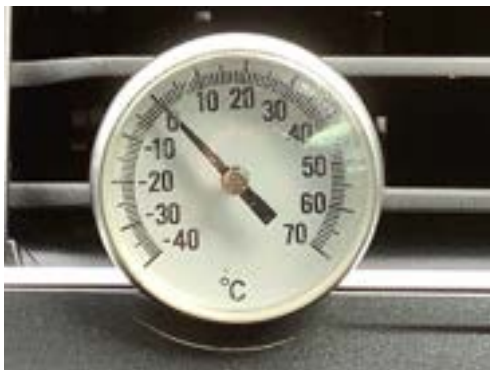
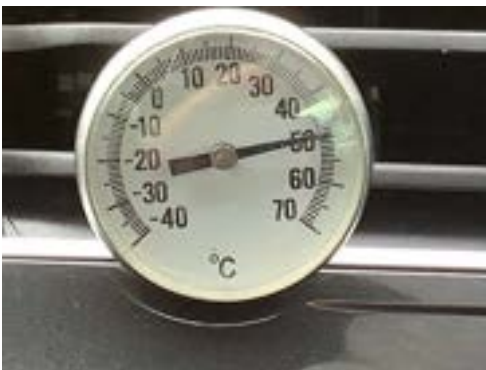
Air conditioning and heater has been tested-all operational.

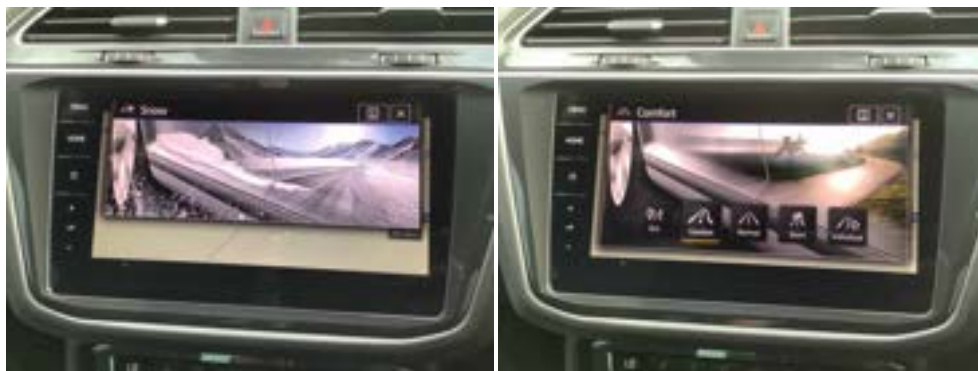
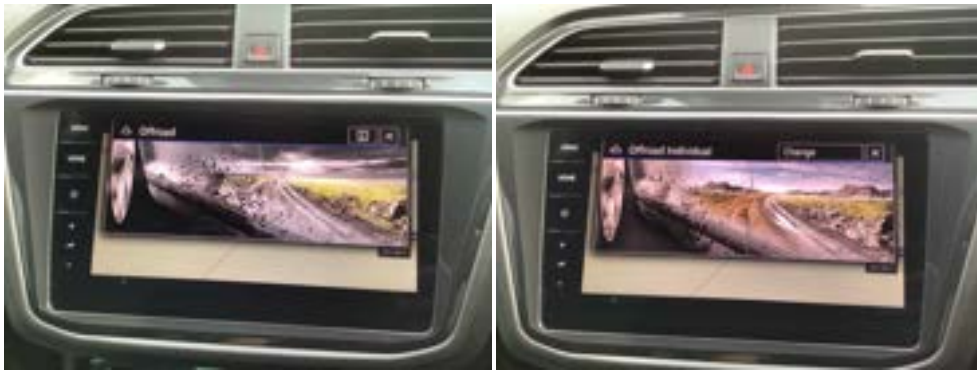
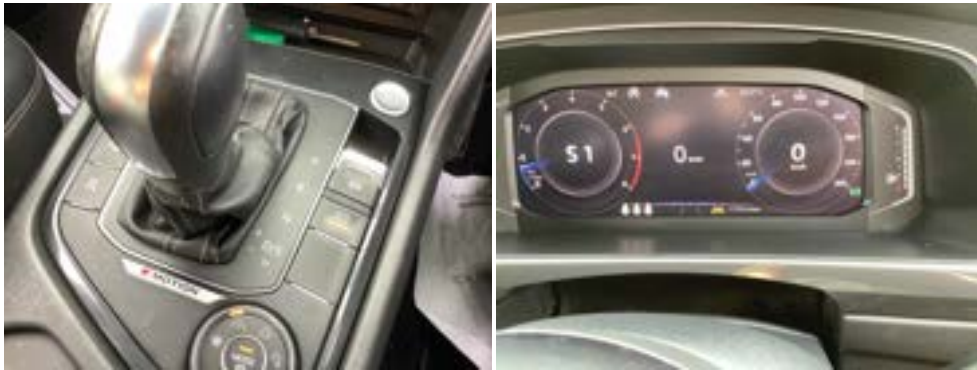
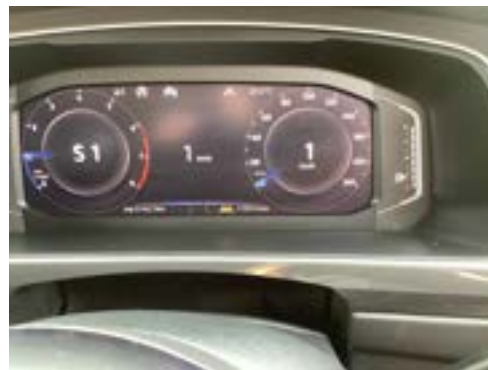
ABS and Cruise control operations have been tested-all ok

Auto brake hold has been tested and operates correctly.

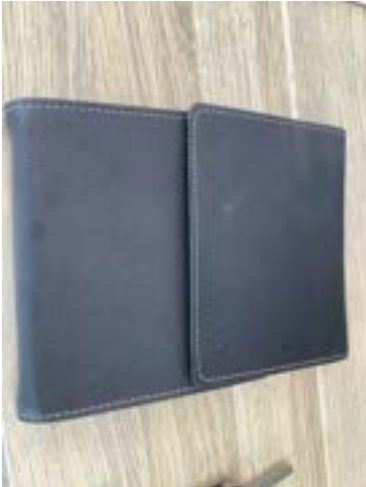
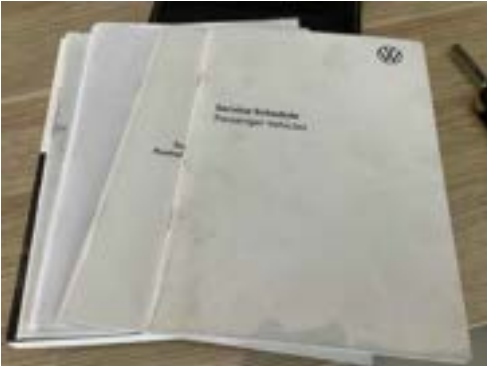
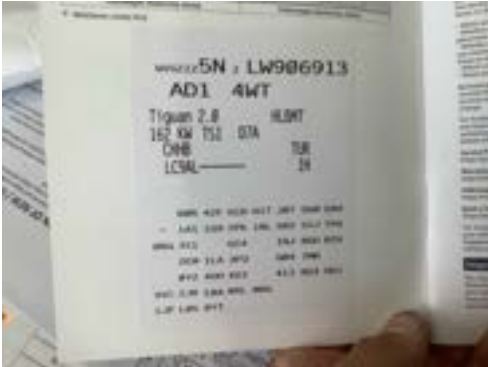
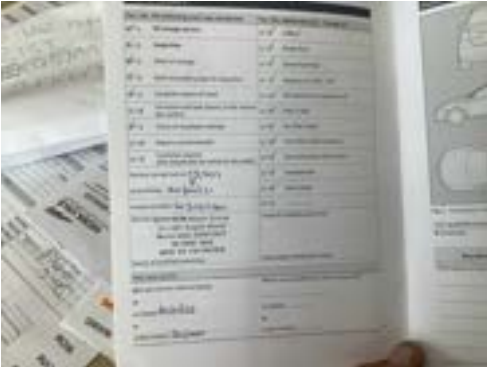
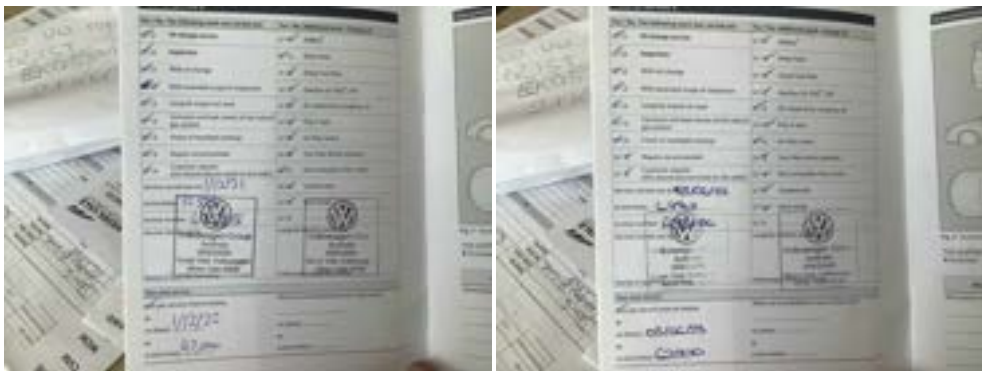
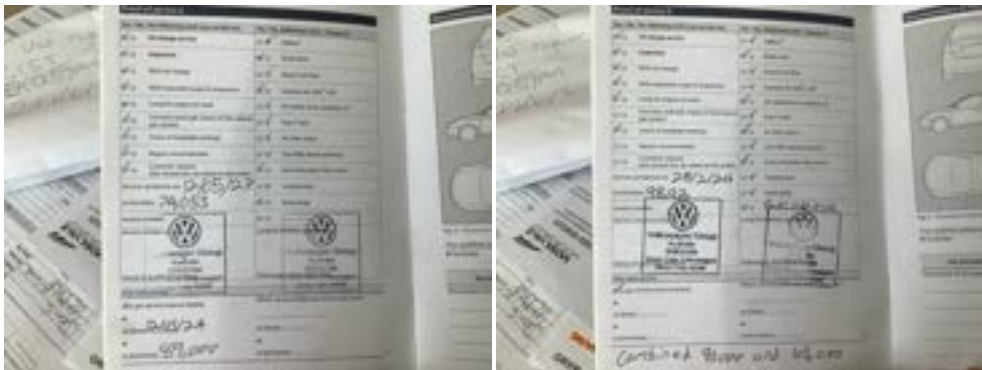
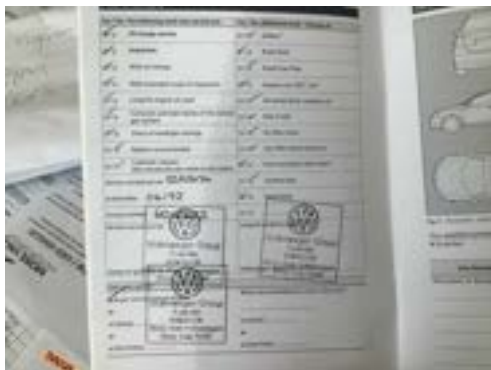
Service records

SERVICE LOG BOOKS SIGHTED AND APPEAR TO BE UP TO DATE.

Next Service due
130000kms

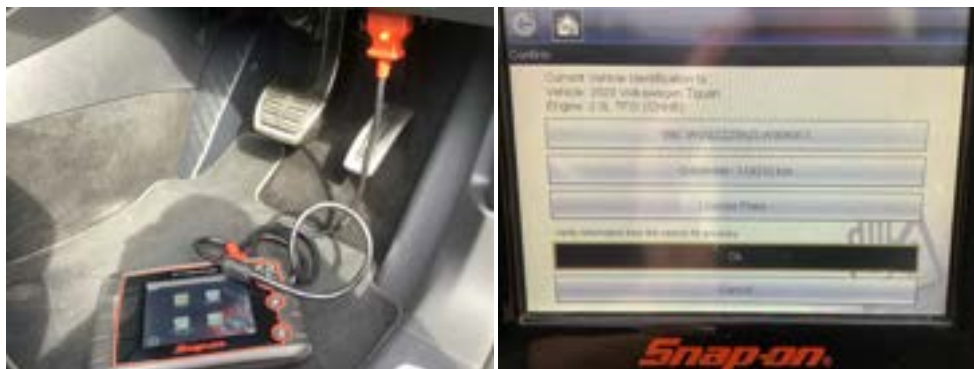
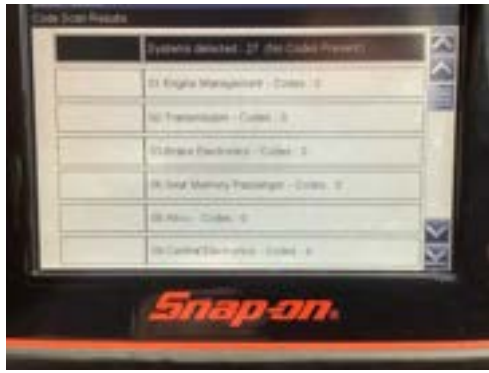
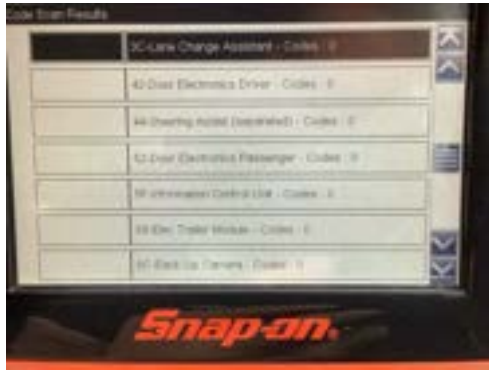
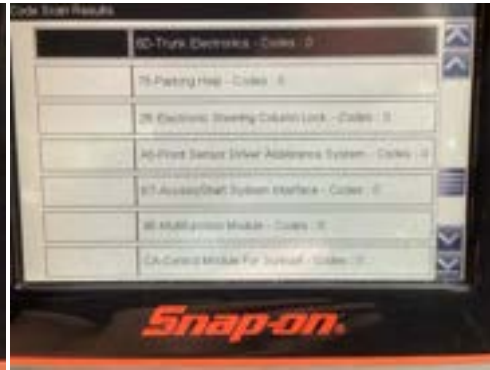
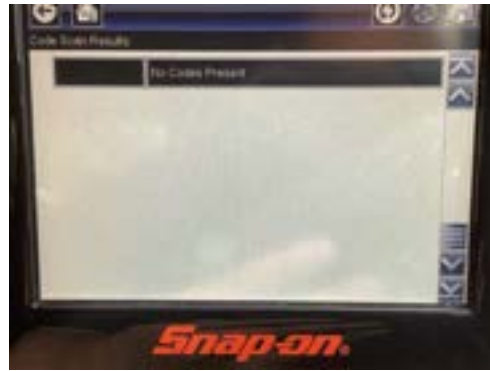
VEHICLE MANAGEMENT SCAN

VEHICLE MANAGEMENT SYSTEM HAS BEEN SCANNED-NO FAULT CODES RECORDED-ALL OK.
